P-19 Huntleigh and Tanglewood Estates

Project Information Meeting
September 2015

Storm Water Master Plan Overview

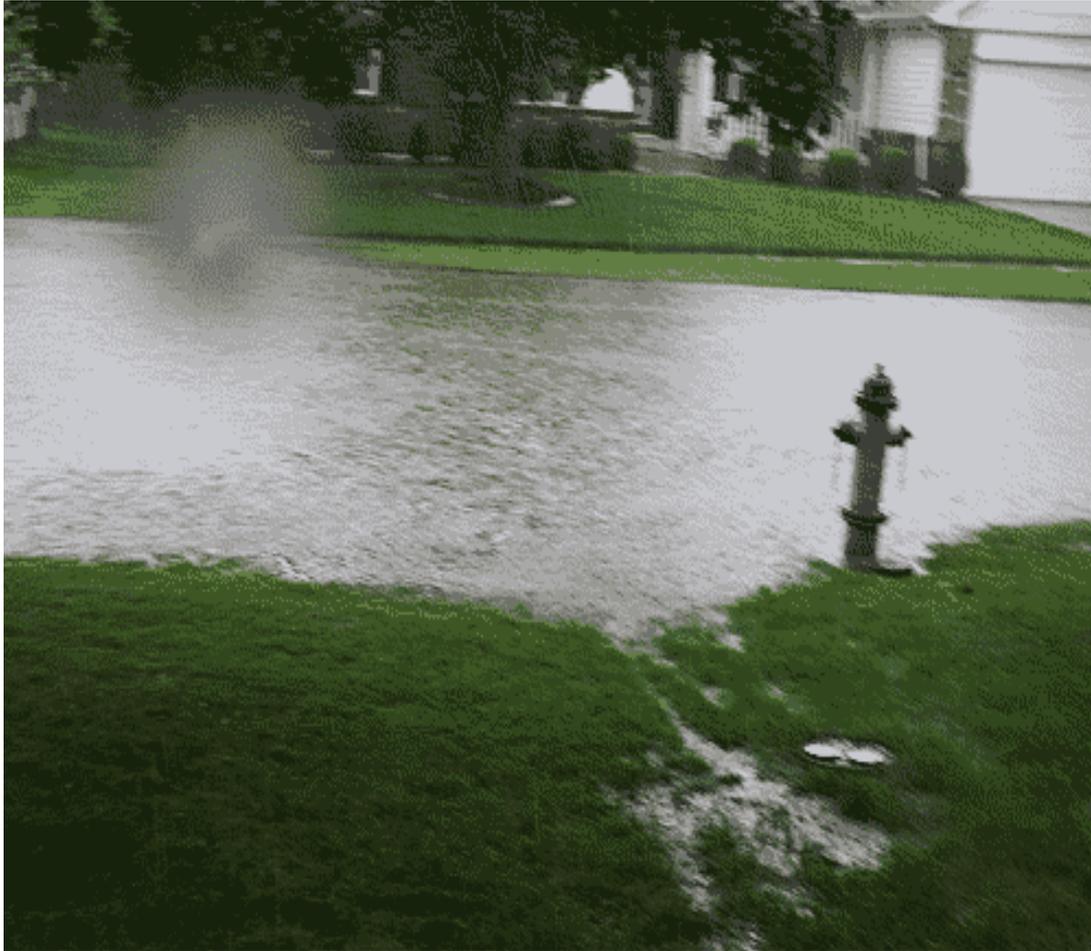
Street ponding

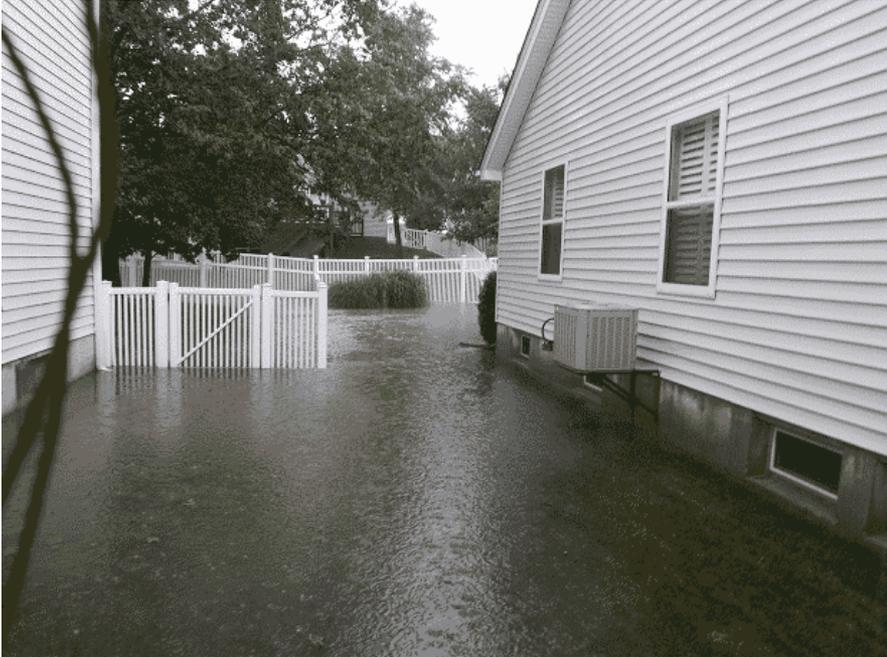
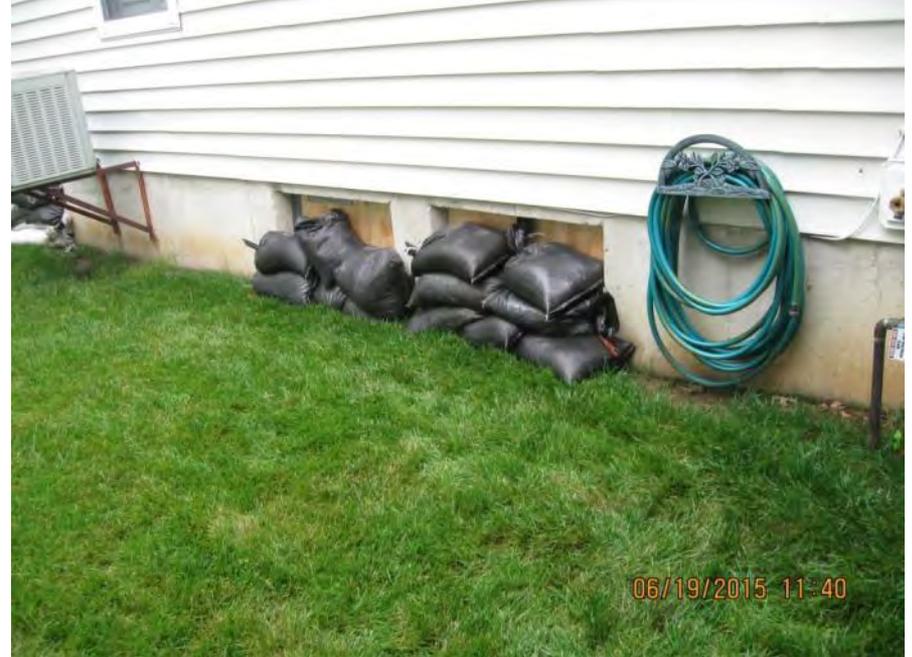
Yard ponding

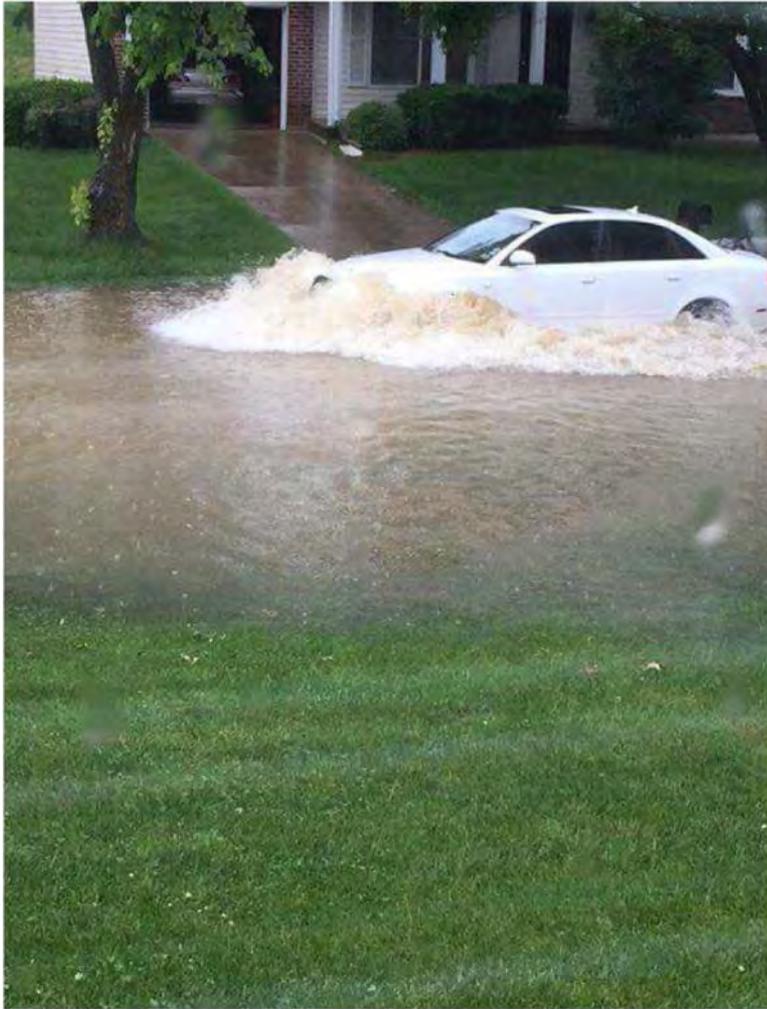
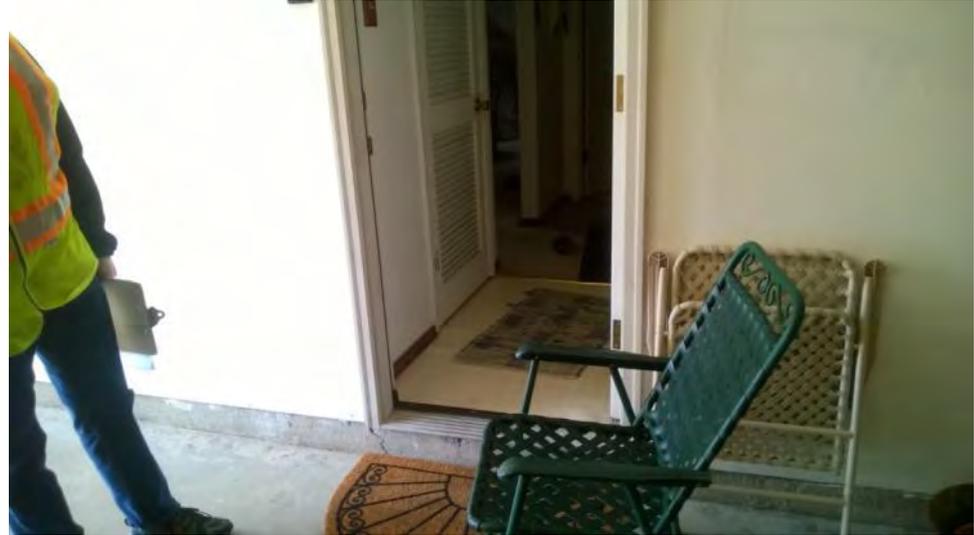
Street ponding (Driftwood Lane between
Burning Leaf Drive and Cedarwood Court)

Ponding has entered house through garage
at 196 Driftwood Lane

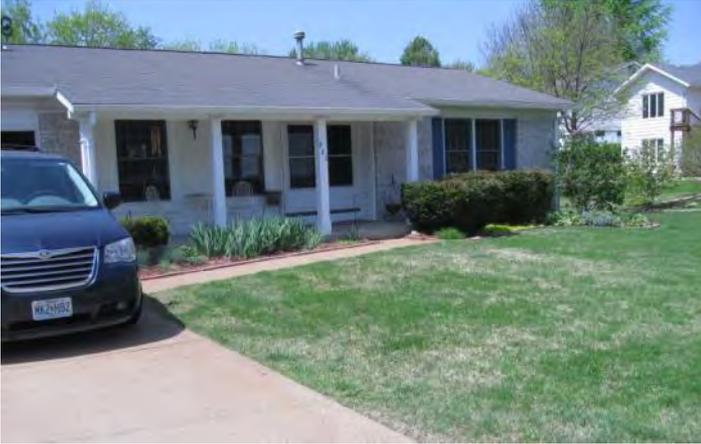
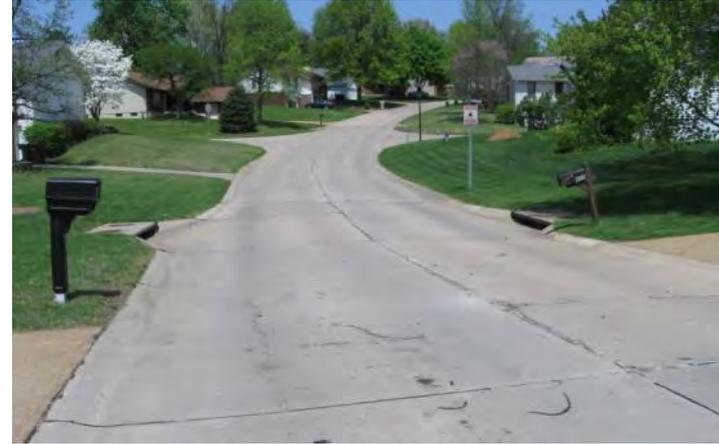
Two street inlets are regularly overwhelmed on Millwood Drive at Driftwood Lane. Ponding has been so deep that water flows along both sides 821 Millwood Drive down to the backyards of Driftwood Lane homes.

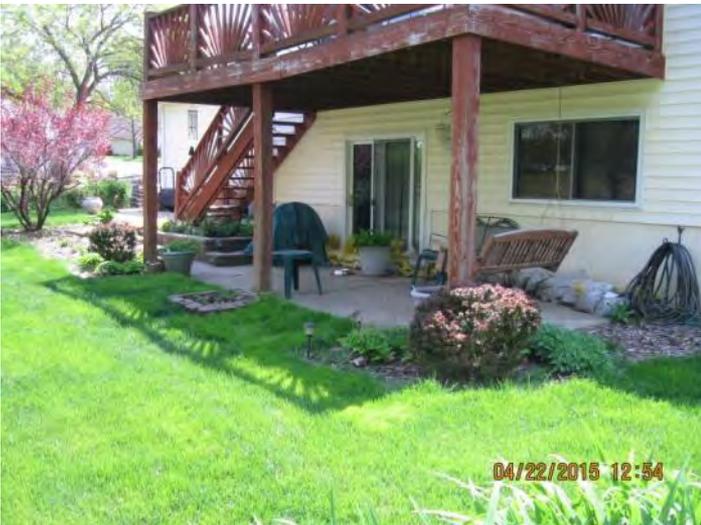
Stormflow enters sliding glass doors at 190 Driftwood Lane located downhill from 821 Millwood Drive. Sandbags are kept on the porch to prevent flooding.

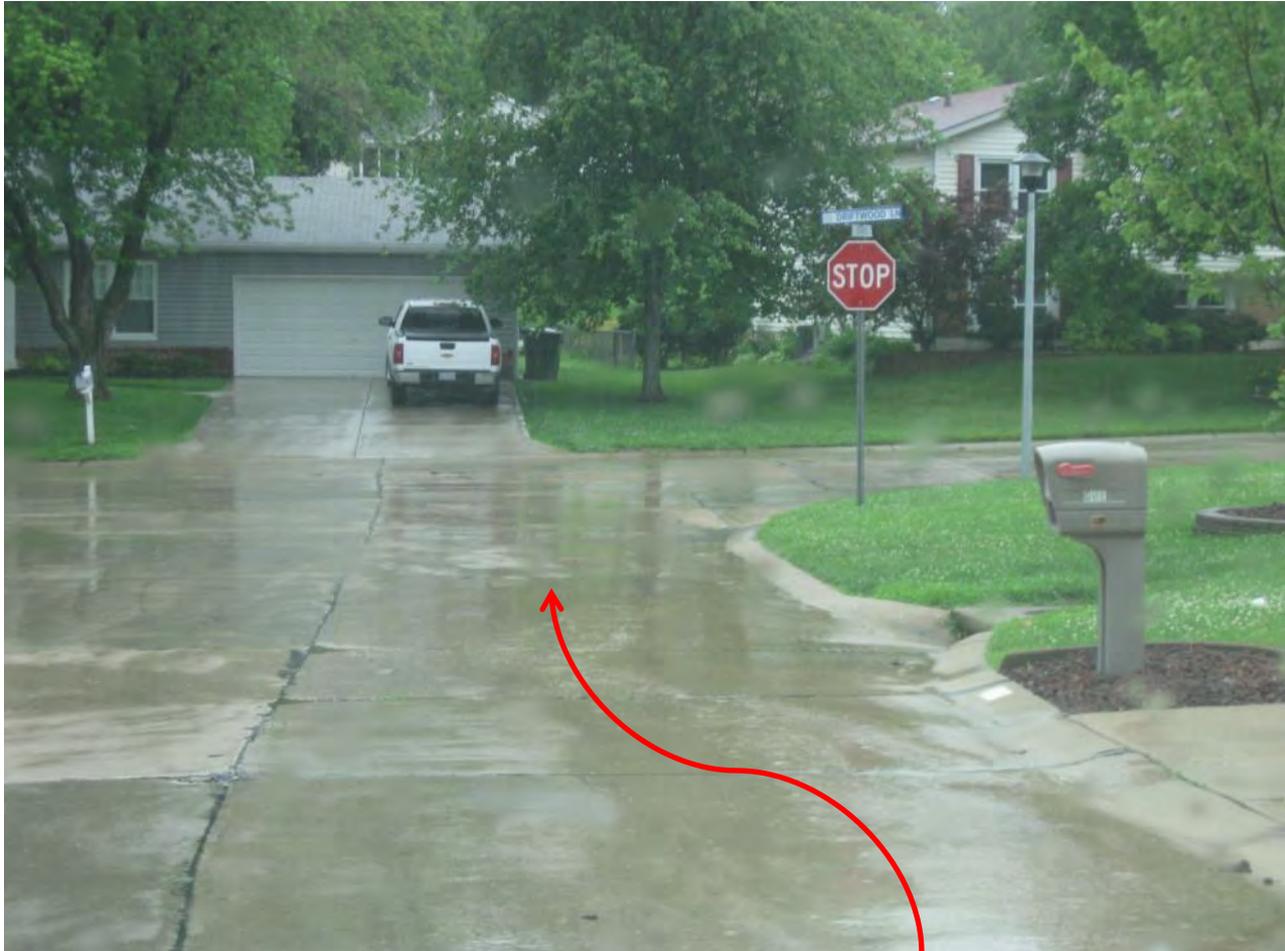
Sources of Drainage Problems: Some storm sewer structures not functioning as designed

Example of street inlet being bypassed due to improper pavement sump.

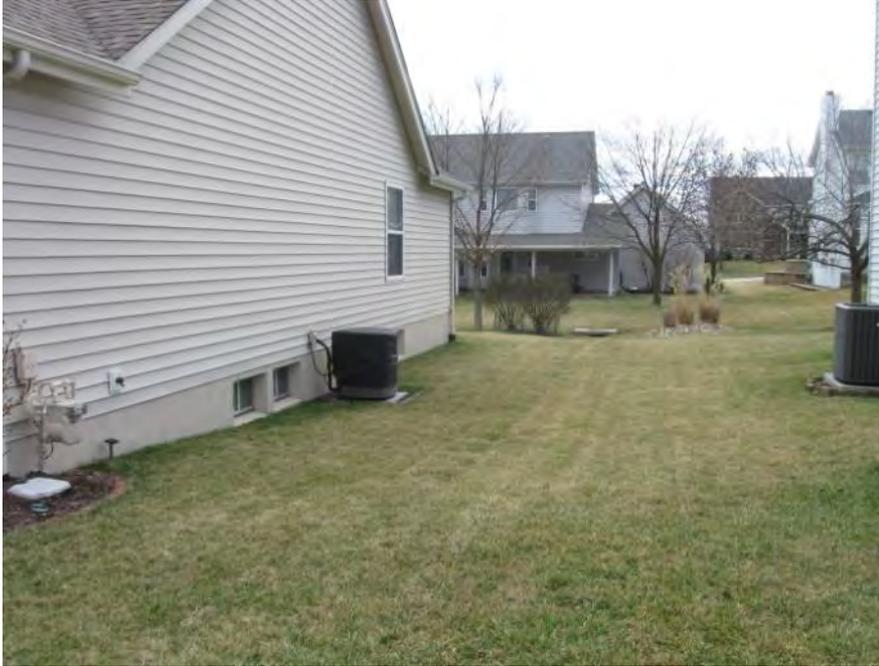
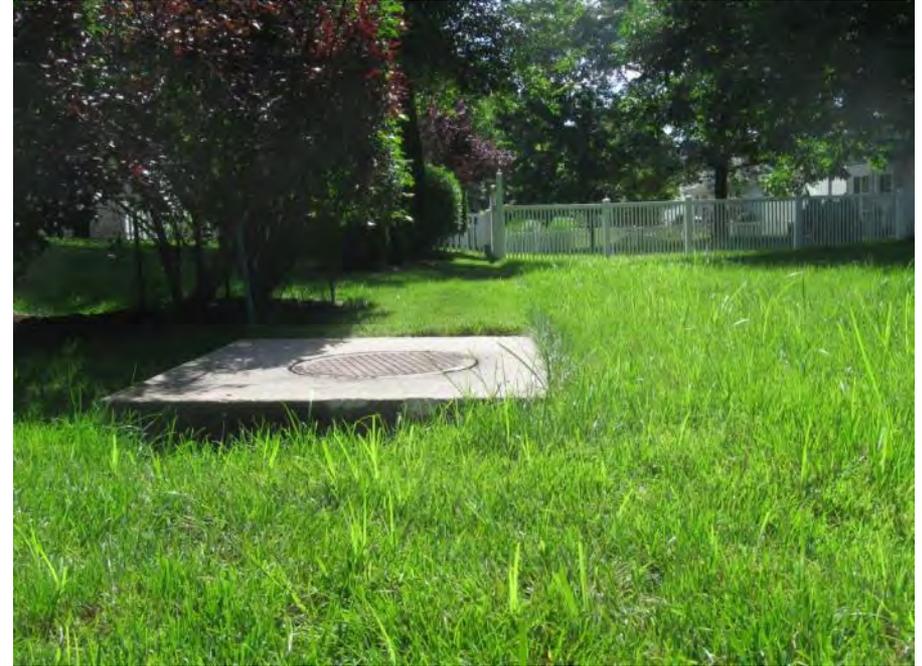
Some storm sewer structures not functioning as designed

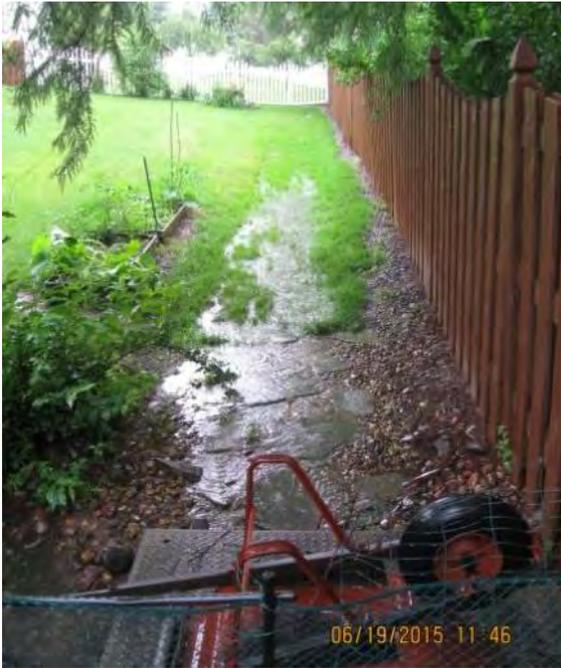
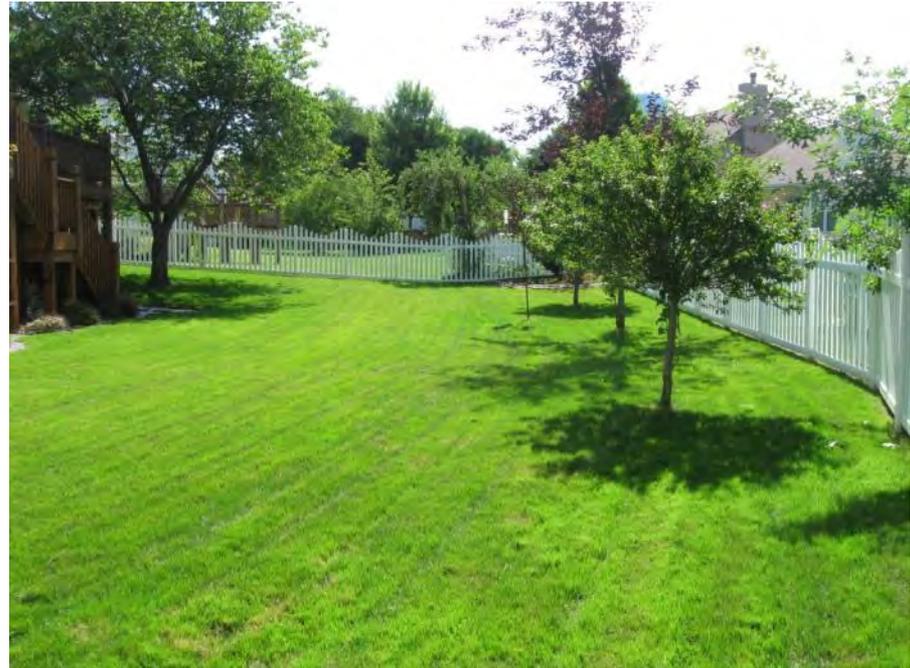
Some storm sewer structures not functioning as designed

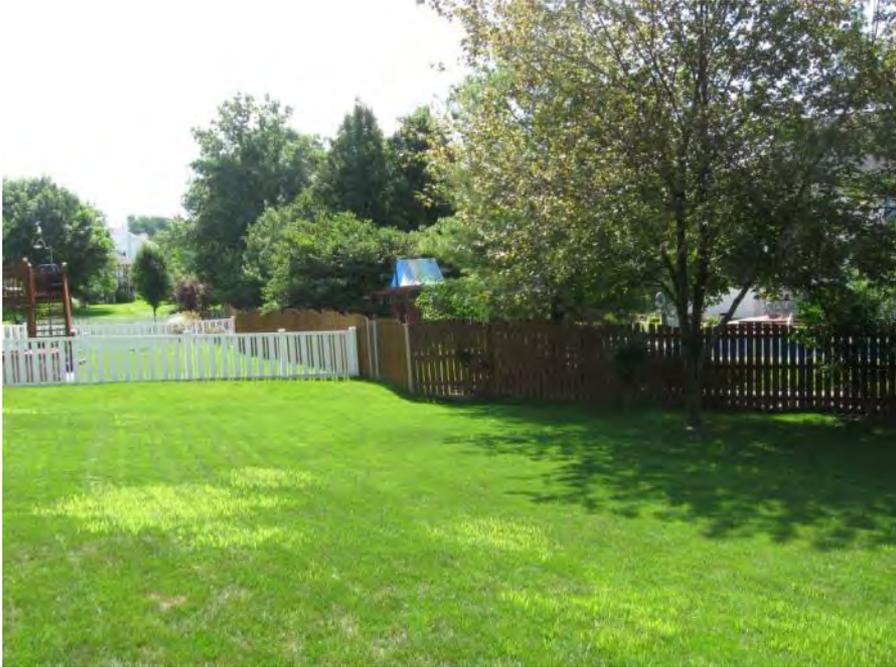
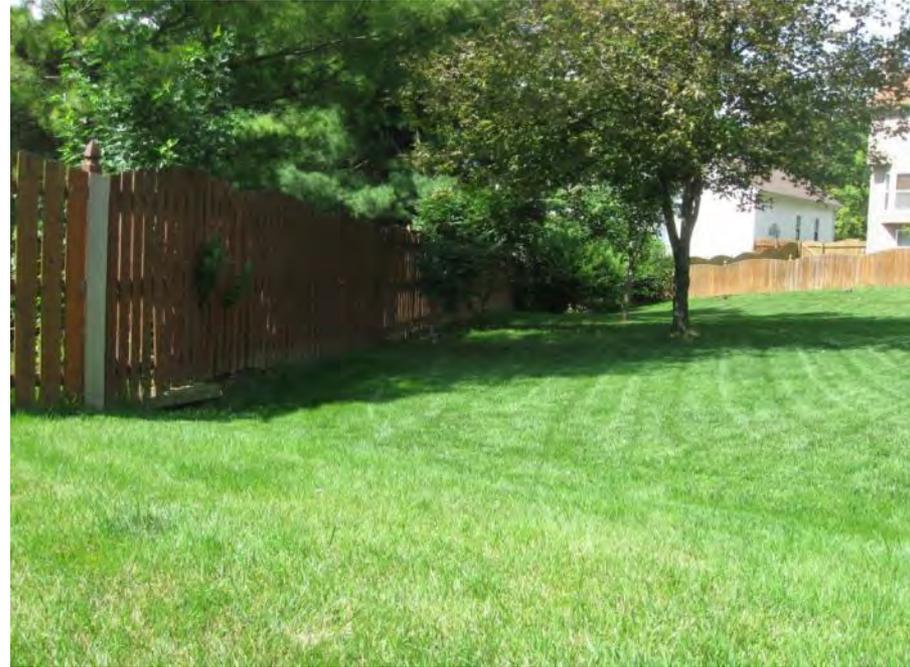
Sources of Drainage Problems: Site D

Some storm sewer structures not functioning as designed

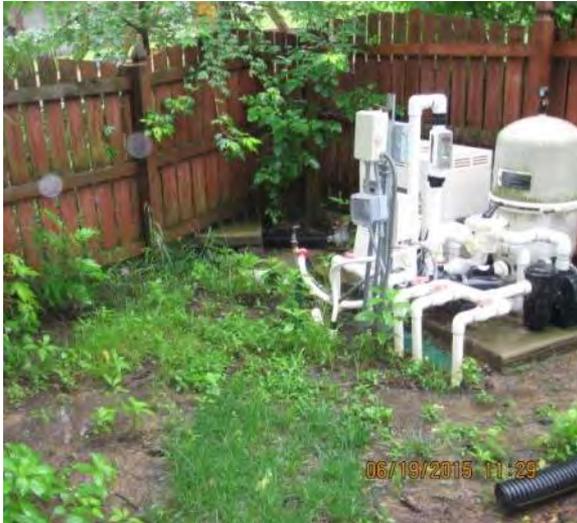
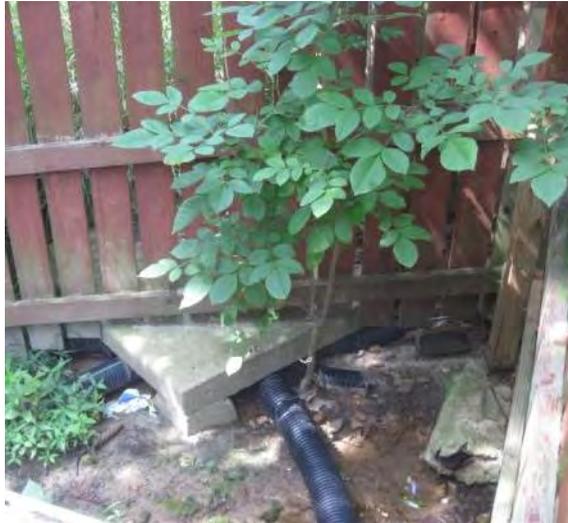
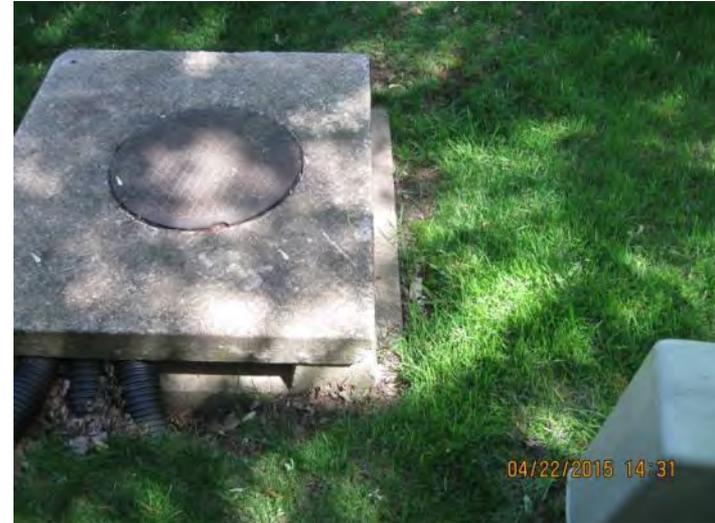
Sources of Drainage Problems: Site D

Some storm sewer structures not functioning as designed

Encroachment of fences and private drain lines causing bypass
(258 Barkwood Trails Drive & 540 Wyatt Drive)

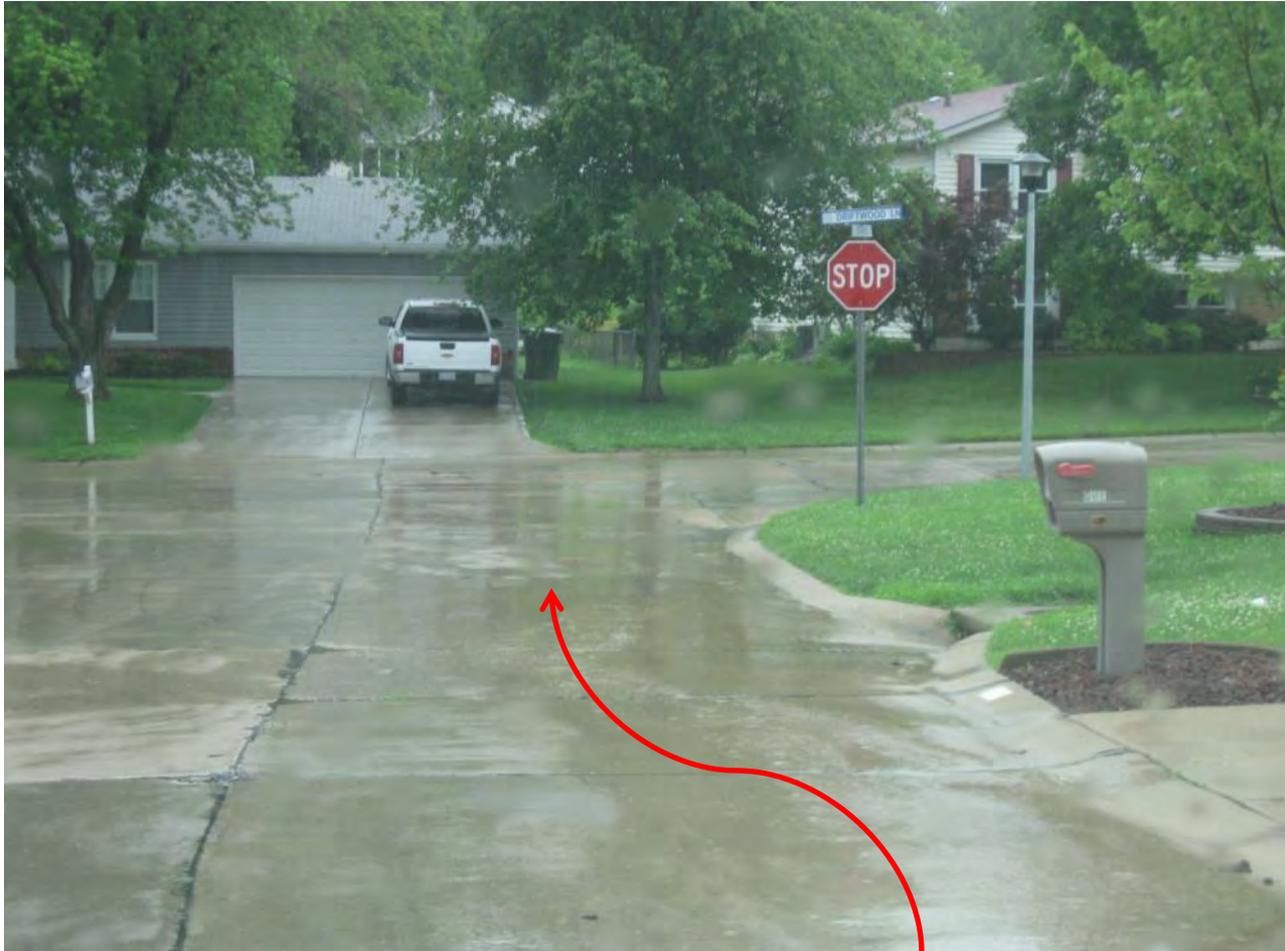
Some storm sewer structures not functioning as designed

Example of street inlet being bypassed due to improper pavement sump.

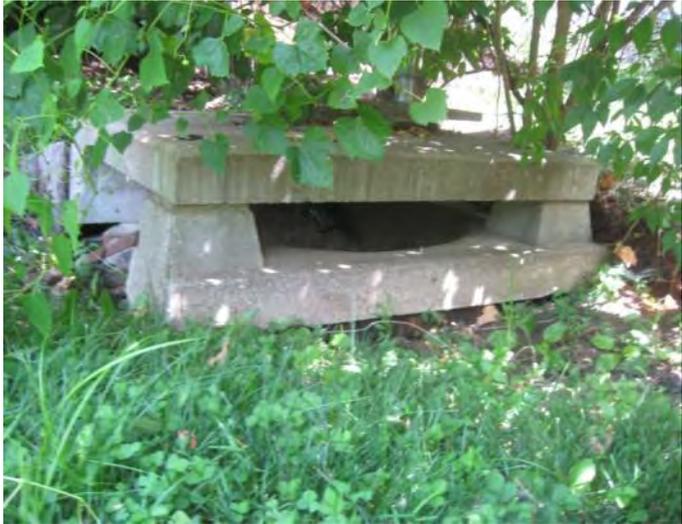
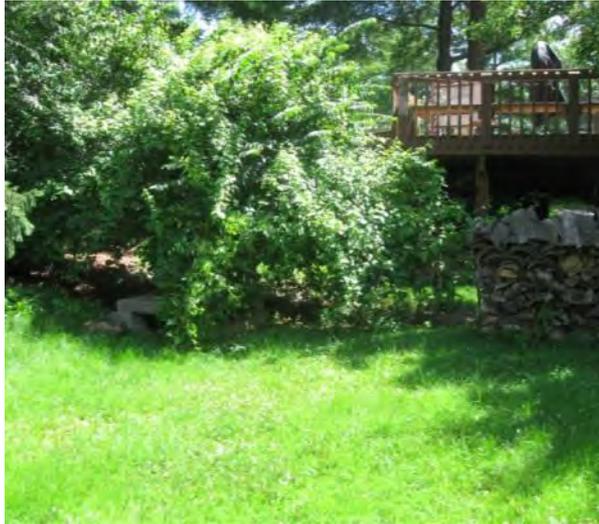
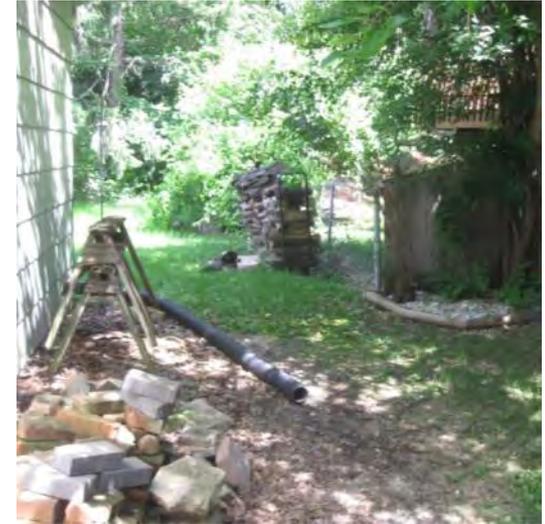
Some storm sewer structures not functioning as designed

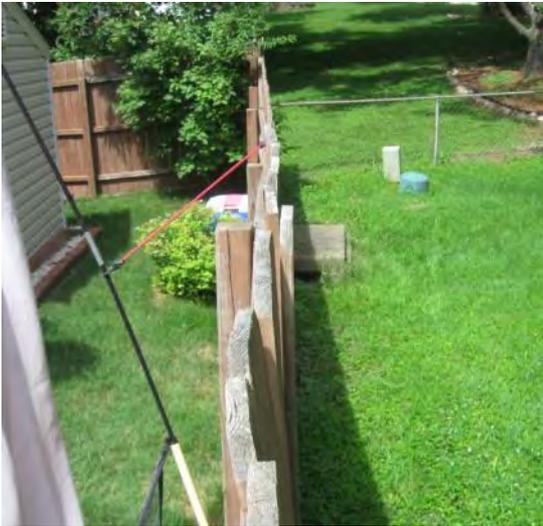
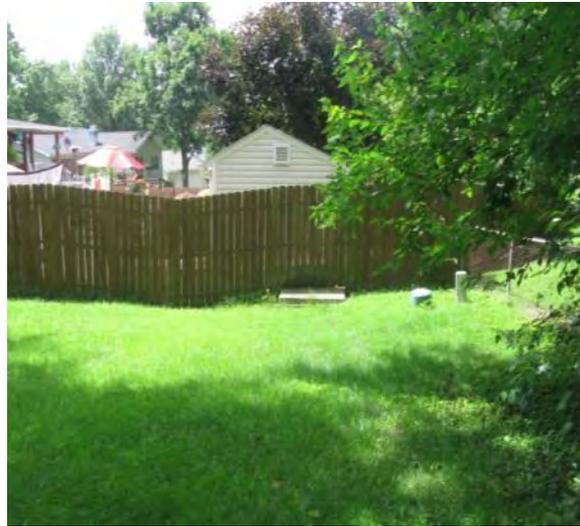
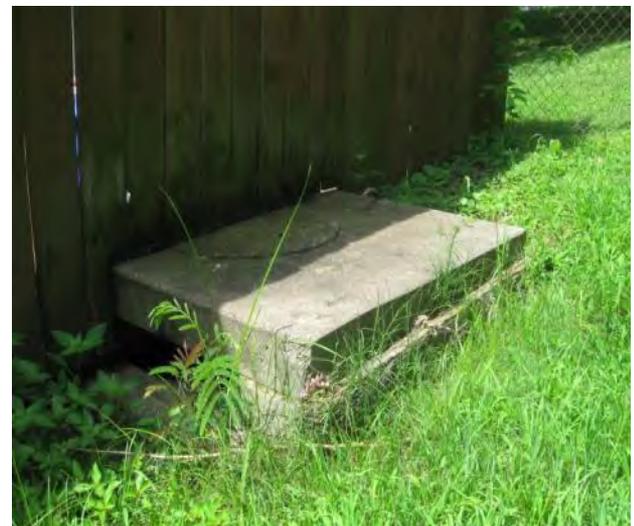
Some storm sewer structures not functioning as designed
