Stormwater Master Plan 2012

CITY OF ST. PETERS, MISSOURI

BLACK AND VEATCH
PATTI BANKS ASSOCIATES

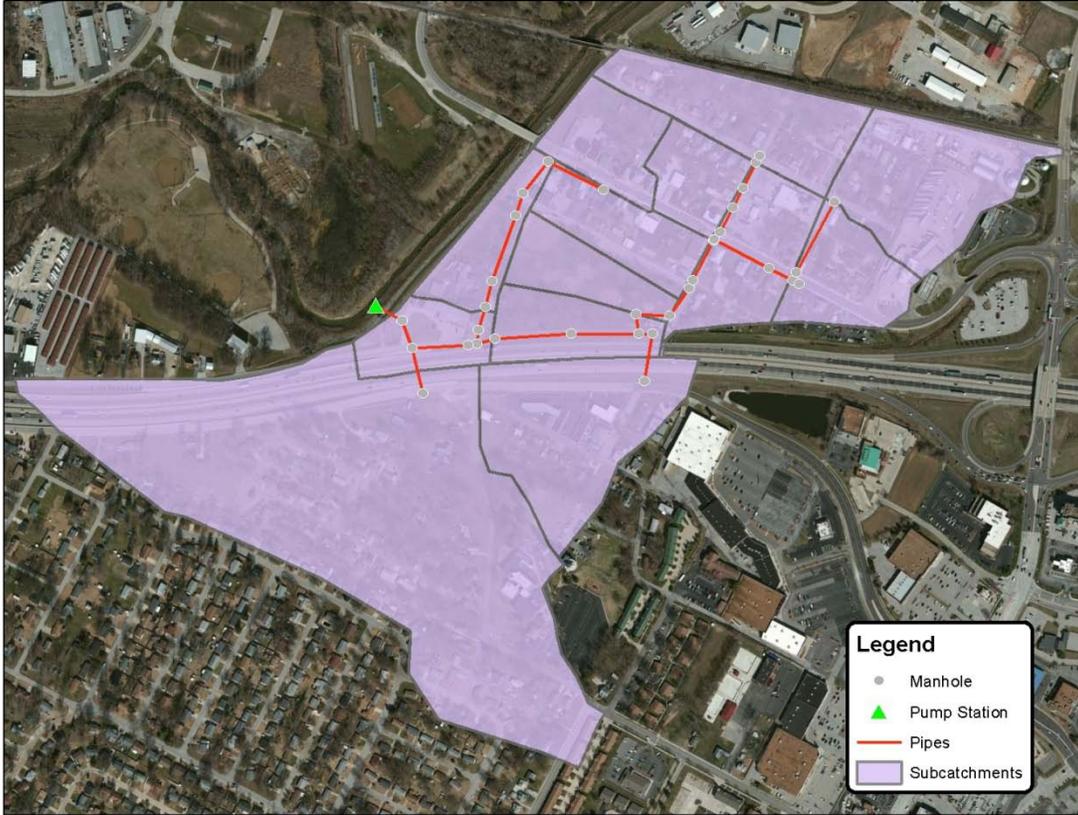
FIGURE 14. OLD TOWN DRAINAGE SYSTEM AND SUBAREAS

The Old Town stormwater drainage basin is a relatively flat basin that is bordered on the west by the Dardenne Creek levee, and road and highway embankments in the other directions; however there is a significant amount of drainage area to the south of I-70 that is conveyed underneath the highway and makes its way into the Old Town drainage system. The stormwater is conveyed in a pipe system to the Old Town Pump Station and discharges to Dardenne Creek. When the water surface elevation in Dardenne Creek is higher, flow is then pumped into Dardenne Creek. In a system such as this, not only do the pipes and storm water inlets need to have adequate capacity for the level of service design event, but so does the pump station. It should be noted that the modeling performed in this basin only evaluated the pipe system shown and did not evaluate stormwater inlets. If stormwater inlets are inadequate, then localized flooding issues can occur; however, their impact is generally limited as excess flows will usually flow down roads to other entry locations into the stormwater system. If the pipe system or pump station capacity is inadequate, more severe flooding can occur. The following Figures 14 and 15 show an overview of the Old Town basin and a schematic of the stormwater system analyzed.

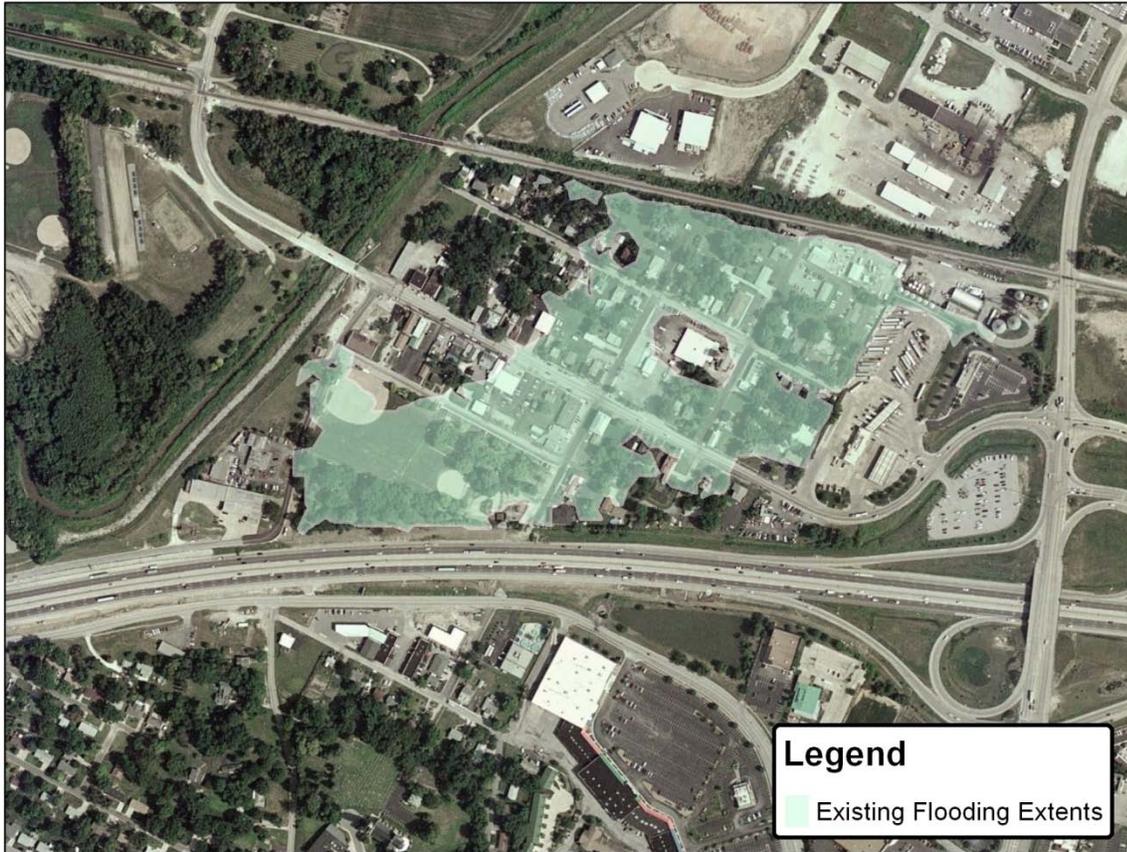
FIGURE 16. OLD TOWN AREA OF INUNDATION, 15-YR, 24-HR EXISTING CONDITIONS

Using the coupled 1D-2D XP-SWMM model, the extents of the flooding were determined for Old Town. Figure 16 shows the extent of the flooding within Old Town:

In the existing conditions, approximately 29 acres of Old Town is inundated to a water surface elevation of 440.3 ft (as the water surface elevation is a two dimensional surface, there is variation across the surface, but for this analysis the concern is the elevation near the lower elevations of the basin). Most of the basin located within the 29 acre inundation area has a surface elevation of approximately 440, which means that much of the area would experience relatively shallow inundation (0.3 ft) and much of the deeper inundation would be in localized low areas.

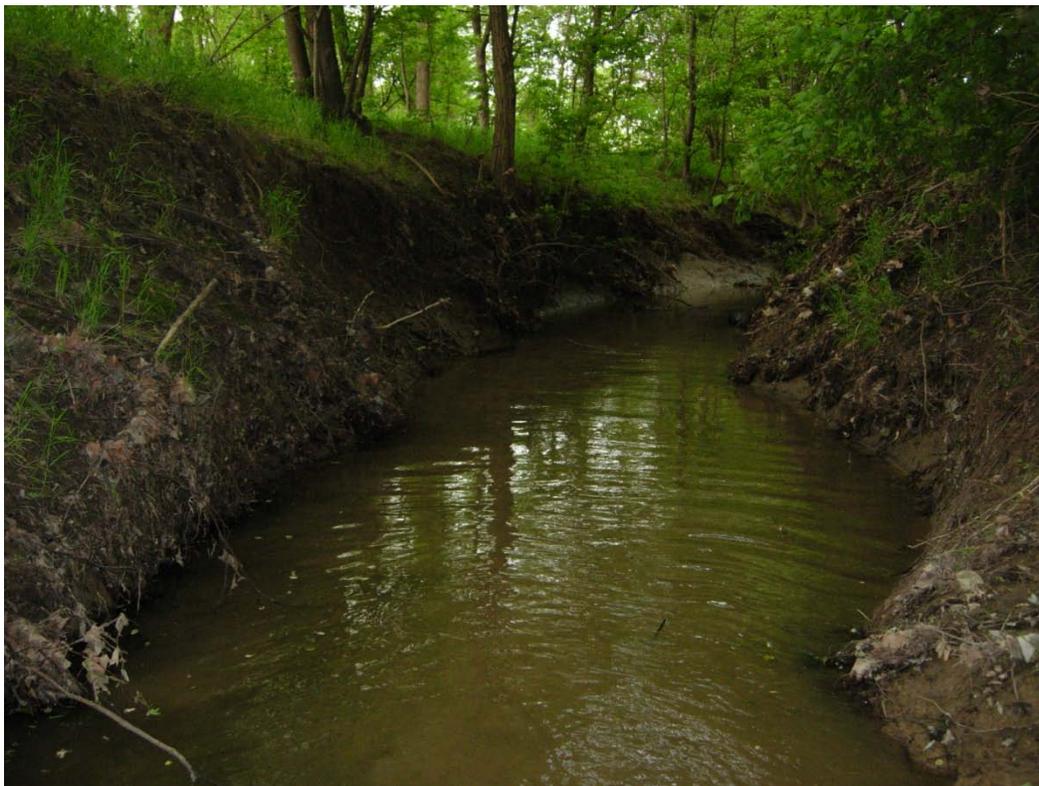
FIGURE 18. INCISED REACH, EAST SPENCER TRIBUTARY NEAR CONFLUENCE WITH SPENCER CREEK

A majority of the stream network is incised, as documented in the 2002 watershed study and as shown in Figure 18. Channel incision is a response to changes in the hydrology of the contributing drainage area as well as channel bed materials and downstream conditions. The stream network within the City limits has varying levels of stability and incision. The downstream ends of the main tributaries to Spencer Creek have already experienced changes in structure and are now very incised. In these streams, further incision is likely to occur as a small low flow channel cutting into the hard clay bed was documented in the field. Reaches higher up in the watershed have very steep profiles and debris jams of roots or other material were often found to provide temporary vertical grade control.

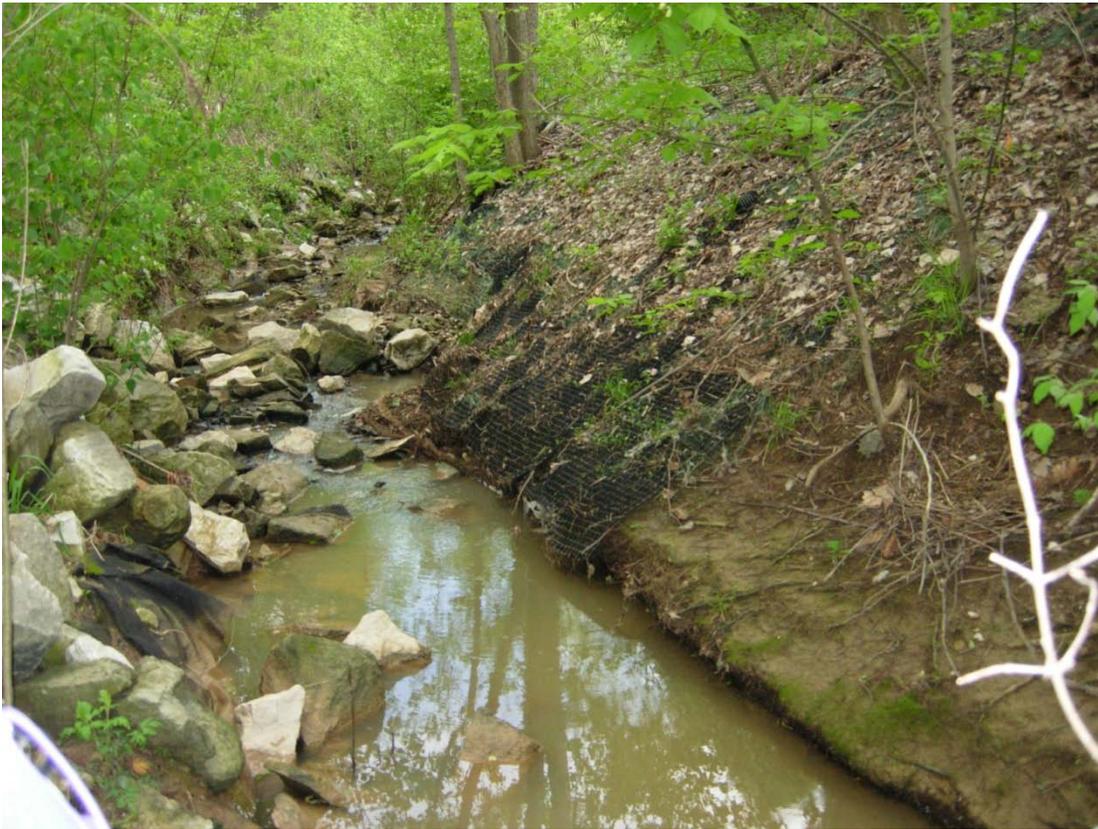
FIGURE 19. TRM SYNTHETIC STABILIZATION METHOD FAILURE

Over the past decade, the City has applied a variety of bioengineered techniques incorporating synthetic and vegetative materials – with varying levels of success. Based on field observation, one of the most critical elements of successful stabilization projects is to ensure that sufficient flow and sediment conveyance are provided.

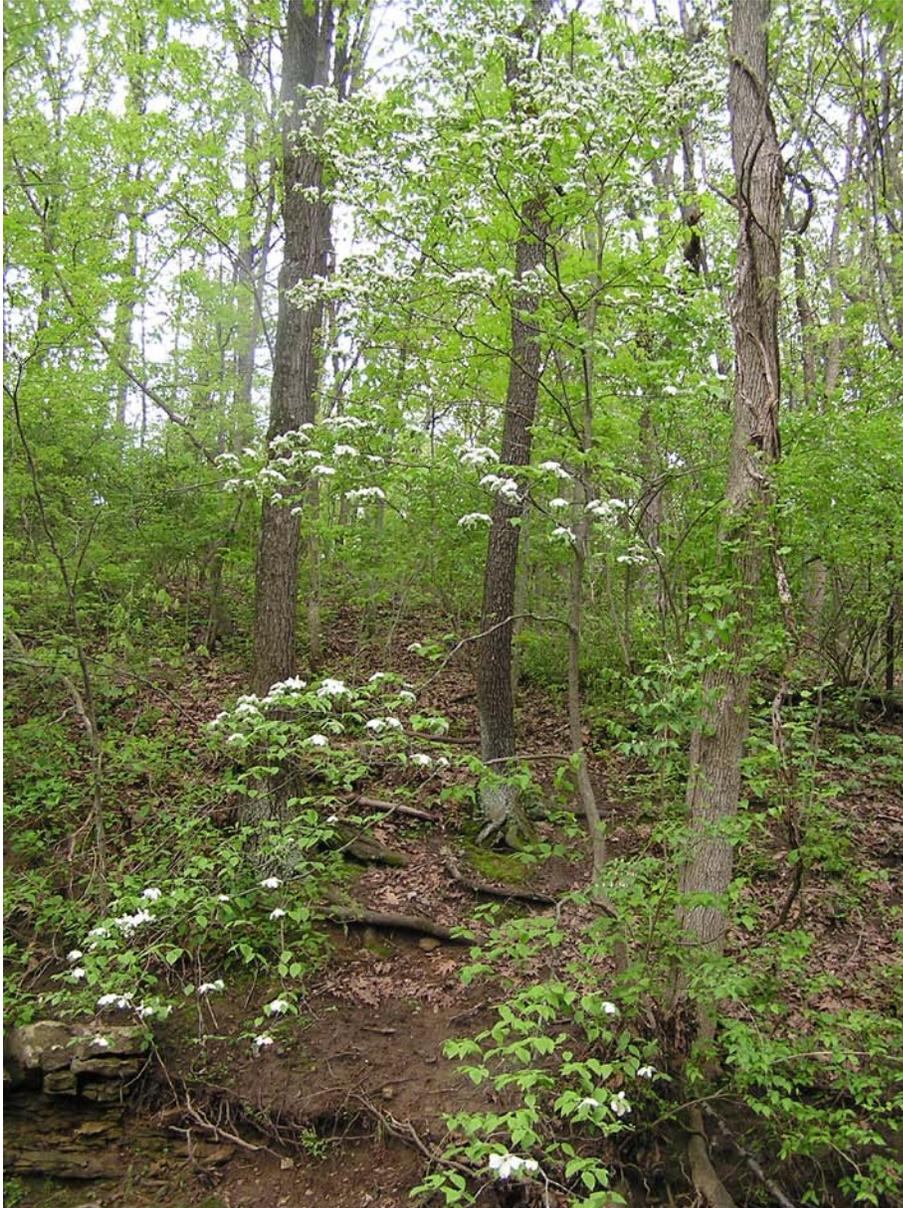
FIGURE 21. DESIRABLE RIPARIAN CORRIDOR CONDITIONS

Desirable riparian corridor: this photo is of an area east of Jungermann Road and illustrates a good mix of canopy and understory species with very little undesirables; trees are a mix of ages, and the canopy is open enough to allow for good understory vegetation.

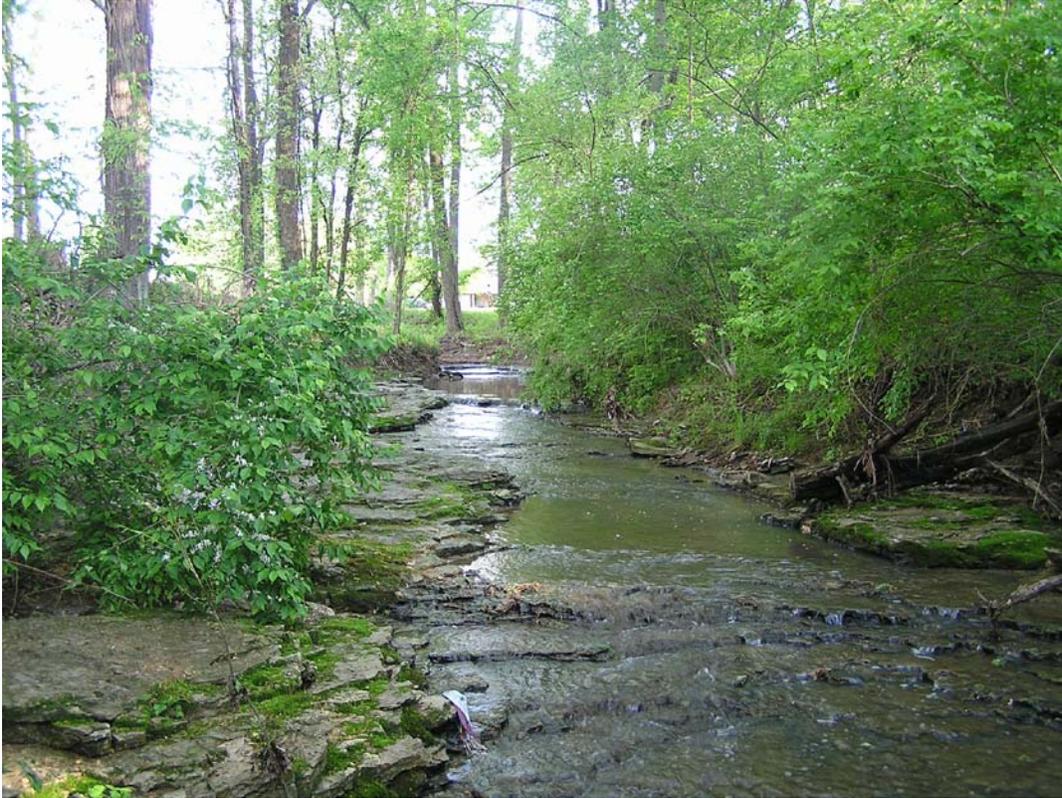
FIGURE 22. UNDESIRABLE RIPARIAN CORRIDOR CONDITIONS

Undesirable riparian corridor: this photo shows undesirable vegetation (honeysuckle) dominating one side of corridor; and a thin, almost non-existent corridor on the other side.

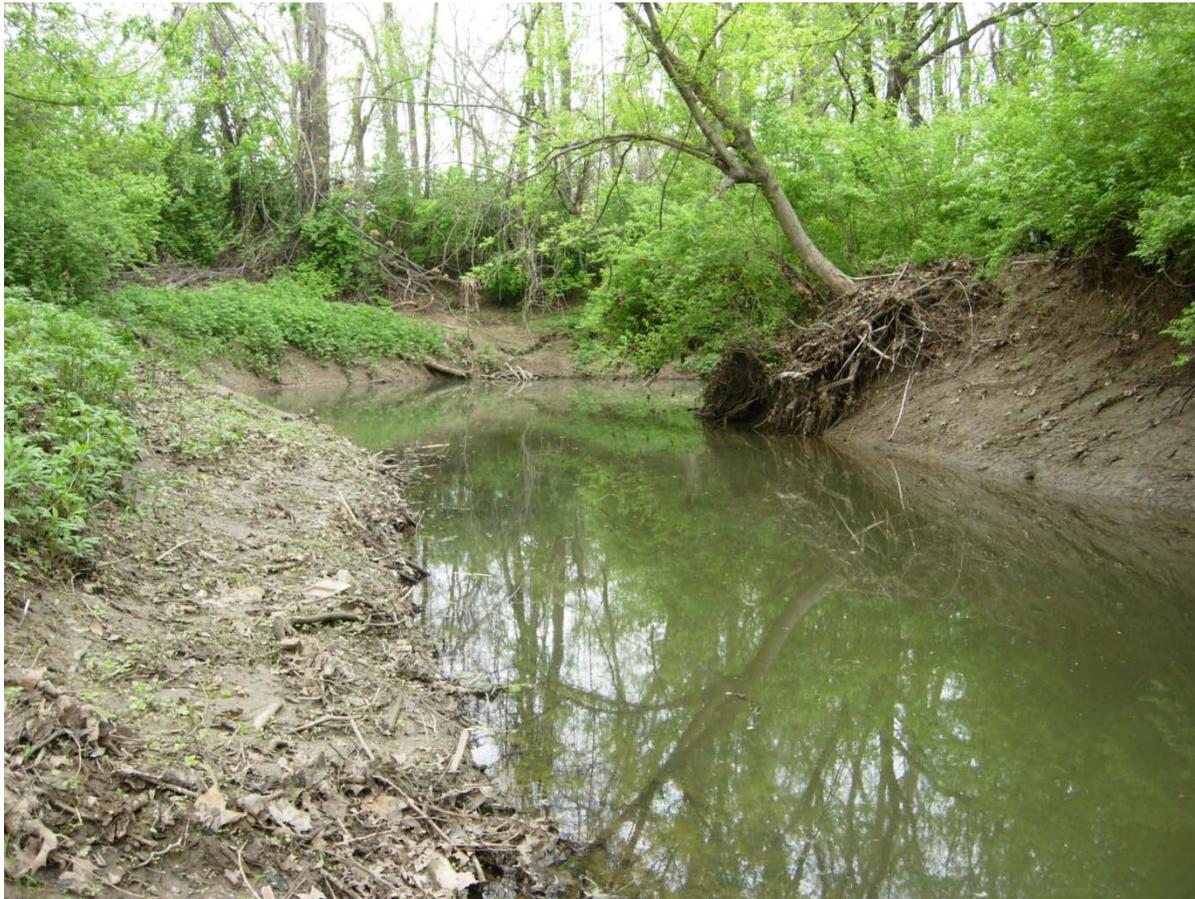
A channel condition rating between 13 and 19 indicates that the reach may be experiencing instability and special measures may be needed to address specific issues that were rated poorly. Streams with scores in this range may have very different appearances because of the specific concern with each stream. In St. Peters, many of the channels show evidence of bank undercutting, excess sediment movement in the channel bed, debris jams, and undesirable vegetation. Figure 2 presents Spencer Creek north of Mexico Road. This reach is experiencing a transition to a wider stream after becoming incised (the channel bed material erodes and lowers the elevation). Bare soil on the banks is exposed to flow in the channel and the vegetation is mostly shrub honeysuckle, an invasive plant that out-competes native species.

FIGURE 2. SPENCER CREEK NORTH OF MEXICO, SCORE: 16

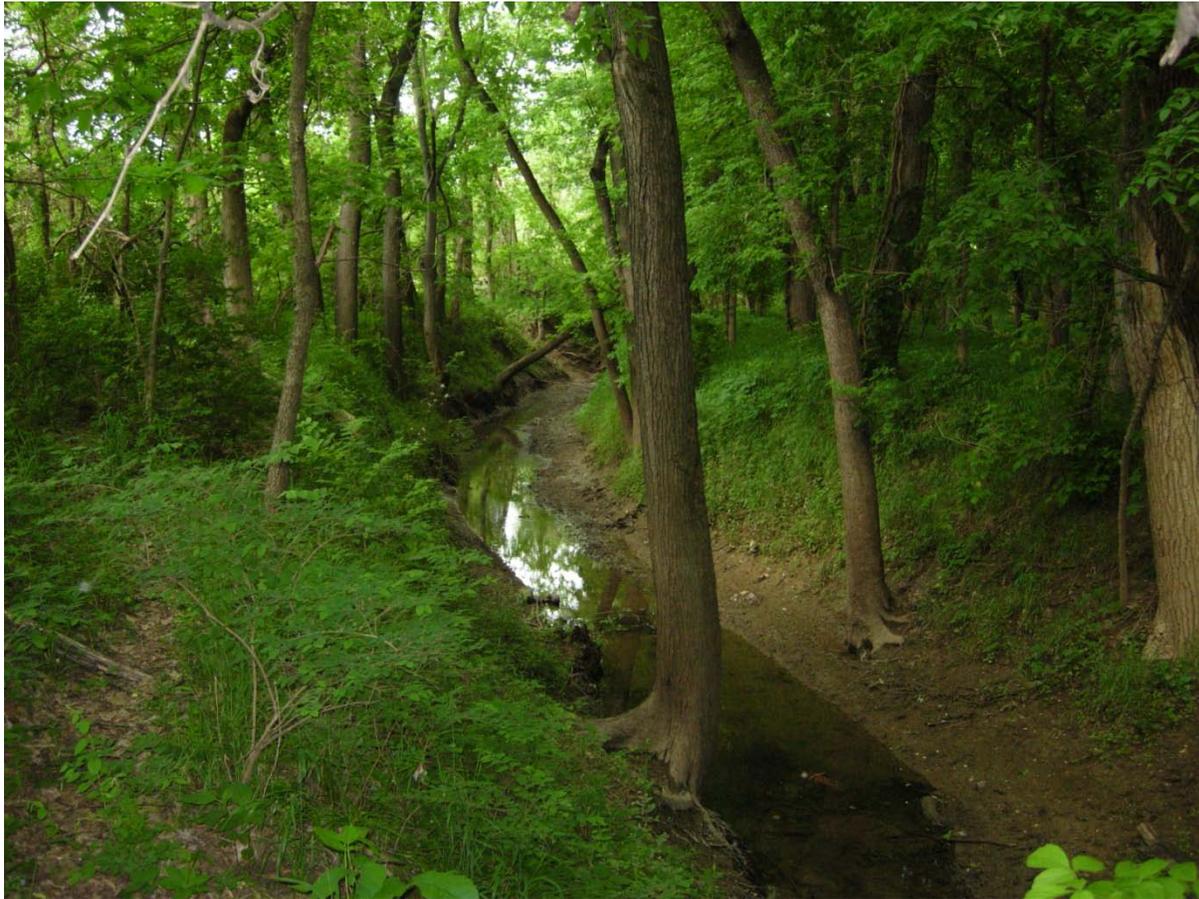
FIGURE 3. EAST BRANCH DARDENNE CREEK, SCORE: 16

Another example of a reach with some instability is presented in Figure 3. This photograph was taken at a location along East Branch of Dardenne Creek where high banks showed evidence of active scouring. This stream channel is becoming more incised as the channel bed lowers. If not addressed, the channel will widen and many of the trees in the riparian corridor will fall into the stream.

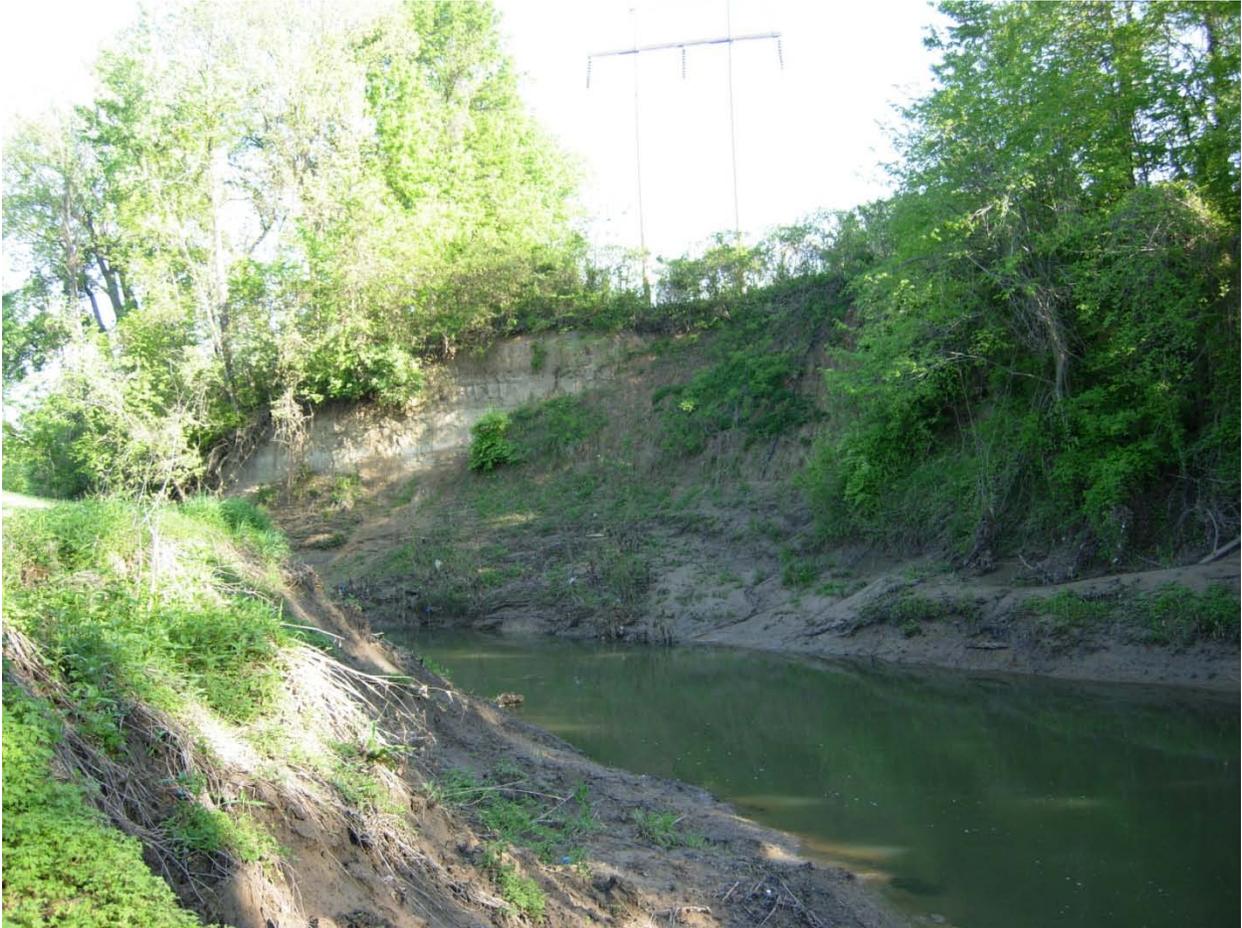
A rating that is greater than 19 indicates that the stream may be experiencing significant system-wide instability. Figure 4 shows a reach of Dardenne Creek adjacent to a golf course and utility corridor. Streams in this category typically show significant erosion, active degradation, and threaten infrastructure. The vertical banks and lack of riparian corridor on this reach result in a very high score.

FIGURE 4. DARDENNE CREEK, SCORE: 22

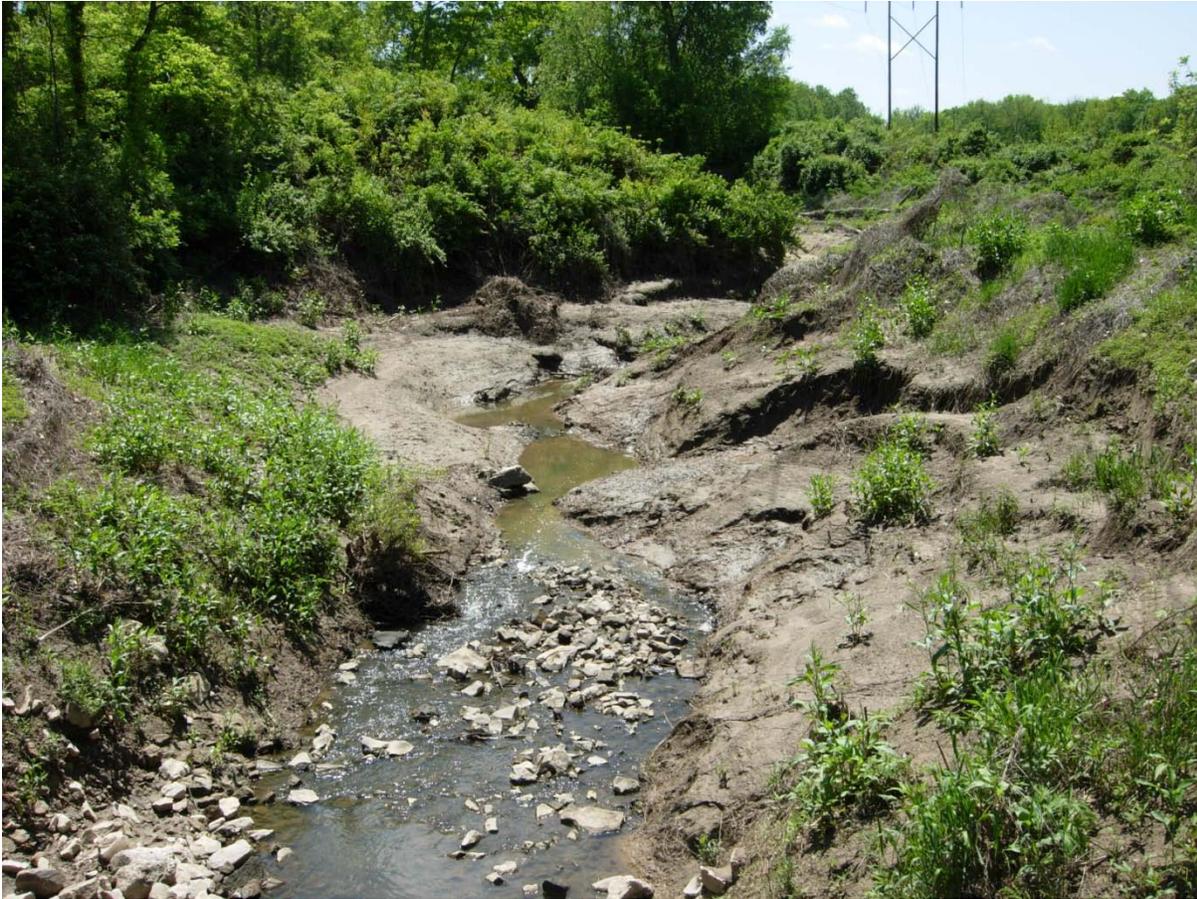
FIGURE 5. EAST BRANCH DARDENNE CREEK, SCORE: 23

Smaller reaches may also be scored poorly. Figure 5 was taken along a tributary to Dardenne Creek. This stream is very unstable and is actively eroding away soil on both banks.

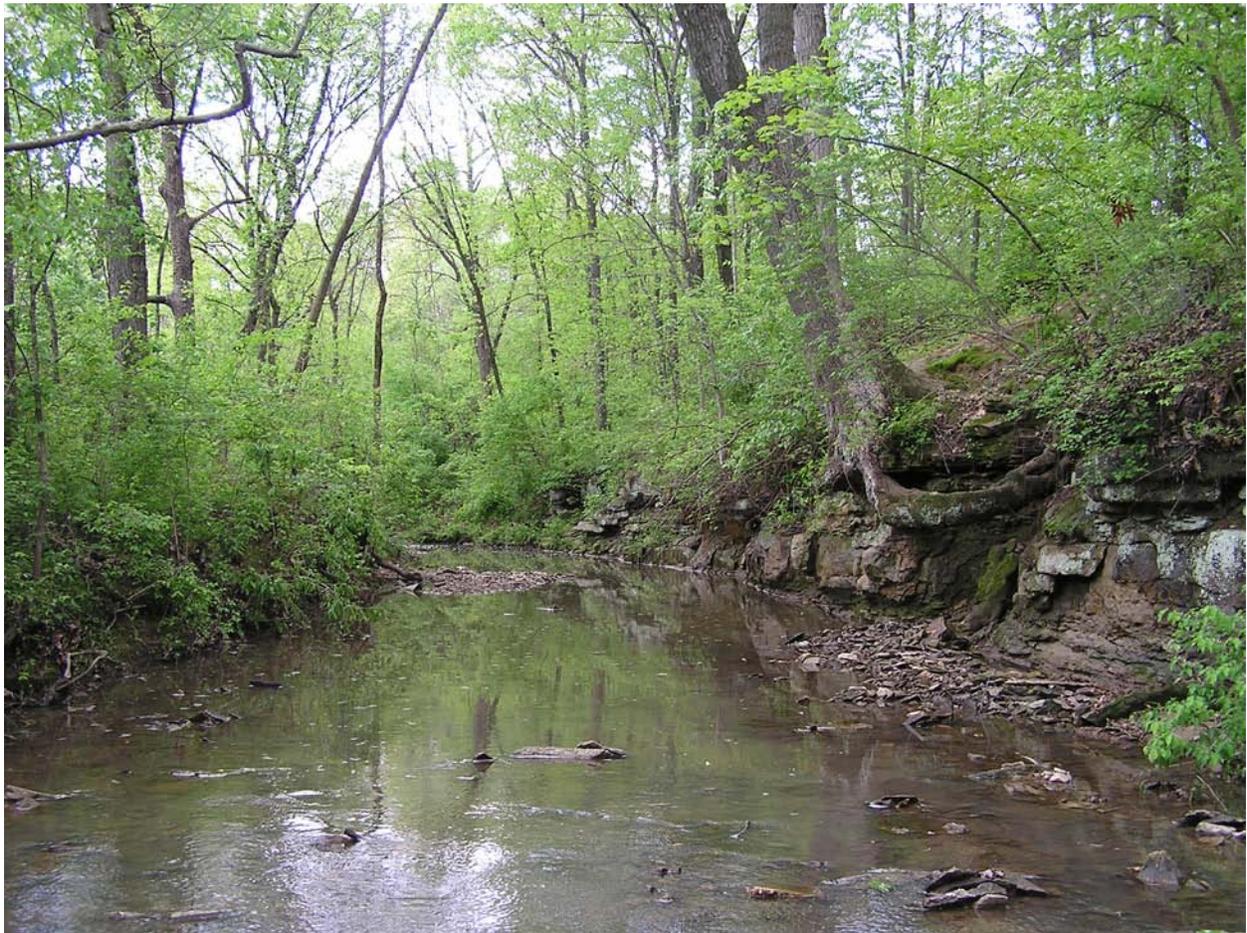
FIGURE 6. SPENCER CREEK NEAR BIRCHWOOD DRIVE, TYPE 1

Generally described as the highest quality naturally occurring stream with little negative impact. Erosion and sedimentation is low, water quality indicators are positive and the surrounding riparian zone is healthy, mature, successional woodland or other high-quality environment.

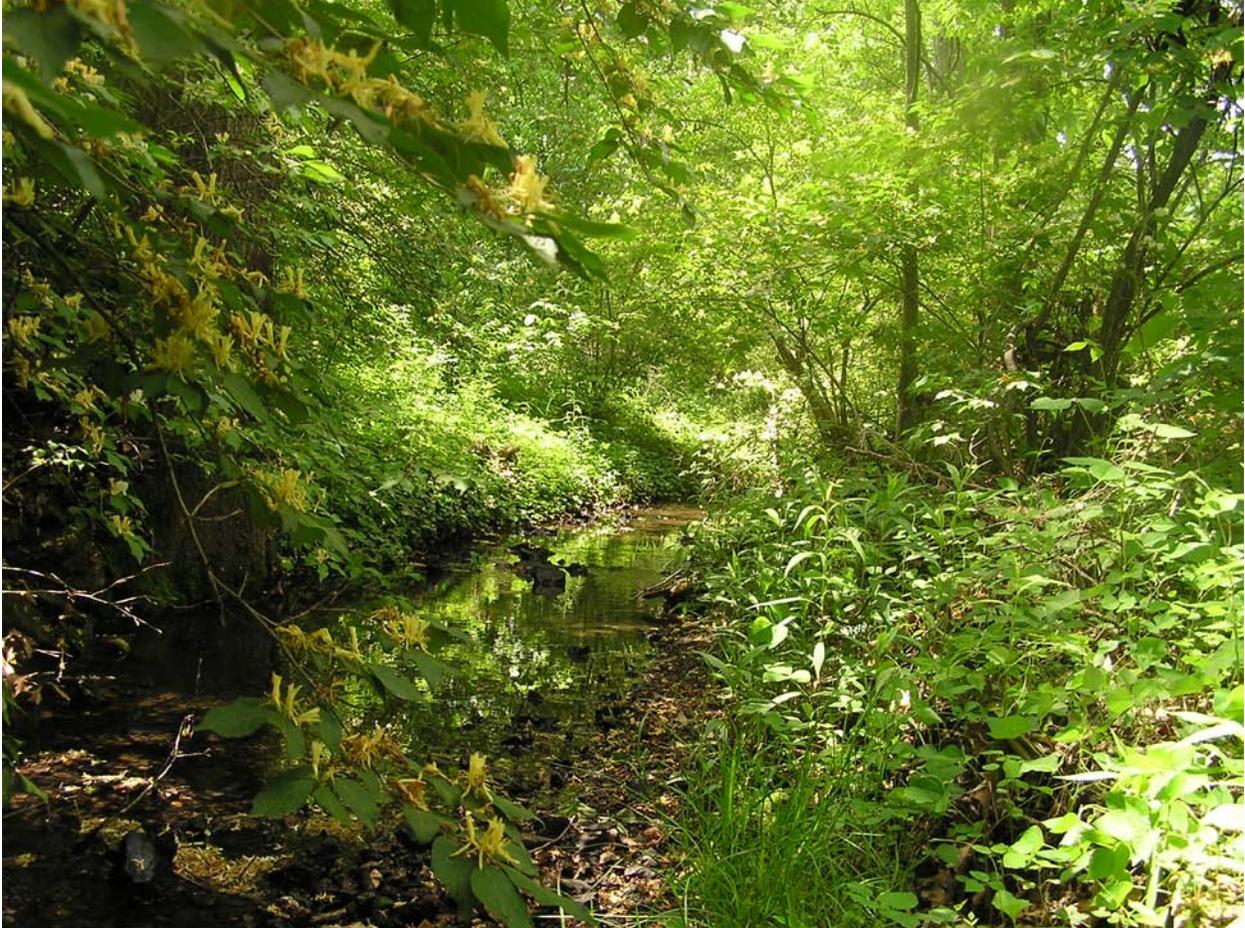
FIGURE 7. DARDENNE CREEK, NEAR FRONTIERS EDGE COURT, TYPE 2

This type of stream may have some down or side-cutting; however, bank and bed composition (bedrock) assist in keeping the impact low. Water quality is generally good and the riparian zone is largely intact, although vegetation may be negatively altered from that of a typical native plant association.

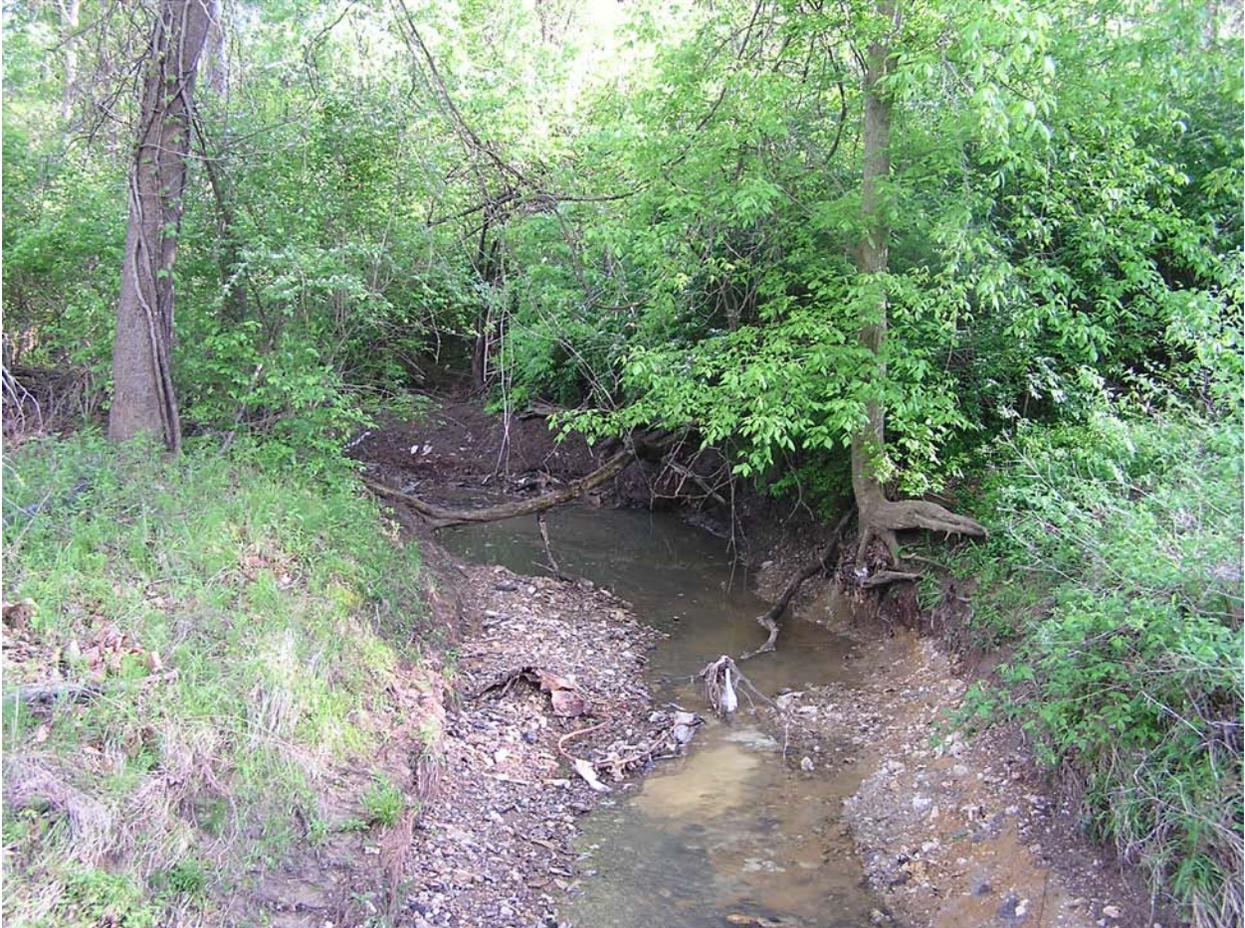
Deterioration of the channel and riparian corridor are more noticeable. While some remnant plant associations may be present, overall vegetative canopy cover is comprised of immature tree species. Water quality may be fair to marginal. The potential for restoration exists although erosion and sedimentation can be greater than desirable.

FIGURE 8. SPENCER CREEK, DOWNSTREAM OF MCCLAY ROAD, TYPE 3

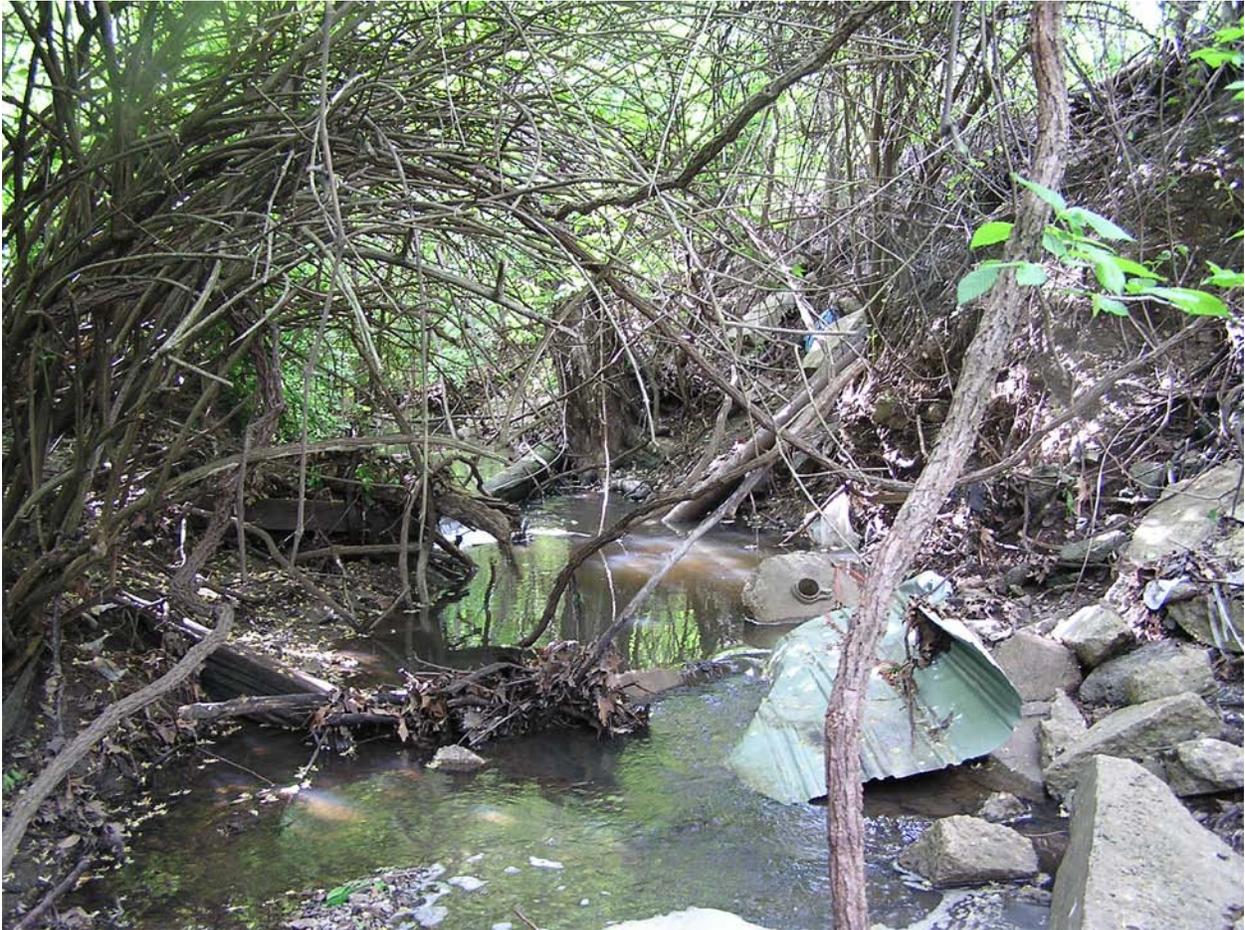
FIGURE 9. EAST SPENCER, UPSTREAM OF OAKTREE RETIREMENT COMMUNITY, TYPE 4

Impacts are greater on this stream type with significant indicators of bank erosion and channel instability. The adjoining riparian corridor may be intact but vegetation is not representative of a native plant association. Water quality is typically poor.

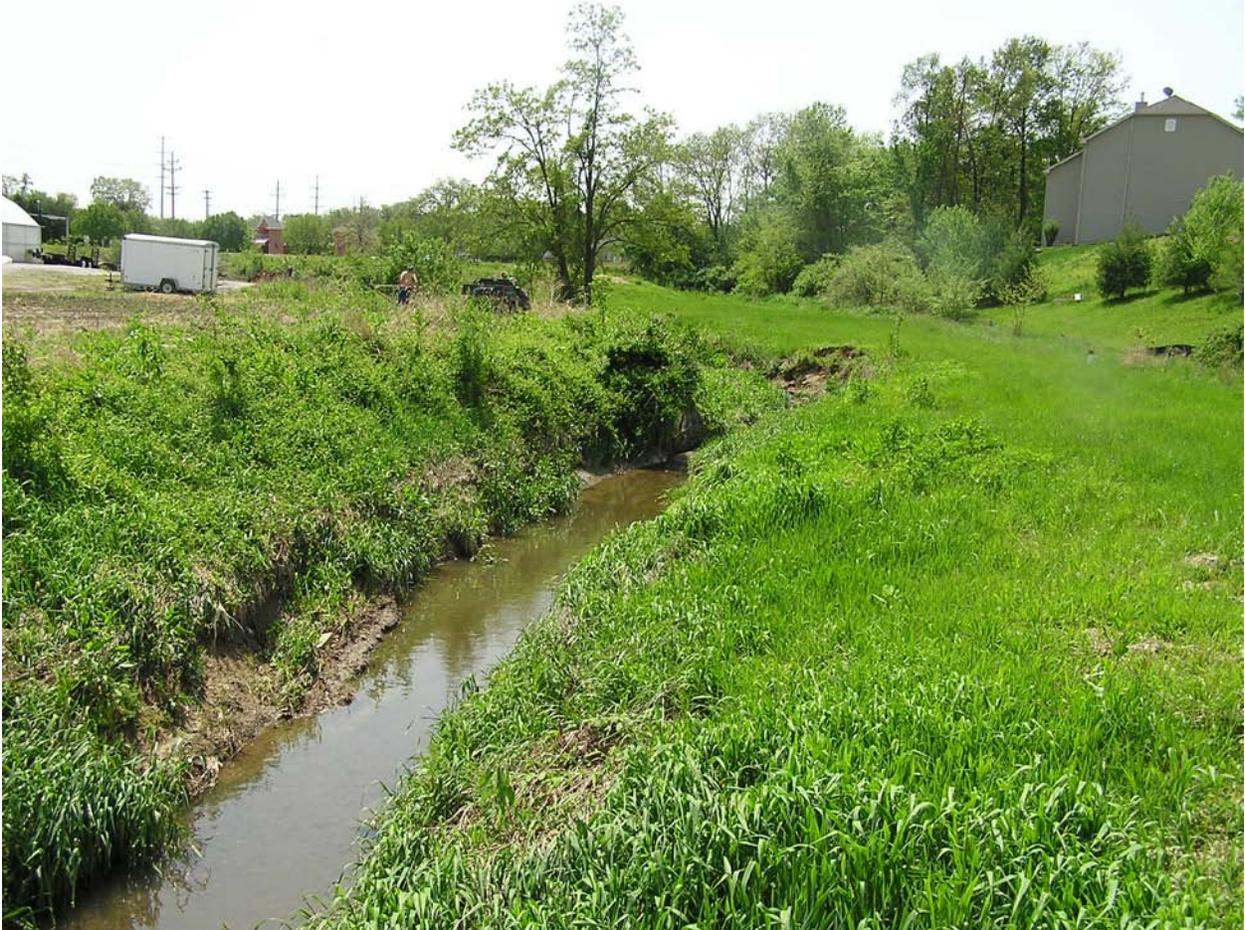
The channel in this type is the most changed. The riparian corridor is impaired to the point of providing little protection or benefit, and erosion and sedimentation indicators are significantly high. Water quality is poor with degradation and absence of macroinvertebrates, fish, mollusks, and amphibians.

FIGURE 10. EAST SPENCER CREEK, DOWNSTREAM OF JUNGERMANN ROAD, TYPE 5

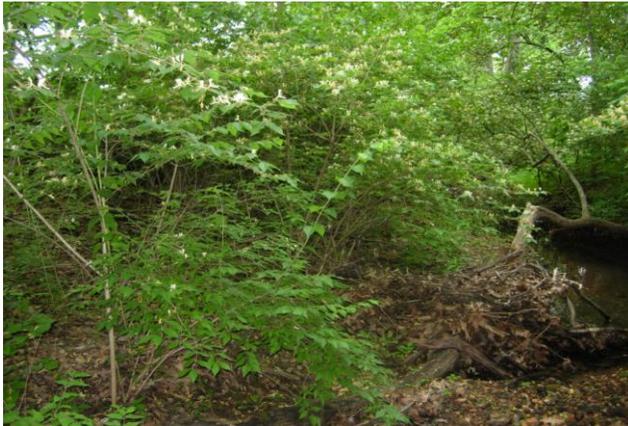
Figure 1. Country Crossing

Solution: Riparian Renovation suggested for stream corridor (1602 linear feet).

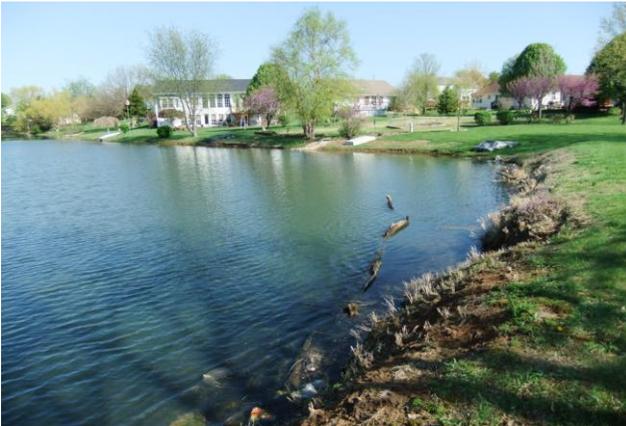
Figure 1. Fawn Lake

Solution: This concept includes grading and vegetative establishment of basin slopes.

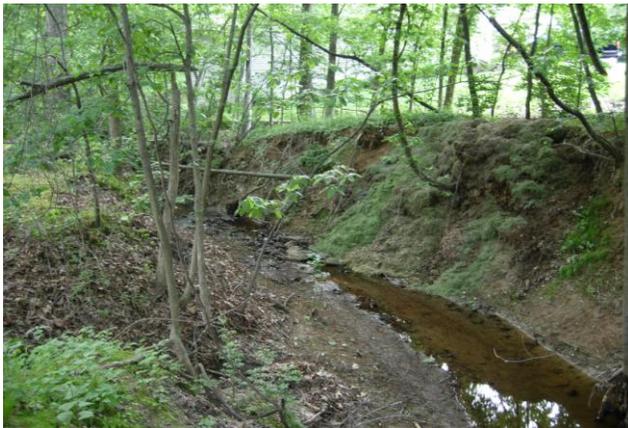
Figure 1. Hollow Creek

Solution: This concept includes the limited restoration and establishment of a vegetated buffer along the entire stream reach. Bank stabilization work should occur at localized areas along about 20% of the length, estimated based on field observation. These stabilization areas are located in the upstream portion of the reach near the backyards of houses around the Hollow Creek Drive cul-de-sac. The stabilization of two outfall structures is included in the project cost.

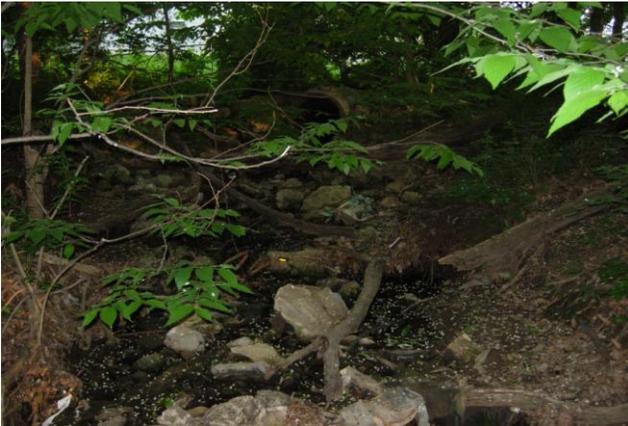
Figure 1. Spanish Trails

Solution: Riparian Renovation suggested for stream corridor (367 linear feet).

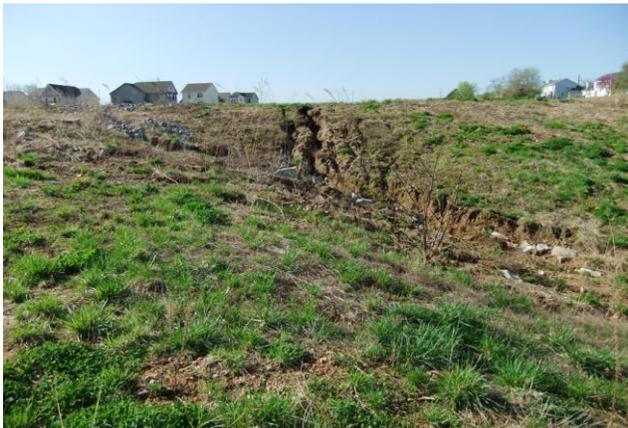
Figure 1. Townes of Belleau Creek

Solution: The concept addresses rill erosion by regrading and restoring vegetation on the basin slopes. The bottom of the basin should be excavated to contain the water quality volume, soil should be amended to enhance infiltration and then, should be vegetated. The concrete swale to be removed and replaced with a vegetated swale. Source control is recommended during construction.

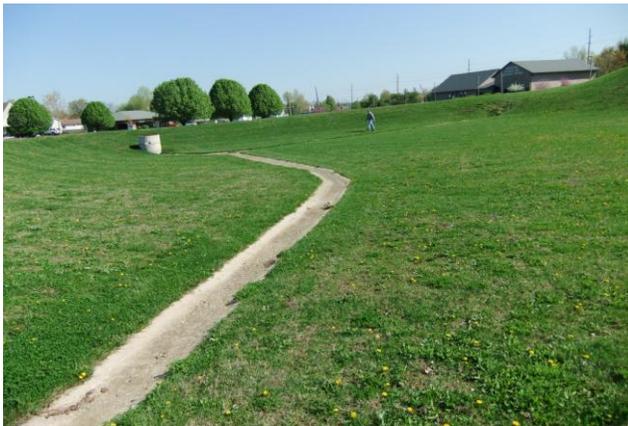
Figure 1. Child of God

Solution: The concept includes retrofitting this basin into a wet pond by modifying the outlet structure, removing existing concrete swales, establishing a water quality ponding area with a bench, and planting wetland vegetation. Tree and shrub landscaping is included to create a more defined buffer between the Salt Lick Road and the basin.

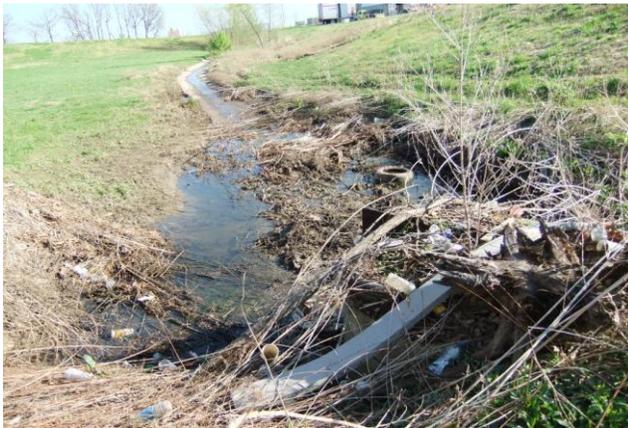
Figure 1. M&H Concrete

Solution: The concept is to replace the existing concrete swale with a wetland swale and restore the remaining basin to a dry detention basin with a forebay structure to control debris. Exposed areas around the swale will be revegetated and sediment deposition at the structure will be removed.

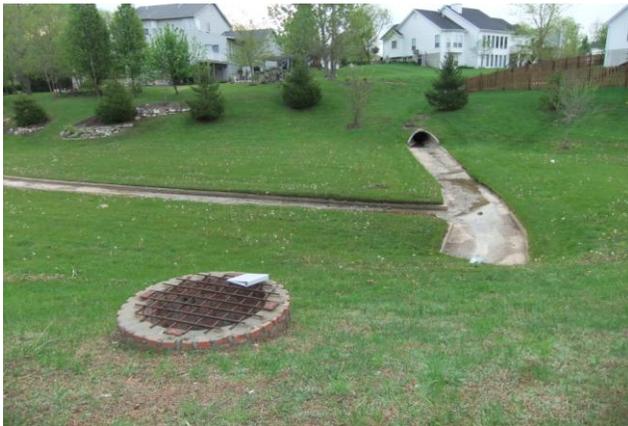
Figure 1. Deer Meadow Ct.

Solution: This concept includes bank stabilization and uses 7 vertical grade controls to stabilize the bed profile. For the basin, the recommended concept is to excavate 2-feet of material from the base (534 to 532 ft) in order to provide additional capacity (1 acre-ft). The recommendation is to replace the concrete swales with wetland swales and amend the soil in the bottom of basin and revegetate.

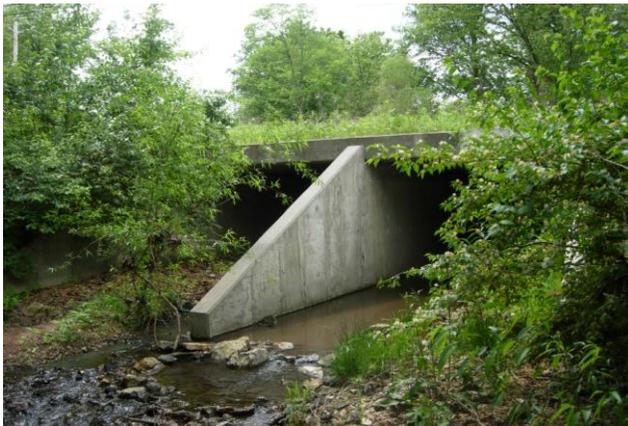
Figure 1. NW Ohmes Farm

Solution: This concept addresses erosion issues at the detention basin and along the channel. Additionally, it includes preservation for the in-line wetland downstream of the detention basin and riparian renovation for the stream corridor downstream of Birdie Hills Road. At the detention basin, the recommendation is to dredge 1 foot of material from the basin and replace the outlet structure in order to convert the basin into a wet pond. The channel stabilization extends along approximately 300 linear feet of stream as needed, specifically targeting the 90 degree bend that threatens a home at 44 Arbor Shadow Court. At least 6 rock checks are included to control the bed profile.

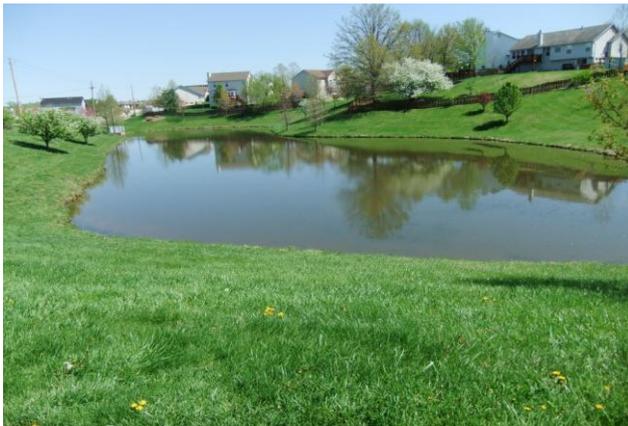
Figure 1. Country Crossing

Solution: This concept, given the project area's high visibility on Ohmes Road, includes aeration of the basin and a 10-ft wetland bench edge treatment and vegetated filter strip buffer that will help filter nutrients from the basin. Additionally, the inlet structure should be protected and the outlet structure should be replaced to allow for flood stage storage in the basin.

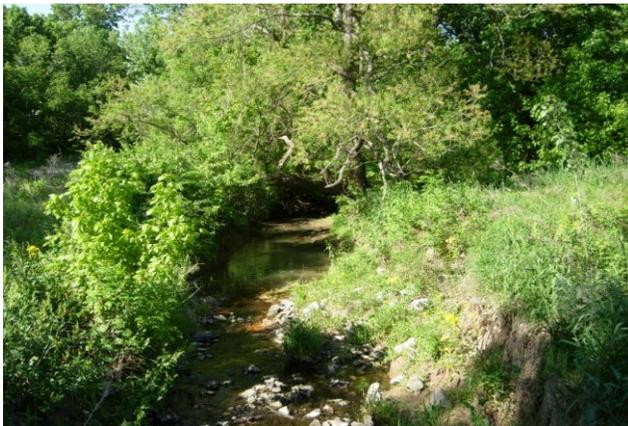
Figure 1. Ohmes Mitigation

Solution: Riparian renovation suggested for stream corridor (1478 linear feet).

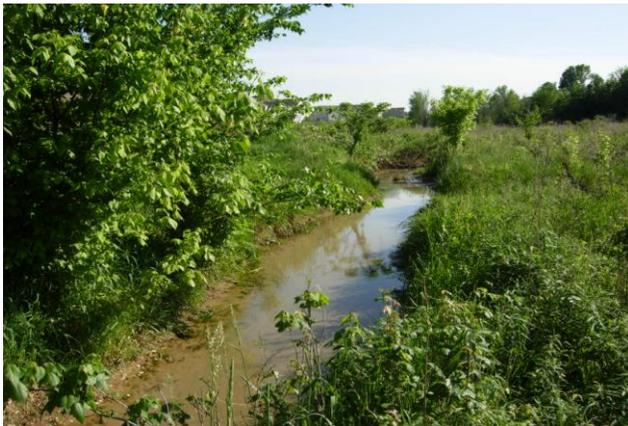
Figure 1. Ohmes-Cherry Creek

Solution: The proposed concept converts the existing basin to a wet pond and stabilizes the basin slopes. Approximately 1 foot of material is dredged from the bottom of the channel (adding 0.8 acre-ft of storage) and the low flow opening on the outlet structure is modified. Bank slopes are stabilized and vegetated. A wetland buffer is installed around the perimeter of the permanent pool. This improvement directly benefits the channel reach downstream where additional improvements are recommended. In the channel, riparian renovation is recommended along the entire reach. Source controls must be implemented in the contributing drainage area during residential development.

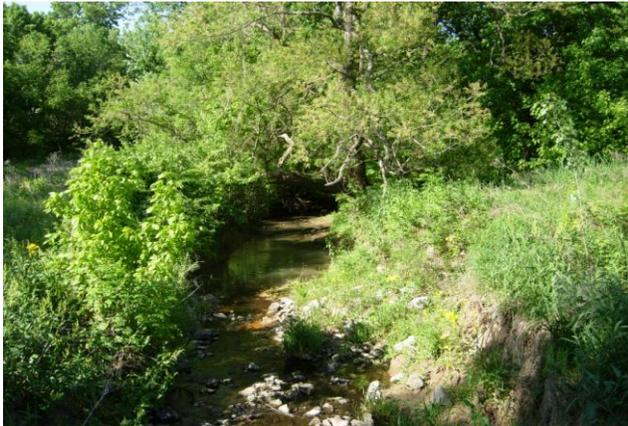
Figure 1. Hope Drive

Solution: This concept addresses further incision of the tributary with the use of two vertical grade control structures. Riparian renovation is included for the entire length of the project (1493 linear feet). Localized bank protection is recommended where the channel erosion threatens the trail (along 500 feet).

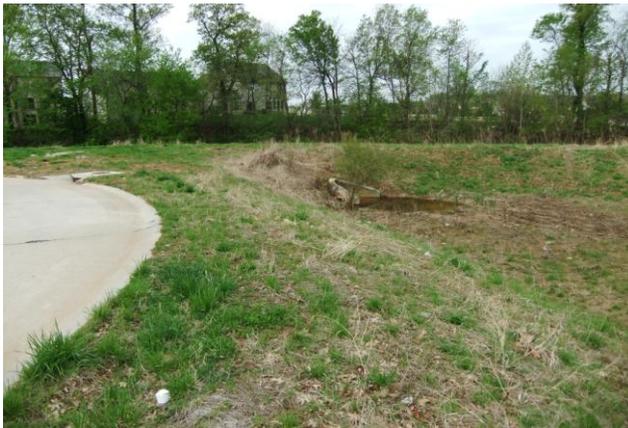
Figure 1. Ohmes-Baytree

Solution: The proposed concept converts the existing basin to a wet pond and stabilizes the basin slopes. Approximately 1 foot of material is dredged from the bottom of the channel (adding 0.23 acre-ft of storage) and the low flow opening on the outlet structure is replaced. A wetland planting buffer is installed around the ponding elevation and the remaining banks are revegetated. Source controls must be implemented in the residential development that contributes drainage to this basin.
