Stormwater Master Plan 2012

CITY OF ST. PETERS, MISSOURI

BLACK AND VEATCH
PATTI BANKS ASSOCIATES

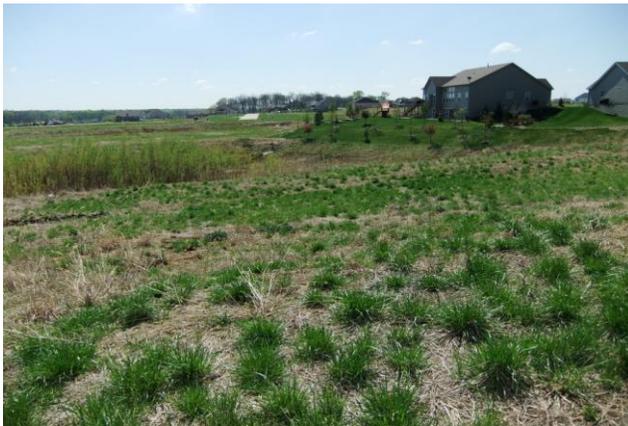
Figure 1. Ohmes-Dogwood Meadow Ct.

Solution: The proposed concept includes stabilization of basin slopes, amendment to the base to increase infiltration, and revegetation of the basin. Limited riprap material may be necessary to protect against erosion at the structures. Source controls must be implemented in the residential development that contributes drainage to the basin.

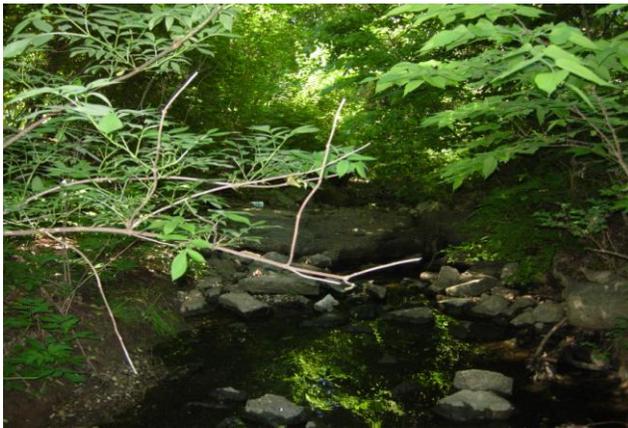
Figure 1. Calwood

Solution: Riparian renovation is recommended for this stream corridor (791 linear feet). Debris jams should be removed. Additionally, 5 rock checks should be installed to stabilize the channel bed.

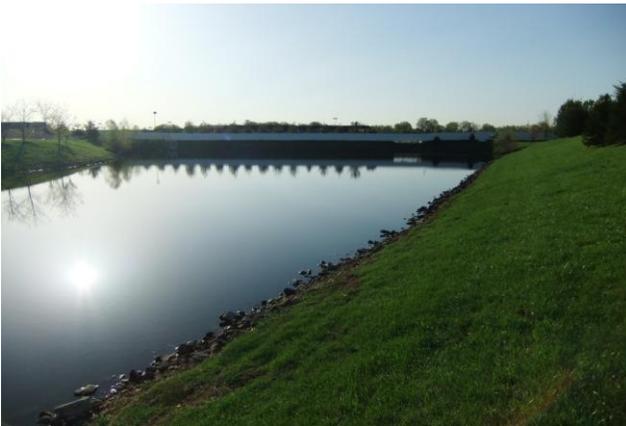
Figure 1. Richmond

Solution: The proposed improvements are limited to the detention basin. A vegetated buffer should be added to this basin. Erosion around inlets should be addressed by limited regrading and placement of riprap to protect the structures. During preliminary engineering of the solutions to address Dardenne Creek flooding, this portion of the revised inundation map should be further studied with bathymetric data of Dardenne Creek incorporated in the model. The flooding associated with this project is addressed in IP-6970-4-3.

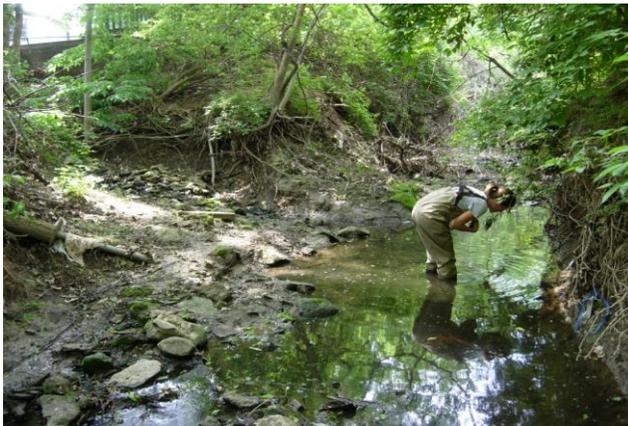
Figure 1. Calwood

Solution: This concept is limited to stream stability. The flooding associated with this project is addressed in IP-6970-4-3. The concept includes riparian renovation along the 515 linear feet of geocell bank stabilization in the upstream portion. In the wooded reach which extends 1706 linear feet, this concept includes renovation of the corridor and limited bank improvement projects to areas where infrastructure is threatened or where bank heights are actively contributing sediment to the channel. Bank stabilization should be prioritized in the reach of the main channel, upstream of the golf course and at any outfall. Areas of encroachment should be re-established as riparian corridor and storage structures should be removed. In the golf course, the tributary and small adjacent contributing drainage ways should be buffered with a vegetated filter strip and the confluence should be stabilized with riprap on the bank of Dardenne Creek.

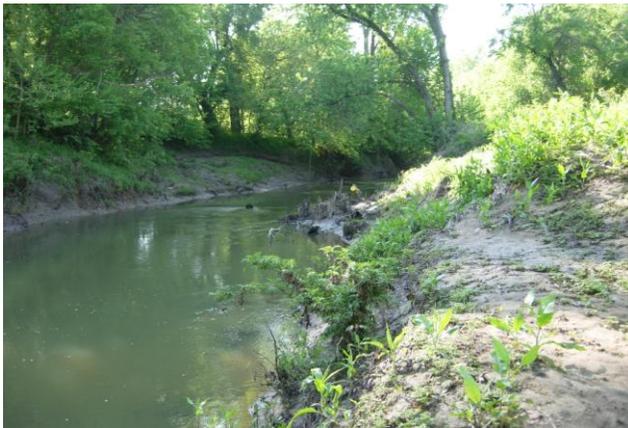
Figure 1. Dardenne b/t Mexico Rd & I-70

This reach of Dardenne Creek extends between Mexico Road and I-70. The reach is experiencing severe bank erosion and potential channel bed degradation. The LIDAR information shows an estimated slope of 0.0009 ft/ft, however, this may not reflect accurate conditions because it represents the water surface elevation in Dardenne Creek.

Solution: The proposed improvements include bank stabilization along this reach and the development of a riparian corridor along the golf course bank (approximately 7,000 linear feet of the project). Riparian renovation is recommended for the right bank. A series of 4 rock checks are included but may not be necessary depending on the actual bed slope. The flooding associated with this project is addressed in IP-6970-4-3.

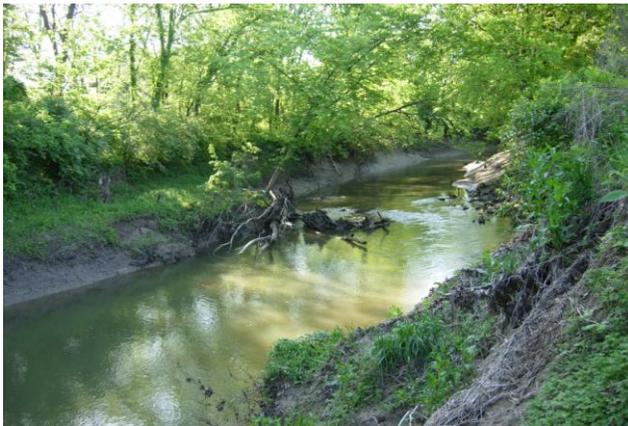
Figure 1. Dardenne at Mexico Rd & I-70

The project area is located at the Mexico Road and I-70 crossings of Dardenne Creek. These bridges may cause constrictions for high flows in Dardenne Creek and flooding upstream may be attributed to these constrictions.

Solution: Address flooding with improvements at Mexico Road and the I-70 tunnel to remove some houses from the 100-year floodplain. Improvements include widening the Dardenne Creek channel along 2000 linear feet and installing a new Mexico bridge with a higher low steel.

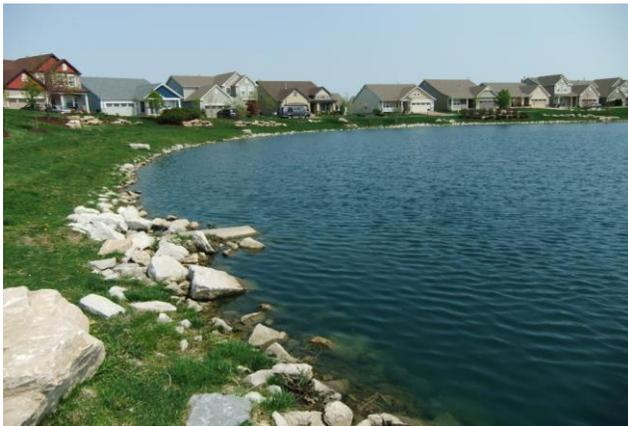
Figure 1. Montecito

Solution: The concept recommendation includes the addition of a filter strip around the existing basin. Riprap should be placed at the detention basin structures to protect from erosion. Recommendations should be made to the homeowners association to avoid adding chemicals to the water and stop mowing a grass strip around the riprap.

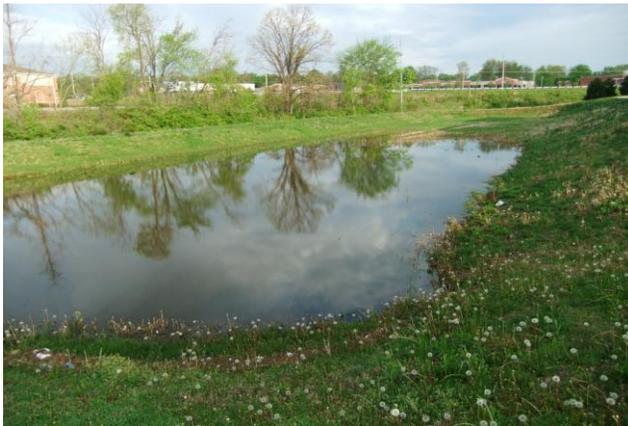
Figure 1. Highlands

SOLUTION: Four detention basins should be retrofitted to retain the water quality volume and use vegetated swales instead of concrete flumes. Additional capacity is provided for DB-7065-01 and DB-7065-04. (Assuming 1 foot of excavation in both basins) There are three stream segments that are included in this conceptual improvement as well. The first segment, south of Deer Meadow Court, includes 375 linear feet of bank stabilization. The outfall structure of the detention basin into this reach should be stabilized. The second reach, 400 linear feet, is located east of Wolfrum Glen Court. On this reach, the recommended improvement is to stabilize banks and develop 4 grade controls. The third segment, 932 linear feet, is located parallel to Castle Douglas Drive and banks should be stabilized. All reaches should have the existing riparian corridor renovated.

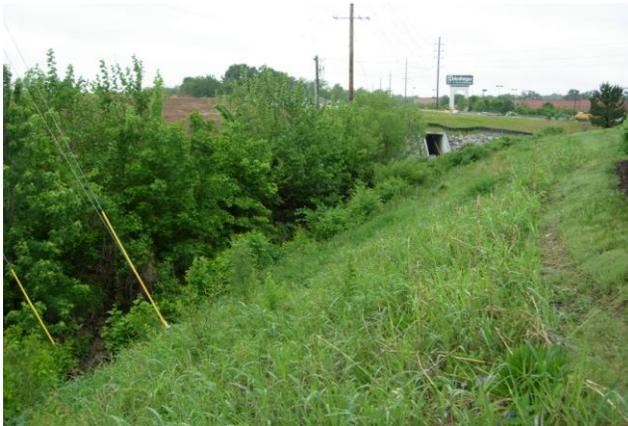
Figure 1. Home Depot

Solution: The conceptual recommendation is to maintain the same alignment, enhance the east riparian corridor, and stabilize the west bank with shrubs and grasses. The hydraulic model shows velocities of 6-10 fps in this reach and therefore, a riprap toe protection would be critical to hold the bank in place. This proposed recommendation also includes grading and riprap improvements to increase the effectiveness off the eastern off-line detention. This concept does not include improvements on the upstream tributary located between MO-94 and parking lots. The existing profile (estimated by LIDAR contours) drops 6 feet over the length of the reach. The Central School Road culvert may provide the necessary grade control and therefore no additional vertical controls are included.

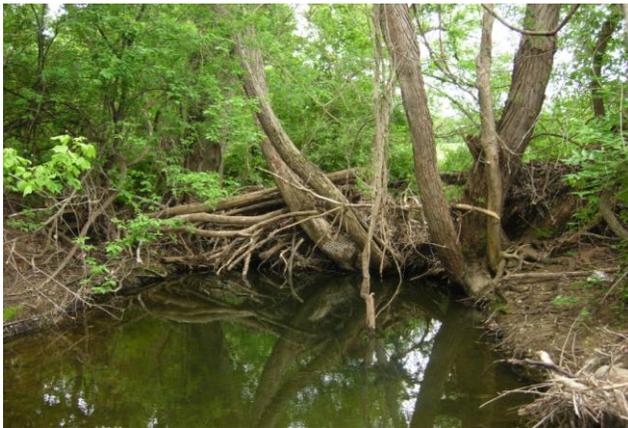
Figure 1. Pittman Hill Road

Pittman Hill Road is overtopping in the hydraulic model. Two structures are shown within both the FEMA floodplain and this study's refined area of inundation during the 100-year event. There was one tall shear bank noted on the downstream side of Pittman Hill Road. Owners on the adjacent property said that this bank was eroding quickly. Upstream of Pittman Hill Road, the riparian corridor is in fair condition but very narrow on the west side. The main channel banks showed evidence of continuous scouring. Debris jams were noted in the field study.

Solution: The concept includes replacement of the Pittman Hill Road culverts with a bridge to address overtopping. Additionally, bank stabilization of the 24-ft tall shear bank downstream of Pittman Hill Road is recommended. This bank is upstream of the area that was protected as part of the Hwy 94 construction project. This project also includes vegetative and riprap toe protection of the reach upstream of the culvert crossing where shorter banks show evidence of continuous scouring. The corridor upstream of Pittman Road should be renovated. The corridor downstream of Pittman Road will require the establishment of a new riparian corridor and limited stream widening.

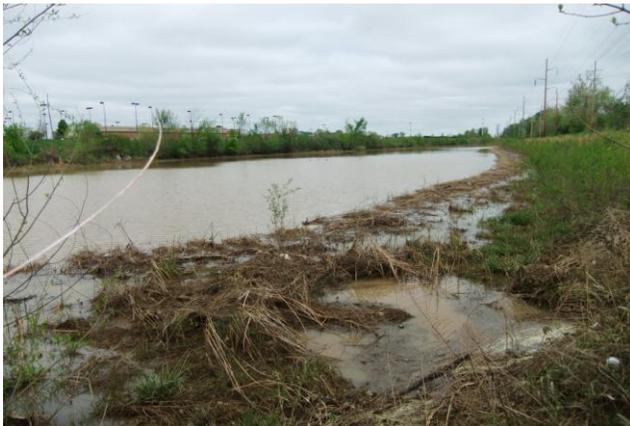
Figure 1. Baltic Creek, downstream of Central School Road

Solution: The proposed concept is to provide an outfall structure for DB-7067-01 and improve vegetation management in the basin. For the second basin in the project area, DB-7067-02, the recommendation is to address the outfall erosion and connection to Baltic Creek. This basin does not have sufficient capacity and additional capacity is proposed (6 acre feet). On the reach of Baltic Creek, the concept is to stabilize the banks and maintain the same alignment. A series of 4 rock checks are included to stabilize the bed profile. The east riparian corridor, buffering the creek from the golf course should be enhanced and the west bank should be stabilized with shrubs and grasses. The hydraulic model shows velocities of 6-10 fps in this reach and therefore, a riprap toe protection would be critical to hold the bank in place.

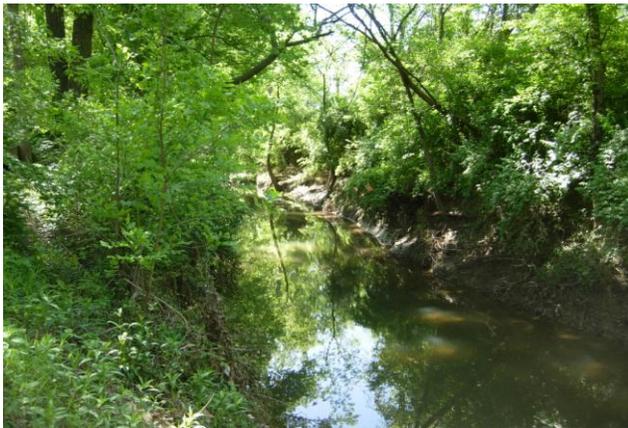
Figure 1. Old Hickory GC

Solution: The proposed concept is to stabilize the bank and construct 2 vertical grade controls. On the entire project, a vegetated filter strip should be established to treat runoff from the golf course. On the downstream 1000 feet, a corridor should be established after benching and developing a low flow channel.

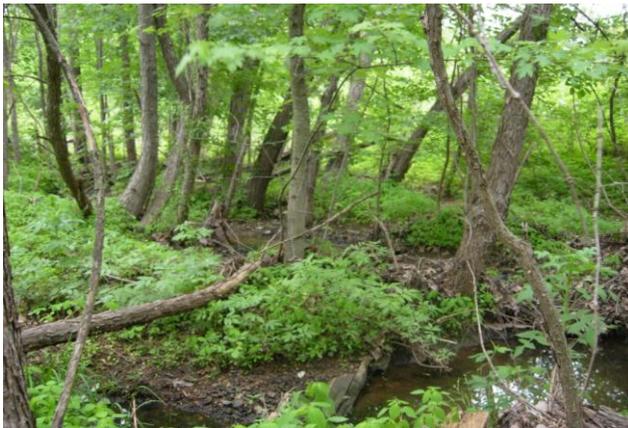
Figure 1. Bruns Place

Solution: The proposed concept includes the installation of 7 grade control structures and riparian renovation of the corridor (along 1592 linear feet). The piped system at 109 Bruns Place Court should have the inlet structure replaced to allow appropriate drainage of the upstream channel. No additional bank stabilization is recommended at this time.

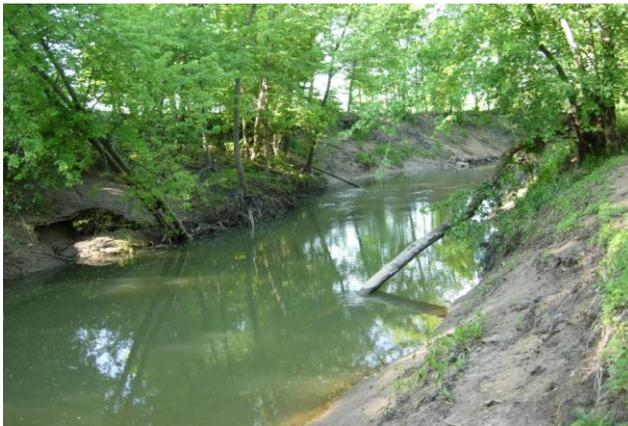
Figure 1. Dardenne Creek at Fairfax

This reach of Dardenne Creek extends between the confluence with Tributary 7 and the Mid Rivers Mall Drive crossing. Although Dardenne Creek is analyzed as a system, this reach is of particular importance because adjacent homeowners have reported backyard bank erosion that may threaten homes. The Mid Rivers Mall Drive crossing shows adequate conveyance for all events analyzed in this study, up to the 500-year. While there are not flooding concerns, residents on the right bank are concerned about bank failures on their property. The bank toe appeared to be more stable than elsewhere on Dardenne Creek - an exposed ledge of cobble and limestone. The upper bank, however, has slid in some areas to form a flood bench. This sliding has encroached on the right bank structures. The profile of this channel should be further investigated because the LIDAR data shows a flat water surface elevation in this reach (Elevation: 446 ft).

Solution: This proposed concept addresses areas of bank slides on the right bank and areas of mass wasting on the left bank. Bank stabilization will include installation of a wall along 1533 linear feet of the right bank, sloping and vegetating the bank in the low flow area. On the left bank, a bench should be graded to allow for higher flows to spread into a larger conveyance area. One rock check is recommended at the downstream boundary of the project to ensure that the bed profile stays in place. Stream corridor restoration is recommended along the downstream section of the project reach. Installation of a new corridor is included for the upstream section of the project reach, on both banks. The total length of riparian restoration work is approximately 1682 linear feet.

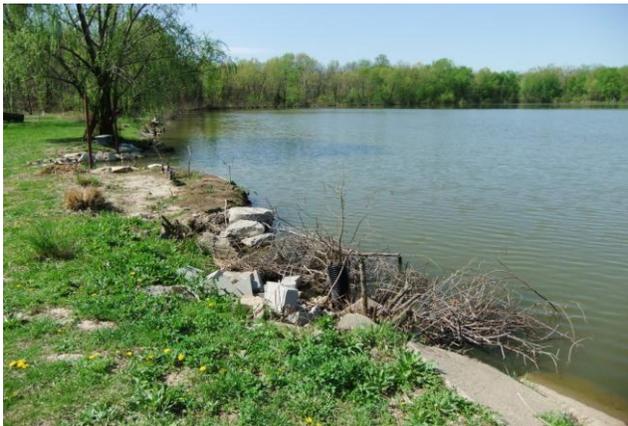
Figure 1. Crystal Lake Detention

This area, located east of Dardenne Creek in Rabbit Run Park, experiences flooding from Dardenne Creek. The project area includes two detention basins, DB-7069-06 and DB-7069-07, as well as the East Branch tributary to Dardenne Creek. There are some anecdotal erosion issues at the wet detention basin and the need for improved sediment management was noted. The existing basin capacity, however, is sufficient. The secondary wet basin, DB-7069-07, is protected with concrete chunks along the perimeter but lacks a vegetative buffer. The outfall structures appear to be cobbled together and not well designed. The downstream section of the stream shows evidence of deep incision and the confluence with Dardenne Creek is actively eroding. The area of inundation in the refined HEC-RAS model indicates that 14 structures are impacted by the 100-year event in Dardenne.

Solution: This proposed concept addresses stream stability and water quality associated with detention. The flooding associated with this project is addressed in IP-6970-4-3. At the main detention basin, a forebay should be constructed to help maintain sediment. A vegetated buffer should be established around the perimeter of both basins for water quality benefit. This project has great visibility from backyards, the trail, and the adjacent park. The outfall to the stream should be protected. Two grade controls should be installed on the downstream end of the channel (along 1848 linear feet). In areas where the stream corridor is lacking (1848 linear feet), benching should be established on at least one bank. The corridor that is in good condition (3977 linear feet) should be renovated.

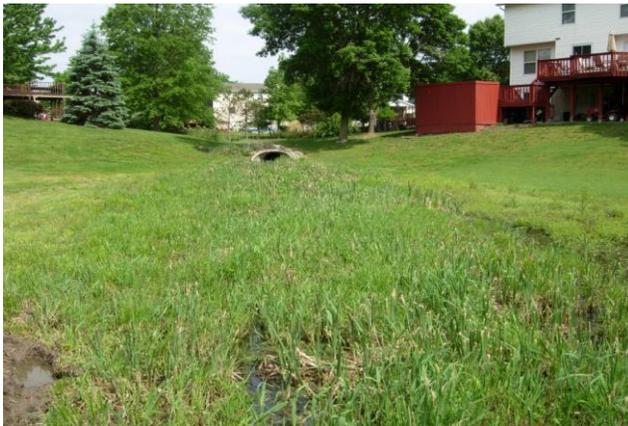
Figure 1. Crystal Lake

Solution: This proposed concept addresses stream stability. The flooding associated with this project is addressed in IP-6970-4-3. The proposed concept along this reach is to restore the riparian corridor. Based on the field study, the bank slope should be restored to a stable slope and revegetated along approximately 25% of the reach. Two rock checks are included to provide stabilization of the bed profile. This bank stabilization is located in the downstream section of the project reach.

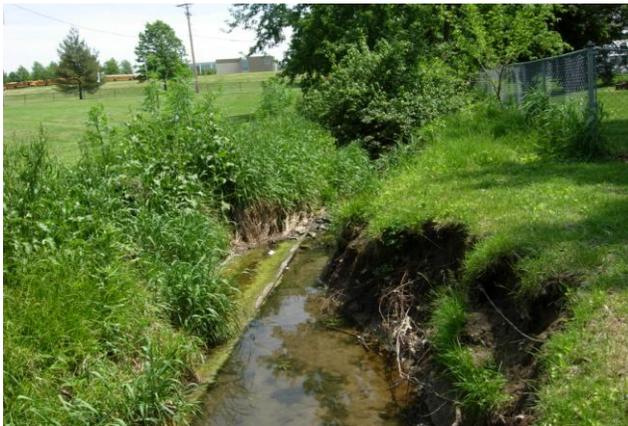
Figure 1. Parkdale

This project, located west of Mid Rivers Mall Drive and south of Grand Teton Drive, includes two reaches. During field reconnaissance, the north reach was documented as an ephemeral vegetated swale. Anecdotally, this channel carries significant flow during storm events and may cause flooding to the adjacent homeowners. The second channel, in the south half of the project area, conveys more flow. This channel has an existing concrete flume along the channel bed in most areas and there is typically erosion on either side of this flume. There was significant algae in the water and the stream lacks a riparian buffer. The existing slope of this channel was estimated at 0.0055 ft/ft.

Solution: This concept routes excess flows from Mid Rivers Mall Drive to the main channel within the project area, stabilizes all erosion areas and uses vegetative buffer strips to help filter nutrients. The north inlets on Mid Rivers Mall Drive should be connected to a new 48-inch RCP that extends south to the main channel. On the north channel, the 1,035 linear feet of swale should be graded and vegetated with native vegetation. For the main channel, 1,450 linear feet, the following is recommended: 1) Remove concrete flume, replace this bed profile control with 4 rock checks, 2) Lay back slopes to stable slope and vegetate, and 3) Develop vegetated filter strip buffer to stream, limited tree plantings.

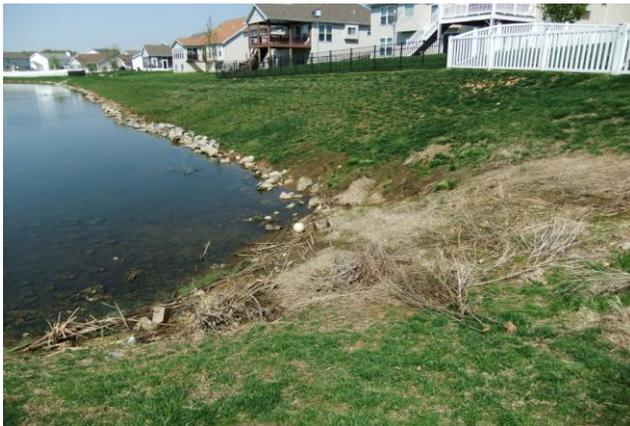
Figure 1. Savannah

This wet detention basin, DB-7069-10, is located in residential backyards, between Creekside Drive and North Hillview Drive. The basin has sufficient capacity and does not show overtopping during the 100-year event. It has approximately 0.9 feet of freeboard during this event. There is limited landscaping around the basin and a riprap shoreline protection that works well to control most erosion. There was evidence of some cattail growth during the field visit. Excessive algae growth was observed around the inlet structure.

Solution: The recommended concept is to add a buffer planting to the edge of this basin. Additionally, 500 square feet of wetland plantings are recommended for the south swale inlet area to help improve water quality in the basin. Riprap should be placed at structures within the basin to protect from erosion. Source controls for nutrients would also be recommended.

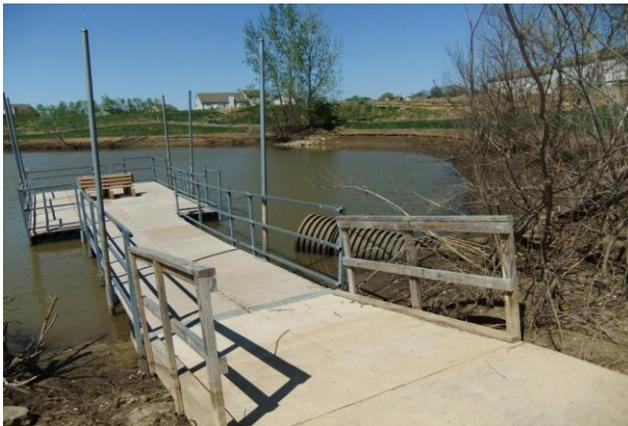
Figure 1. Ohmes Farm/Woodland

This project includes a series of three basins, DB-6969-02, DB-6969-04, DB-6969-07, located on the southern edge of the Ohme’s Farm residential development and the north side of Woodland’s Park. The existing basins have already experienced problems and present an opportunity for a community resource that doubles as a demonstration of successful water quality management. The ongoing development of Ohme’s Farm has contributed significant sediment loads to the system of basins. The outlet structure of the third basin has failed and all of the basins show evidence of bank erosion and rill erosion.

Solution: The concept is to integrate these 3 basins to better manage water quality and volume. The first basin will be restored to an extended dry detention basin. The exposed pipe between the first and second basins will be replaced with an open channel to connect the buried pipe and second basin. The second basin will become a functional fishing pond with a boardwalk that connects two docks and a walking trail. The pipe system between the second and third basins will be restored to an open channel with two bridges, one pedestrian and one for maintenance traffic. The third basin will be established as a polishing wetland connected to the boardwalk and trail. Additionally, the stream reach downstream of the GRG trail crossing should be stabilized with a grade control to prevent further headcut migration from Dardenne Creek.

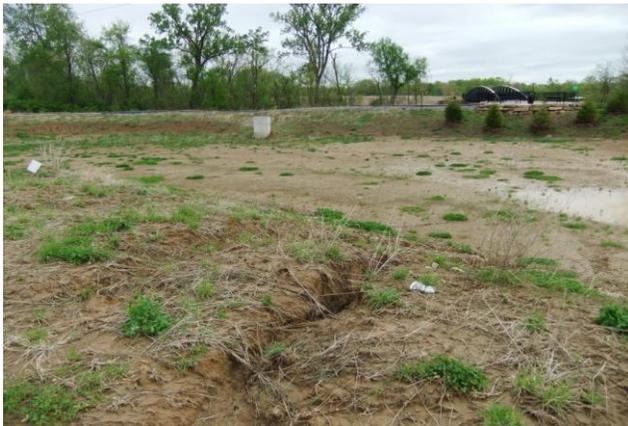
Figure 1. Ohmes Farm-1

Solution: This concept includes retrofit of the existing wet detention basin by modifying the outfall, addressing rill erosion on the banks by grading and revegetating, and removing material that has sedimented in the basin (assuming a depth of 1 foot). Additionally, riprap should be added to the basin structures to protect from erosion.

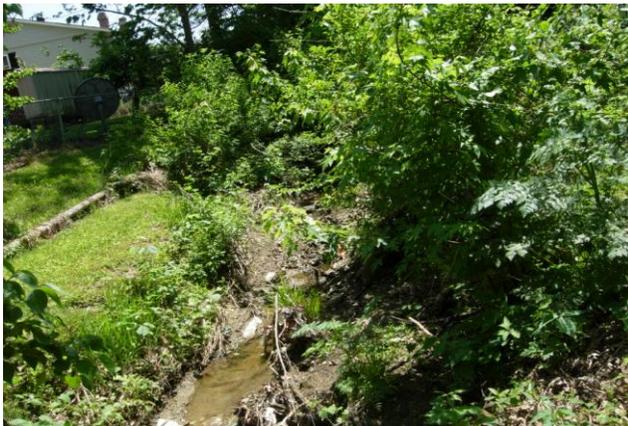
Figure 1. Country Hill Manor

Solution: This proposed concept is to expand the capacity of the detention basin to reduce the impact on the downstream channel. Approximately 1500 cubic feet of storage is added by grading modifications on the west side of the basin. The berm on the east side, extending 185 linear feet, should be raised approximately 4 feet to elevation 504-ft. A vegetated buffer is included for the perimeter and amendment of soil is recommended for the base of the basin.

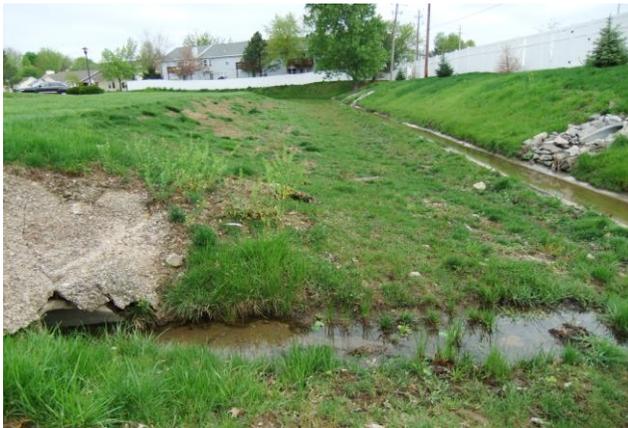
Figure 1. Crown Colony

Solution: The proposed concept is to replace the concrete flume with a wetland swale, develop a vegetated filter strip buffer between the basin and the parking lot, and modify the outlet structure to retain the water quality volume in the basin. The remaining area of the basin should be amended with appropriate soils that enhance infiltration and planted with dry detention vegetation. This basin shouldn't be modeled as a basin because it functions as an open channel. In order for the 25-year event to be contained in the channel, an additional 15 ac-ft of storage would be needed, requiring excavation of approximately 5 acres. This is not likely feasible.

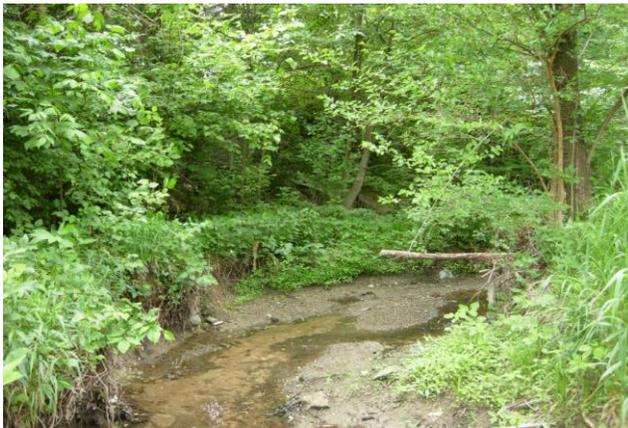
Figure 1. Schnucks/HS-1

Solution: This proposed concept addresses restoration of the riparian corridor on the downstream section of the project reach. The flooding associated with this project is addressed in IP-6970-4-3. In the reach behind Schnuck's Grocery Store, the recommendation is to develop a wetland swale through this area. An access point should be developed to ease maintenance of harvesting wetland plants. A wetland swale should also be developed in the marshy area north of the channel to help retain sediments with establishment of vegetation.

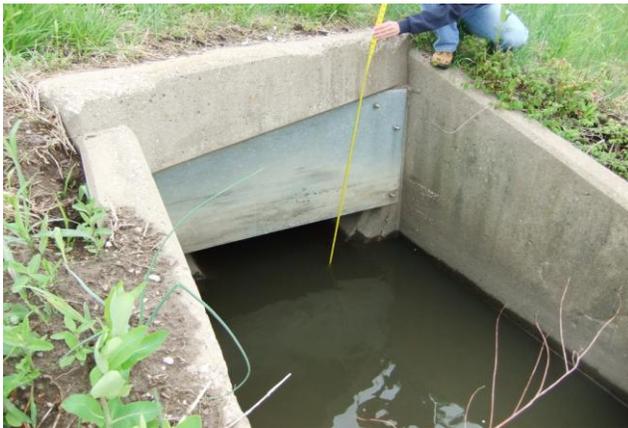
Figure 1. Shrine

Solution: The proposed concept is to install a vegetative buffer around the basin perimeter to improve water quality and help stabilize the shoreline. Riprap should be placed around structures to protect from erosion.

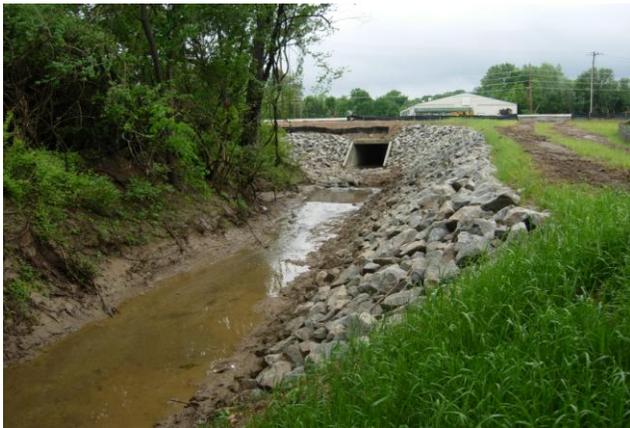
Figure 1. Old Farmhouse Rd./Community Park

Solution: This concept includes the bank stabilization, vertical grade control, and addresses the functionality of the Central School Road culvert crossing by adding a silt wall on the upstream side of the culvert array. Two rock checks are included in the proposed concept. Due to the health of the existing corridor, stabilization of the banks downstream of Central School Road is not recommended at this point; instead, riparian renovation is recommended on this reach. For a section extending 500 feet upstream of Central School Road, banks should be stabilized and a low flow bench should be established.

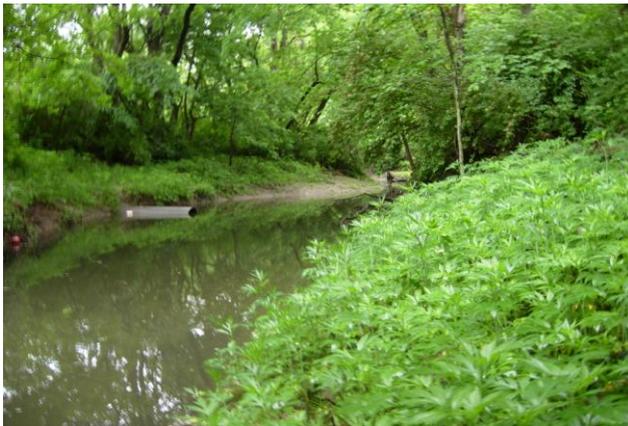
Figure 1. Harvestowne

Solution: Riparian renovation suggested for stream corridor (788 linear feet). Additionally, the buffer on the east side should be enhanced.

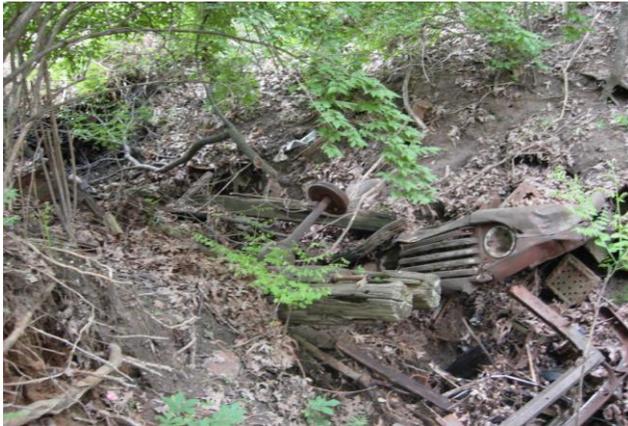
Figure 1. Athens Drive

This existing channel, in Pegasus Farms, is formed by a pipe outlet from Morningside Drive. This pipe discharges to a steep ravine and re-enters a piped system to Kenworth Drive. This very steep channel has an average slope of 0.054 ft/ft with bank heights up to 12 feet. Active bank erosion and dumping of lawn waste was noted in the upstream portion of this reach. The existing woodland corridor should be preserved on this upstream portion. On the downstream portion of the project reach, the corridor is lacking. Access for construction may be difficult because the channel is located in backyards and there are not street crossings in the project area.

Solution: This concept utilizes a series of 13 rock checks to stabilize the invert elevation of the channel. The upstream corridor (200 feet) should be preserved and a downstream corridor, along 315 linear feet, should be enhanced. Large debris should be removed from the channel (shopping cart, old truck).

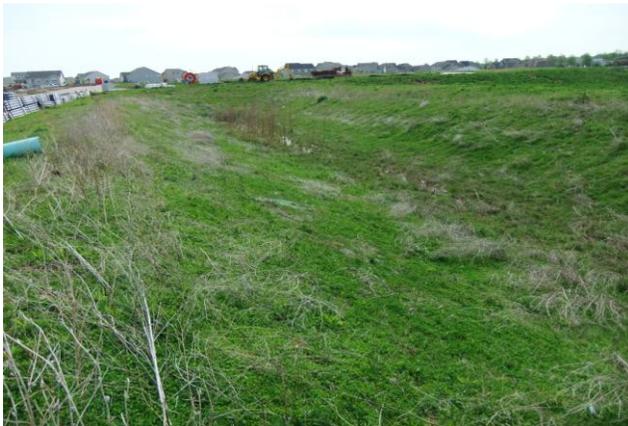
Figure 1. Bellemeade Subdivision Detention

Solution: The concept recommendation includes a vegetated shoreline buffer around each basin, wetland benching, improvements to the landscaping. A wet pond retrofit is recommended for DB-7169-11 and 7169-10.

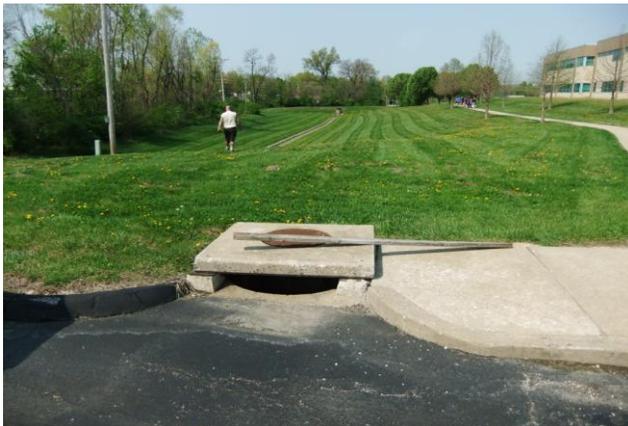
Figure 1. Dubray Middle School

Solution: The concept project is to retrofit the existing detention basin to a wet pond and add buffer along top of basin. For the stream reach, 10 grade controls, benching, and vegetation is recommended. Riparian renovation is recommended for the reach. This stream project and the proposed wet detention basin could be great educational opportunities and signage is included in project.

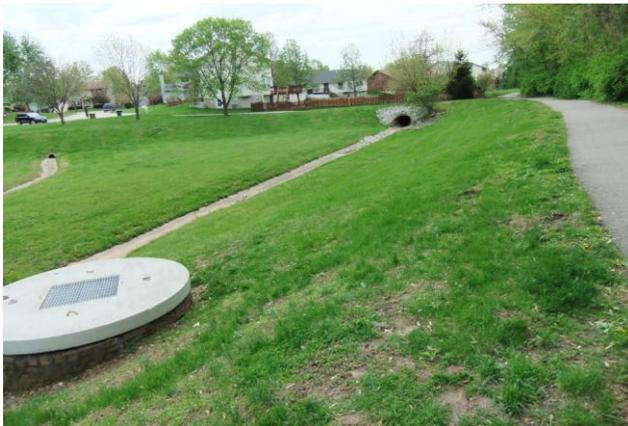
Figure 1. Carrington Place

Solution: This concept includes recommendations for the detention basin and channel stability. For the basin, 1-ft of material should be excavated from the bottom to add capacity. Additionally, the grading on the channel side should be refined with a berm that reaches elevation 488 (along 100 total feet). Signage should be used because of high visibility along trail. The existing concrete swales should be retrofitted using vegetation and settling around the pipe structure should be addressed with grading and riprap protection. For the channel, the entire riparian corridor should be renovated because it is contributing to the stability benefits of this system. This concept addresses bank erosion and shear banks in the main reach (downstream of Willott Road) by installing stable slopes, vegetation, and riprap toe protection on 50% of the slopes (typically the outside of a bend). A series of 6 grade control structures is recommended downstream of Willott. Upstream of Willott, 4 grade control structures should be installed on the east

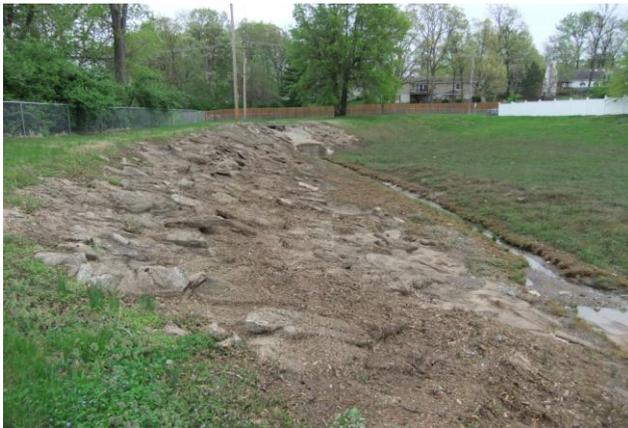
Figure 1. Pegasus Farms/Willott Square

This project area, south of Willott Road, includes two detention basins. The east basin, DB-7169-04, has a grouted riprap bank and low flow channel. There was water in the channel during the field visit and the bottom of the basin was not quickly infiltrating. This basin is undersized although there are no anecdotal complaints. The west detention basin, DB-7169-06, does not retain any volume, an observation and concern raised by the City. This basin was not selected during the screening process for this study.

Solution: This concept increases the capacity and functionality of the east basin by excavating 1-foot of the basin bed, retrofitting to a wet basin, and providing new maintenance practices for DB-7169-04. Additionally, the north side should be raised with a 2-foot berm extending 150 linear feet (to elevation 510). In the west basin, the outlet structures should be modified so that more flow is retained during typical rain events. The concrete swale should be replaced with vegetated swale and the remaining area on the base should be amend with soil that enhances infiltration, then vegetated.

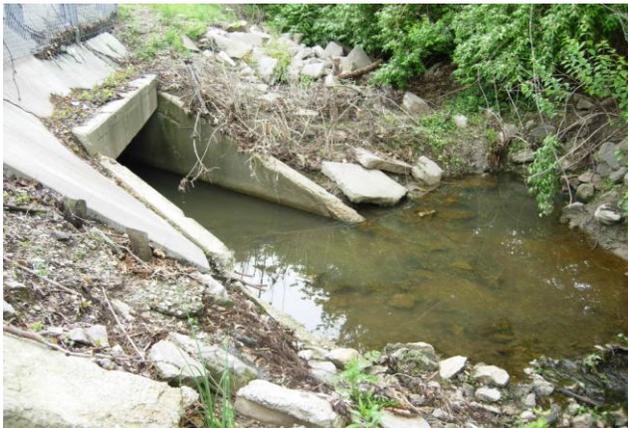
Figure 1. Eldorado

The project is located on West Spencer Branch and includes the reach that extends through the El Dorado Estates, between Mexico Road and Executive Center Parkway. The trapezoidal concrete channel, located at the Mid Rivers Mall along SueMandy Drive is represented in this project reach but not included in the concept. Good pool riffle structure was observed on this reach between Mexico and Executive Center Parkway. Cobble and gravelly sand bed on a hard clay layer was documented. This reach has high banks and a significant amount of debris. The profile of this reach was estimated at 0.0044 ft/ft.

Solution: This proposed concept includes stream stabilization along West Spencer between Mexico and Executive Center Drive. Walls are included in the bank stabilization along the reach due to the constrained nature of the channel. The proposed concept includes 5 rock checks.

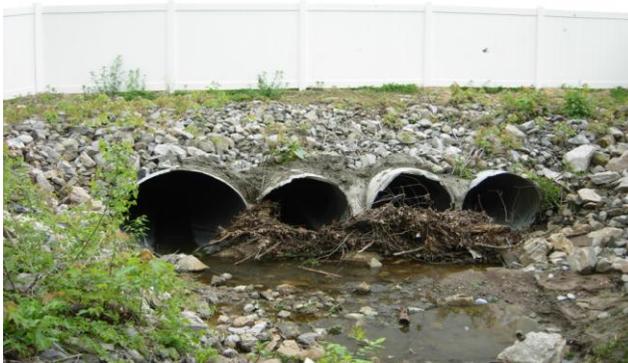
Figure 1. Brookmount Apts.

Solution: To determine if a new culvert array would be necessary to address the flooding complaint upstream, the system that was installed should be further studied. This recommendation includes replacing the culvert array with 4 40-inch RCP pipes and stabilizing the entrance and outlet to ensure that the banks are protected.

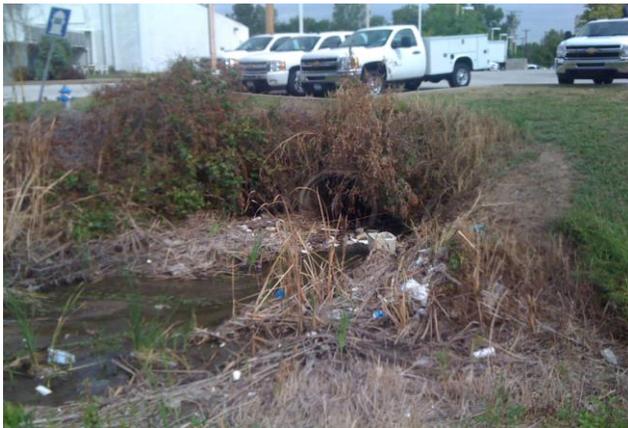
Figure 1. Old Town I-70 Service Rd. North

Solution: This system should be studied in more detail to verify elevations of swale. From the information provided and a rough model of the drainage system, the following recommendations have been developed. Reduce the amount of vegetation in the swale to reduce roughness (ongoing maintenance not included in capital cost). Replace pipes with 48" RCP, set lower.

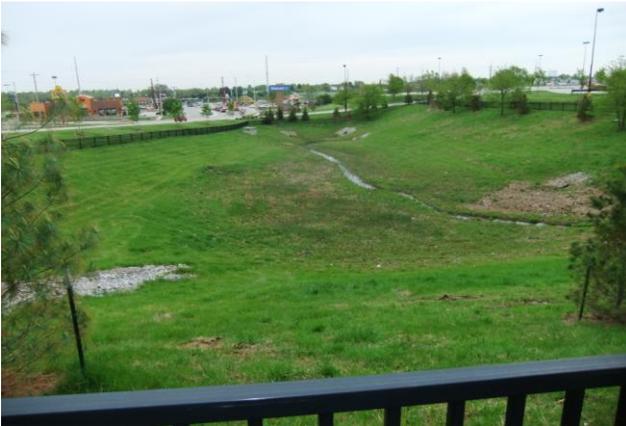
Figure 1. Walmart

This existing dry detention DB-7267-14, located east of Jungermann Road, and south of Hwy 94, is maintained by Walmart. The basin is in overall good condition with some localized erosion.

Solution: This proposed concept includes installation of diverse vegetation in the swale area and recommendations to change mowing and fertilizer maintenance practices. Riprap should be added at basin structures to protect from erosion.

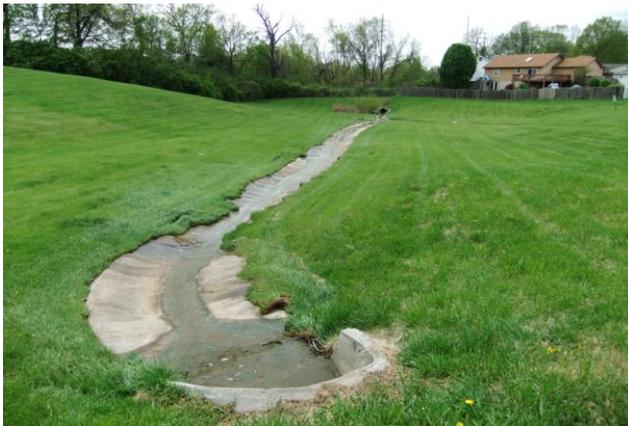
Figure 1. Park Ridge Estates

The existing detention basin, DB-7267-04, is an extension of the surrounding backyards and currently mowed and likely fertilized. This basin has sufficient capacity. The field reconnaissance documented concrete swales and debris around the outlet and localized erosion along the concrete swale. Both stream segments have existing riparian corridors that could be improved and significant debris in the channel. There are localized areas, such as downstream of Centre Pointe Court, where active bank erosion was noted.

Solution: On the channel reach, localized bank stabilizations are recommended on 75 linear feet downstream of Centre Pointe Court and riparian renovation is recommended for the entire reach. One rock check is included in the concept to help stabilize the bed of the channel. In the basin, the outlet structure should be replaced to manage flows, erosion should be addressed in an area adjacent to the concrete swale. Maintenance practices for the basin should include reduced mowing and fertilization.

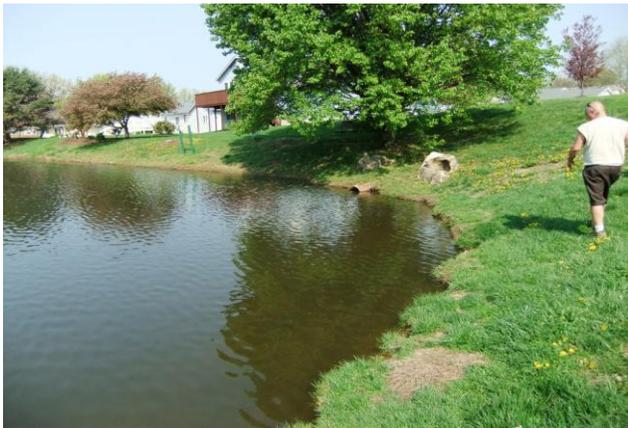
Figure 1. Enwood

Solution: The concept recommendation includes planting a shoreline buffer around the basin to help stabilize this area.

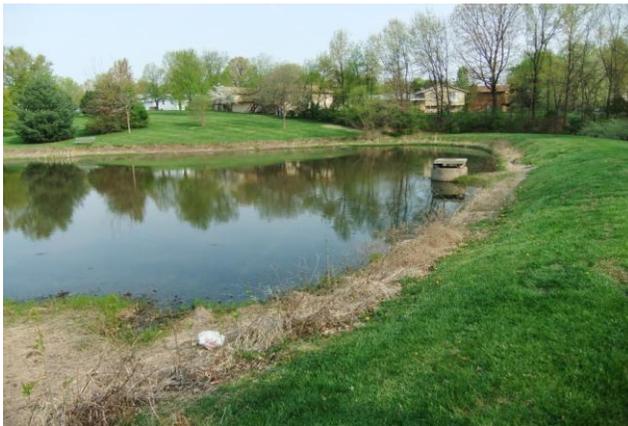
Figure 1. Country Creek

This existing wet detention DB-7268-04, located just upstream of Margaret Brown Court, does not have sufficient capacity. Additionally, algae was noted in the basin during the field visit, indicating that a filter strip may be beneficial. The shoreline did not have any live vegetation, although it appeared that some wetland vegetation may have established in the past.

Solution: The concept recommendation includes planting a shoreline buffer around the basin to help stabilize this area. This basin may be evaluated in the future as part of a regional detention study to alleviate flooding at Jungermann Road.

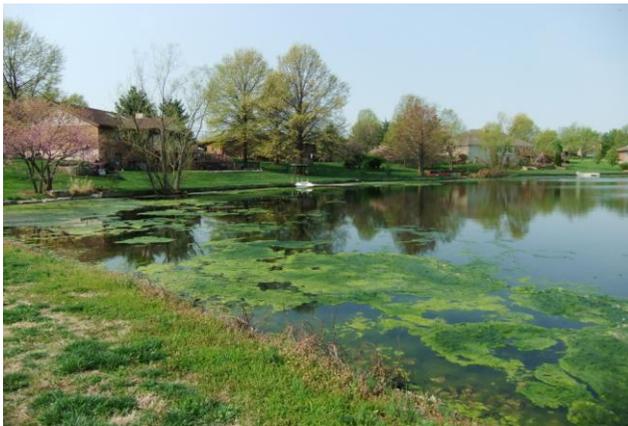
Figure 1. Hidden Lake

This existing wet detention basin, DB-7268-07, is located at Hidden Lake Drive in the Hidden Lake Estates subdivision. The presence of algae was documented during the field visit. The shoreline was protected in some places by decaying railroad ties or a low concrete wall. The basin is used for recreational boating. This basin is an amenity for the surrounding homes but not very accessible to the public. There is an opportunity to address nutrient water quality issues.

Solution: This concept recommendation is to replace the existing concrete drainage flume with a vegetated riprap swale and stabilize confluence with basin. Wetland plantings should be installed in local benched areas within the wet basin and a vegetative buffer should be planted around most of basin, allowing access points for public use. There should be a public education effort regarding fertilizer applications around the basin.

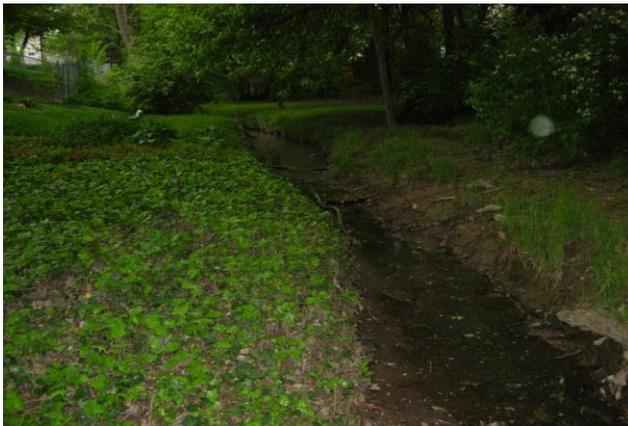
Figure 1. Colby Drive

Solution: This concept addresses localized bank stability on 650 linear feet of the channel (about 25% of the channel within the project area). This bank stabilization work is located in the middle of the downstream reach, upstream of the area protected by riprap. The concept includes use 21 vertical grade controls over the entire reach. Riparian renovation and honeysuckle management is recommended for the entire project area and debris jams should be cleared.

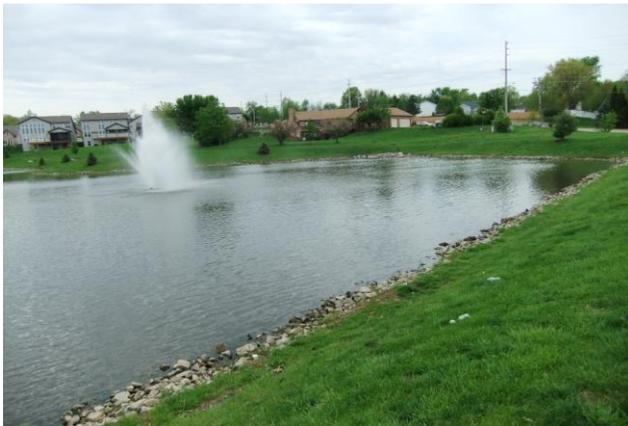
Figure 1. Penny Lane

This existing wet detention basin, DB-7269-01, is located between Spencer Road and Revolution Drive. Overall, the basin is in good condition but lacks a vegetative buffer. Small riprap protection edges the shoreline and a fountain in the middle of the basin provides aeration. There is a potential capacity issue that may be addressed by modifying the outlet structure.

Solution: This concept includes increasing the basin capacity by modifying the outlet structure. Riprap should be placed at all basin structures to protect from erosion. Additionally, a vegetative buffer strip should be installed around the basin perimeter.

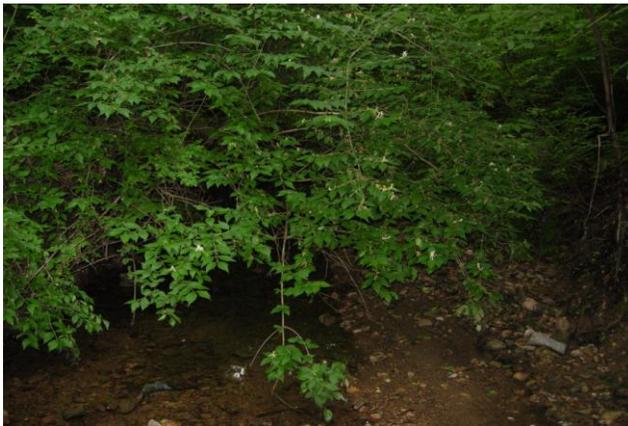
Figure 1. Spencer Crossing

Solution: The recommendation is to renovate the riparian corridor (1164 linear feet).

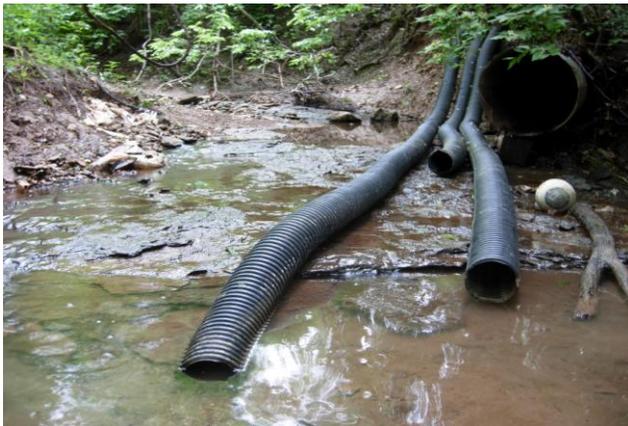
Figure 1. Oak Creek Park

This reach of incised channel lacks floodbenches and evidence of mass wasting was documented during field reconnaissance. In some sections, the channel bed was characterized with bedrock. Some homemade gabion structures were documented. The riparian buffer was not sufficiently wide. The detention basin outfall structure into the channel should be replaced and protected (at the upstream end of the reach).

Solution: This concept addresses bank stability issues along the entire reach of the channel with walls (along one side of the channel), vegetative protection, and 12 vertical grade control structures. The existing riparian buffer should be renovated and widened. New riparian buffer should be implemented in any area where it has been removed by homeowners (estimated at 20% of the reach).

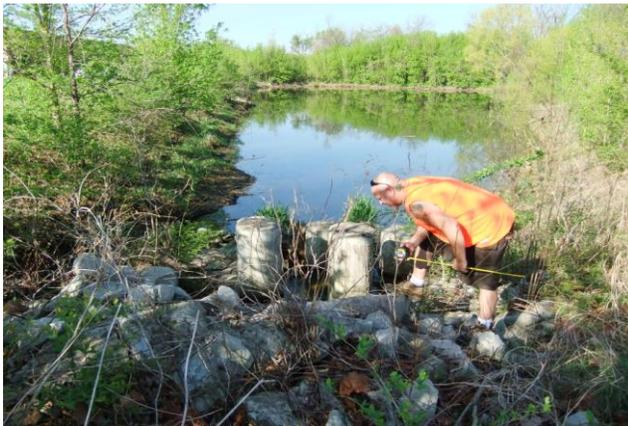
Figure 1. St. Peters Executive Centre

This project area, located close to Executive Centre Parkway and west of St. Peters Center Boulevard, includes two existing wet detention basins, DB-7270-01 and DB-7270-10, and a reach of stream that extends between Veteran's Memorial Parkway and its confluence with Spencer Creek. The south detention basin has a sink hole at the outfall structure and an oil sheen was noted on the basin. This basin has sedimented in and the outlet pipe is 80% full of sediment. The north detention basin appears to be undersized and the outfall structure is not functional. Continuous overtopping of the spillway has led to rill erosion on the berm. The downstream channel is deeply incised below this basin with a dense canopy that prevents the establishment of vegetation. The channel reach north of Executive Centre Parkway is also incised and contributing significant sediment to the watershed. A braided channel and wetland swale was documented in the channel reach extended downstream of Executive Centre Parkway.

Solution: This concept addresses erosion at both detention basins and the stability of the stream reach as needed. At the south detention basin, approximately 2 feet of material should be dredged. A vegetated filter strip, small pockets of wetlands, and new outlet structure are included. At the north basin, the existing outfall structure should be replaced and a spillway should be stabilized. A vegetated filter strip and wetland bench should be established. The short reach between the north basin and the confluence with Spencer Creek should be stabilized. The stream reach, upstream of Executive Centre Parkway, should be stabilized. Ten rock checks should be used to control the bed slope and outfall structures should be protected. A narrow riparian corridor and filter strips would be established along the top of bank. There is a potential to include additional upstream BMPs in this project area to treat water from hot spots such as the car dealership parking lots.

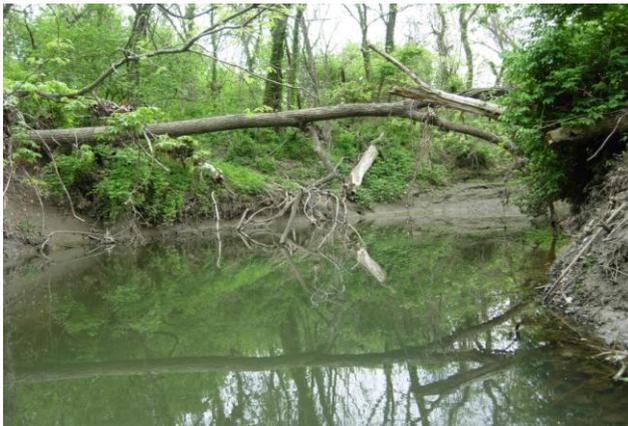
Figure 1. Executive Centre

This project includes a reach of Main Spencer Creek that extends between Executive Center Parkway and Spencer Road. The right bank has failed and will continue to change as the bank consists of silt loam soils without armoring. The reach downstream of Spencer Road has shown that riprap armoring in the trapezoidal channel is a successful solution for this reach. However, the channel shape in this reach has already started to form a bench that reconnects the reach with a wider floodplain. The water surface elevation was completely flat when LIDAR data was taken and therefore, the bed profile should be studied more in depth to determine the necessary grade controls. The stability of this channel does not impact infrastructure at this time but may be contributing substantial sediment to the system.

Solution: This stream stability approach incorporates benching, 1 grade control structure, and vegetation management along the main channel of Spencer Creek at this location.

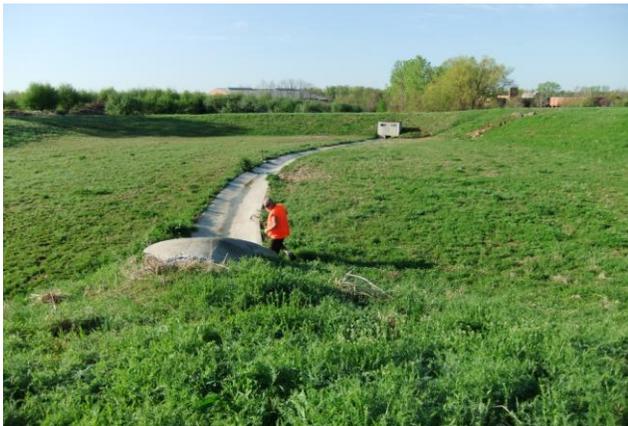
Figure 1. I-70 Executive Centre

This project is located directly north of City Hall and includes approximately 1250 feet of stream and the DB-7270-09 detention basin. The area is associated with flooding of Mexico Road, noted by the City during a 2011 storm event. The City noted that steps have been taken to modify the outlet structure of the detention basin to better control low flow events and create a functional dry detention basin. Additionally, the open channels have experienced severe erosion and contribute significant sediment loads to the system downstream.

Solution: The concept includes stream stabilization along approximately 1250 linear feet with new riparian corridor. Stream reaches on the upstream and downstream sides of the detention basin should be stabilized by establishing a stable slope and vegetation. The channel toe should be protected with riprap and 2 rock check riffle structures are used to control the bed slope on these steep incised channels. The inlet to a pipe upstream of Mexico Road should be modified to include wingwalls and a headwall, reducing entrance losses at this transition. A narrow riparian corridor and filter strips should be established along the top of bank. To address sediment issues in the contributing drainage area, the rill erosion of the slope north of Executive Center Parkway should be addressed by developing a stable slope and establishing vegetation.

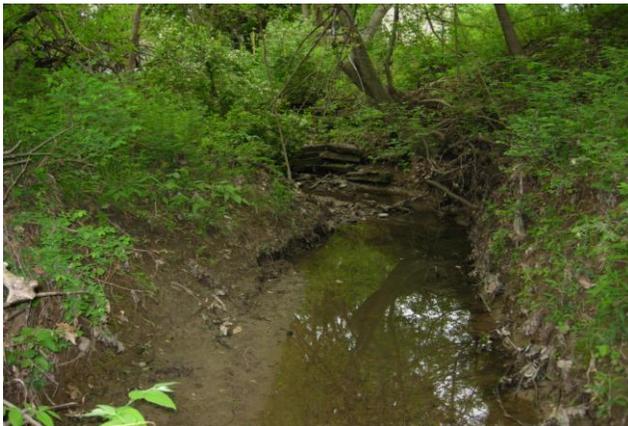
Figure 1. Spencer Rd. Storage

Solution: Construct 300-foot berm, 2-4 feet tall around north and east side of storage facilities, bringing elevation up to 462.
