Stormwater Master Plan 2012

CITY OF ST. PETERS, MISSOURI

BLACK AND VEATCH
PATTI BANKS ASSOCIATES

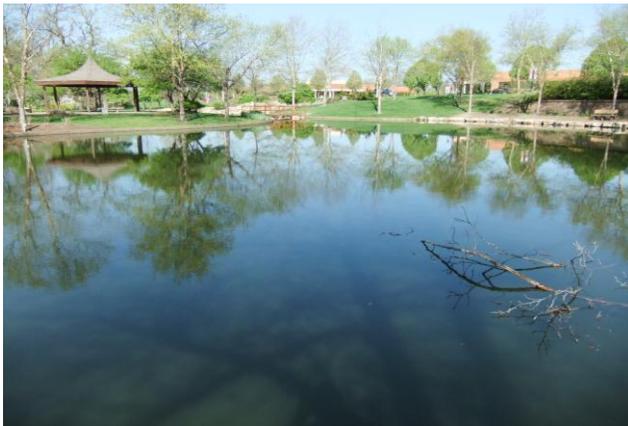
Figure 1. City Centre

Solution: The concept includes stabilizing the channel reach to improve sediment management. A series of 4 rock checks are included to stabilize the bed profile of the channel. To establish a successful restoration project, this channel should be reconnected with a wider floodplain on at least one side. This concept includes relocating the trail to be within the floodplain bench and excavating a wide bench along most of the south side of the channel. At the detention basin, some wetland plants and benching should be incorporated.

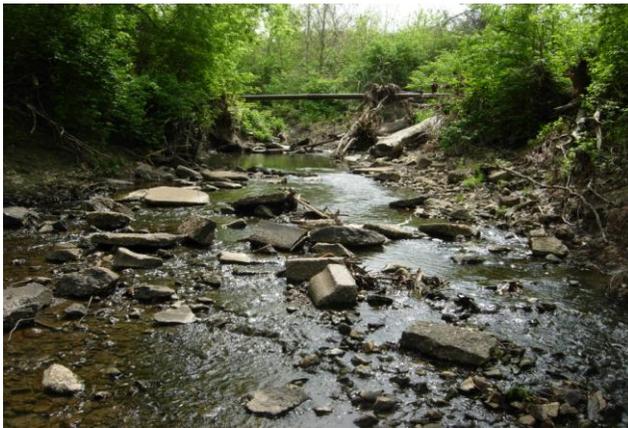
Figure 1. Carrington Estates

Solution: This concept includes bank stabilization of the project reach and repair of mass wasting areas. Additionally, the concept incorporates the installation of 4 rock checks to control the bed profile elevation and prevent further degradation. Riparian renovation of the stream corridor is included.

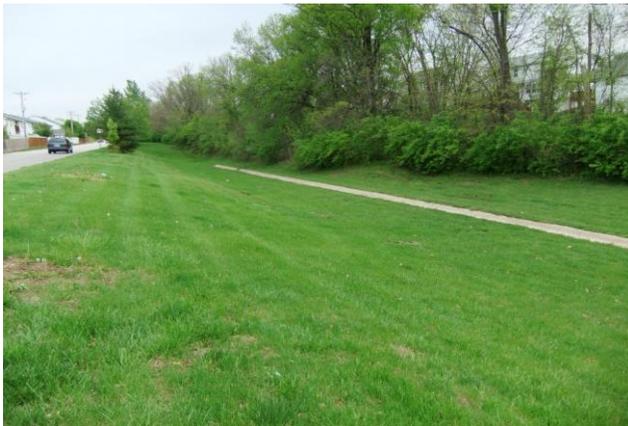
Figure 1. Canyon Creek

This existing detention basin, DB-7366-01, has not been adequately maintained and excessive debris was noted in the basin during field reconnaissance. The outfall structure should be redesigned.

Solution: This concept recommendation includes retrofitting the dry detention basin to an improved dry basin. The outfall structure should be replaced and erosion areas should be stabilized with riprap. The concrete swale should be removed and vegetated. The surrounding area should be amended with soils that enhance infiltration, then seeded.

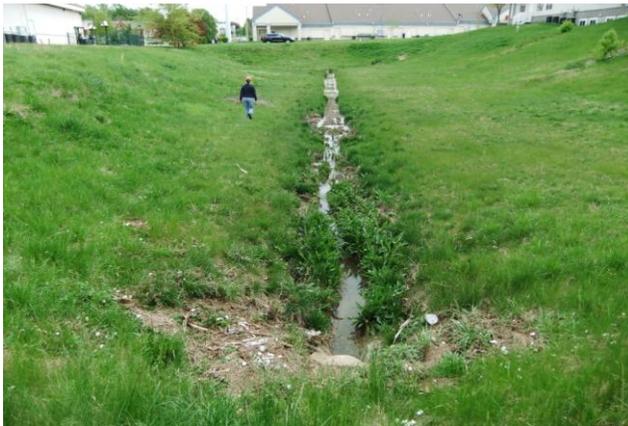
Figure 1. Triad Center Dr. & Queens Ct.

Solution: The concept includes retrofitting the existing dry detention basins into wet basins for improved water quality. All structures are replaced and the concrete flumes are removed. Wetland and perimeter plantings should be installed after some excavation and grading work. Riprap should be placed to protect each new structure from erosion.

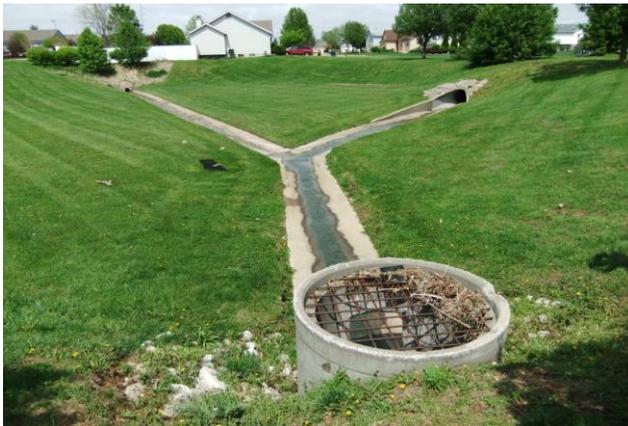
Figure 1. Ashleigh Estates

Solution: The proposed concept includes replacing the existing concrete swales with riprap vegetated swales. This project requires approximately 5 more ac-ft of storage to address capacity concerns and provide water quality benefit. Riprap should be installed at all structures to protect from erosion.

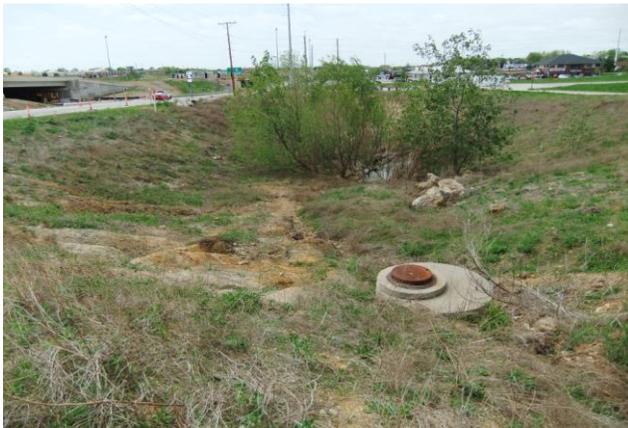
Figure 1. Queensbrooke Village

This existing wet detention basin, DB-7367-19, is located northeast of the intersection of North St. Peters Parkway and Woodstone Drive. Rill erosion was observed on the banks during the field visit. The basin has sufficient capacity.

Solution: The proposed concept includes a filter strip buffer between the roadways and basin. Additionally, grading and vegetative establishment on the basin slopes should be completed to address existing erosion. The water quality volume should be developed and revegetated. Riprap should be placed at all structures to protect from erosion.

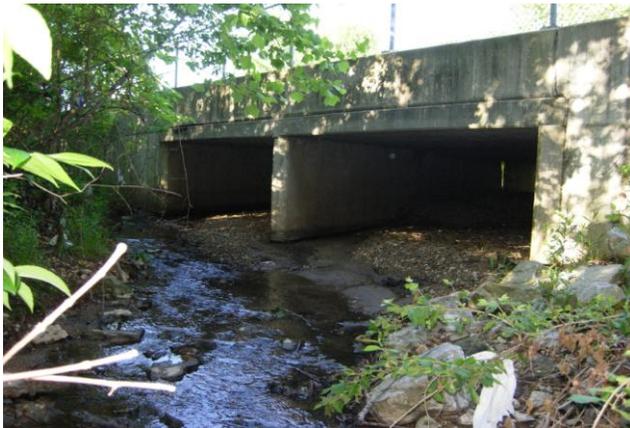
Figure 1. Jungermann Road at Spencer Creek

The Jungermann Road Bridge project is located along the main channel of Spencer Creek. This has been an area of concern during each of the significant 2011 storm events. The existing hydraulic model does not show flooding in this area during events as large as the 25-year however the City has documented roadway ponding several times in 2011. There are two possible causes for this difference between modeling and reality: 1) the open channel provides sufficient conveyance but local drainage infrastructure is inadequate to convey flow from the street, 2) the USACE hydrologic analysis for the area is not representative of contributing drainage area and the open channel does not have sufficient capacity. Also, the conveyance capacity of the downstream channel may be the cause of flooding at Jungermann Road.

Solution: Several options were evaluated at this location. The modeling approach used in the USACE models and assumed for the updated study did not produce overtopping of Jungermann Road at this crossing. A more conservative assumption was applied in the HECRAS model routing a higher flow through the bridge and this produced overtopping. Upstream detention should be considered when the hydrology of this contributing basin is further refined. Potential detention locations are indicated in the CIP report. To address overtopping that resulted from the conservative modelling approach, the existing culvert at Jungermann should be replaced with a bridge. The sump area along Jungermann should be filled - impacting approximately 800 linear feet of this road. Additionally, a berm should be constructed on the north side of the channel, downstream of Jungermann Road.

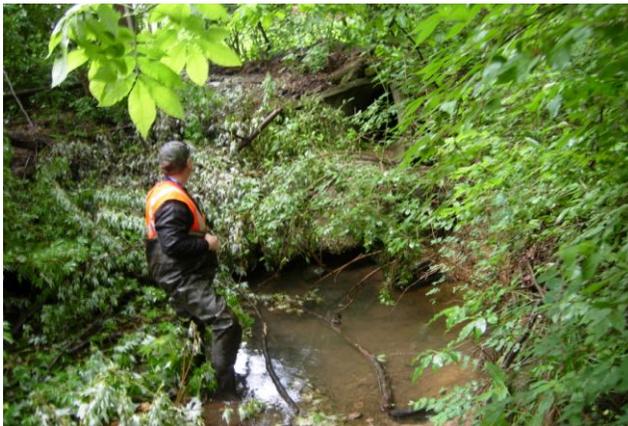
Figure 1. Tanglewood

This existing stream reach, located between Autumn Leaf Drive and Jungermann Road, is in the Tanglewood subdivision. An unnecessary culvert crossing may be creating a constriction in flow. Bank cutting was evident and invasive vegetation in a narrow riparian corridor was noted.

Solution: This concept includes stabilization of each bank by sloping and vegetating. Management of riparian corridor is another feature of the recommendation. Two rock checks are included to control the bed profile elevation.

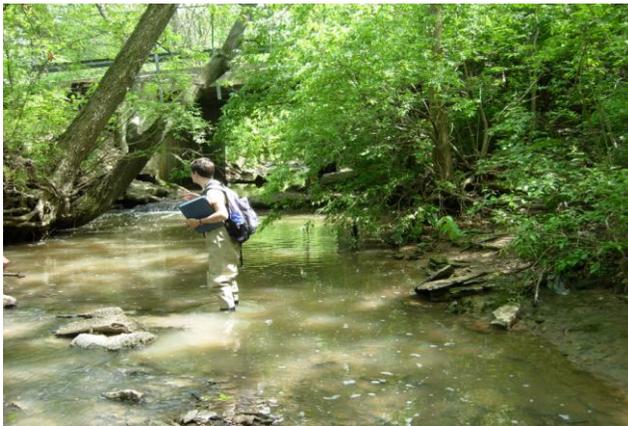
Figure 1. Burning Leaf Drive

The crossing of Burning Leaf Drive in the Tanglewood subdivision is currently overtopping. Six structures are impacted by the 100-year inundation area.

Solution: The low area at Burning Leaf Drive should be raised along approximately 300 linear feet and 3 10x10 culverts should replace the existing bridge crossing. One rock check is included to help stabilize the bed profile of the channel. Additionally, 150 linear feet of channel improvements will be necessary as part of the culvert installation. One other option evaluated was new regional detention upstream, however, there was not sufficient land available to add the capacity needed to reduce peak 100-year discharge.

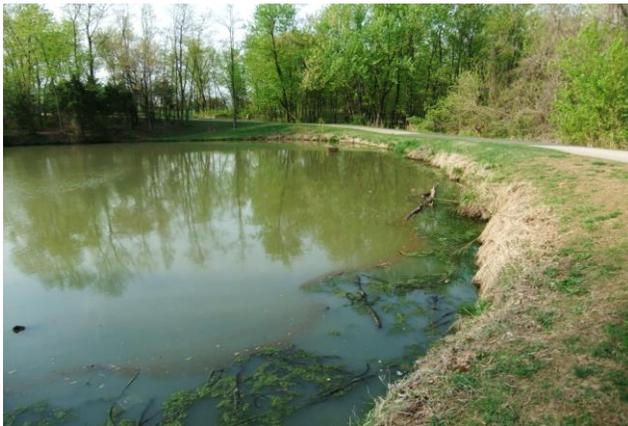
Figure 1. Laurel Park

The existing wet detention basin, DB-7368-09, is located at a City Park in the Huntleigh Estates subdivision. Erosion was noted around the perimeter of the basin, particularly at the location of an existing asphalt trail. Failure at the outfall structure was also noted.

Solution: The concept proposed includes utilizing this accessible, City-owned detention basin as a water quality project. Erosion issues should be addressed along the bank with riprap shoreline protection. A buffer that includes wetland vegetation should be established around the perimeter with breaks to maintain access to the water.

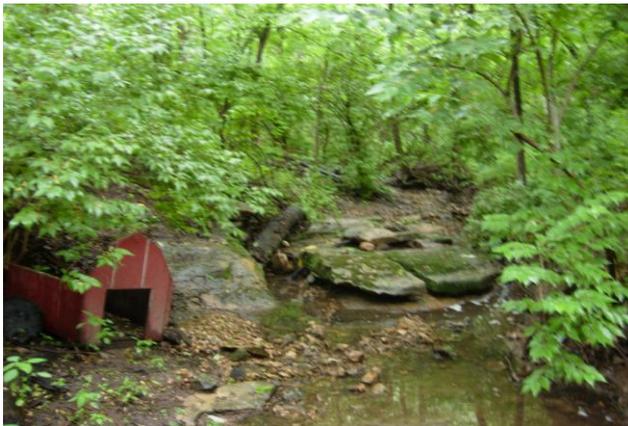
Figure 1. Kelly Leaf

This stream reach along the Tanglewood tributary was characterized as slightly incised with sharp meanders, significant debris jams, and good cobble bars. The buffer on the left bank was documented to be in good condition.

Solution: The recommendation for this project reach is to preserve the corridor through riparian renovation. Six rock checks are included for vertical grade control.

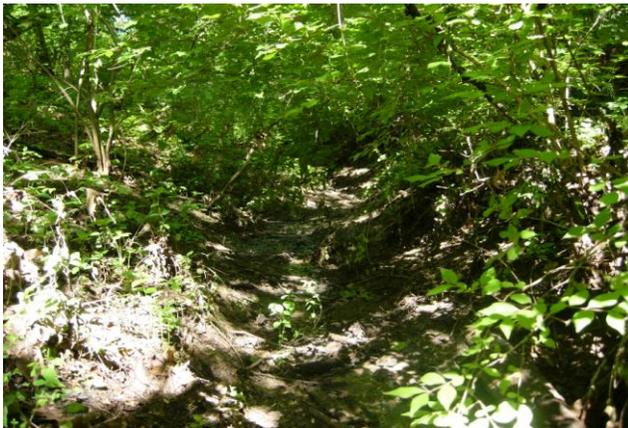
Figure 1. Jungermann Office Center

This project stream reach is located on the Hidden Lake tributary in the Jungermann Office Center subdivision and extends between Hermana Lane and McClay Road. The outfalls along this reach are not protected and could lead to significant bank erosion. In some reaches, the bank failure threatens existing concrete retaining walls that have a fractured limestone base.

Solution: Stream stabilization is recommended for this reach and due to the close proximity of structures, the use of walls will be necessary along portions of the reach. This very incised channel should be reconnected with a floodplain and therefore, the recommendation is to remove portions of the existing bank to create a wider bench. These areas will need to be established with new riparian corridor (assumed to be at least half of the entire reach). Six grade control structures will be used to stabilize the bed profile.

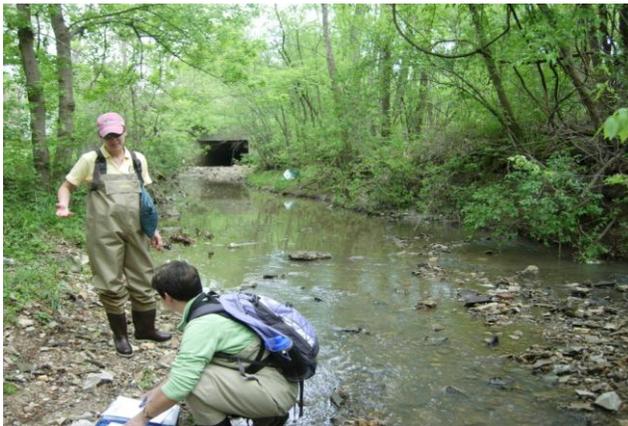
Figure 1. Spencer Creek in Millwood Subdivision

Solution: The proposed solution addresses flooding of 2 residences by adding fill in the floodplain downstream of Millwood Drive and completing channel improvements along Spencer Creek. Additionally, IP-7368-2-1, a project that includes improvements to Burning Leaf Drive, must be completed to address flooding. Limited stream stabilization approaches are included along 25% of the Spencer Creek main channel (the most upstream reach within project boundary) and riparian renovation is included in the entire project area. Seven rock checks are included to stabilize the bed profile. Upstream regional detention was evaluated as an alternative, however, it was determined that insufficient area was available to add a level of detention that would significantly reduce the 100-year water surface elevation.

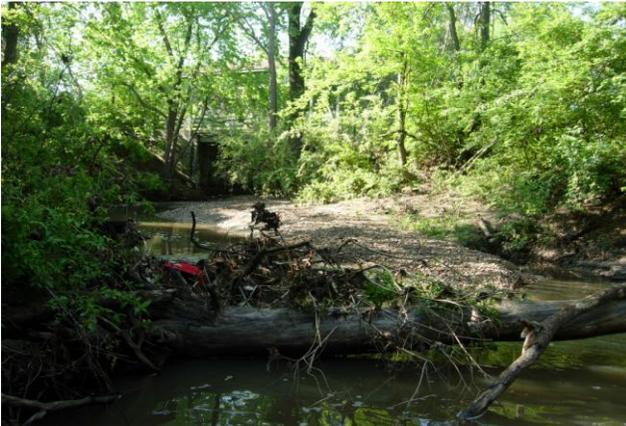
Figure 1. Spencer b/t Sutters Mill and Boone Hills

Solution: The proposed solution addresses flooding by replacing the existing culvert array at Boone Hills Drive with 4 12x15 boxes and filling floodplain areas just north of Showboat Circle Drive on both sides of channel to raise floodplain grade by 2 feet. This project also includes limited stream stabilization approaches are included along the upstream 2414 linear feet of this project reach. Four rock checks are included to stabilize the bed profile of the channel. Riparian renovation is included in the entire project area (3597 linear feet).

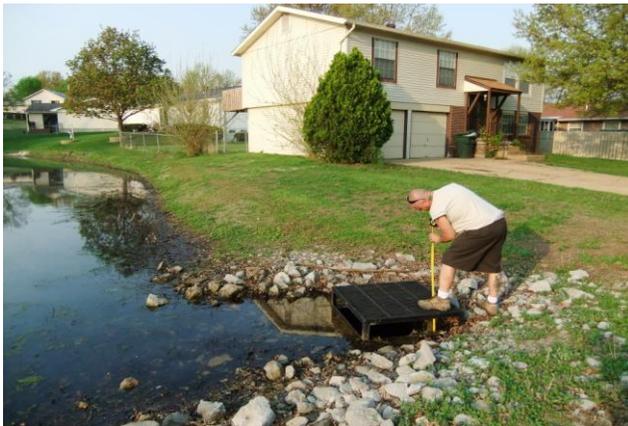
Figure 1. Applewood

Solution: The concept recommendation includes replacement of the outfall structure, implementing a shoreline buffer of vegetation and riprap, and increasing capacity by excavating additional 2 feet from the bed of the basin. The basin is borderline on 25-year capacity and this additional storage will prevent street flooding.

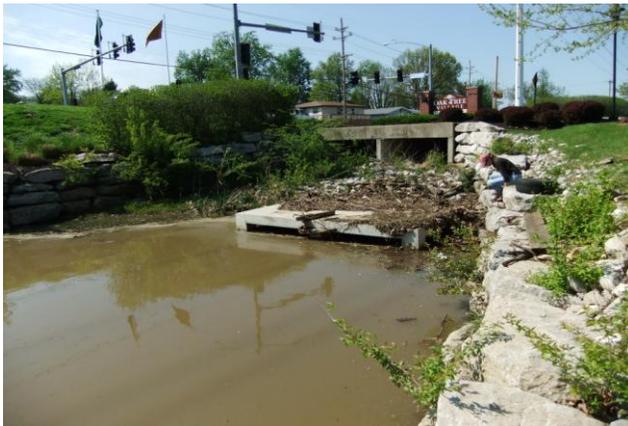
Figure 1. Boone Hills Drive and Jungermann Road

Solution: This concept includes improvements to the existing detention basin, development of a new dry detention basin west of Jungermann, and channel improvements. At the existing basin, the outfall structure should be further studied. A forebay structure should be added to better manage debris in this basin. A vegetative buffer should be established along the street that runs adjacent to the basin. In the upstream reach, the left bank should be repaired with a 5-ft wall and sloped/vegetated section. Three rock check structures are included to stabilize the bed profile of the channel. The riparian corridor should be renovated along the entire reach. To the west of Jungermann Road behind 410 Jungermann Road, a new dry detention facility is proposed with the addition of a 70-ft long berm that raises the grade 4 feet.

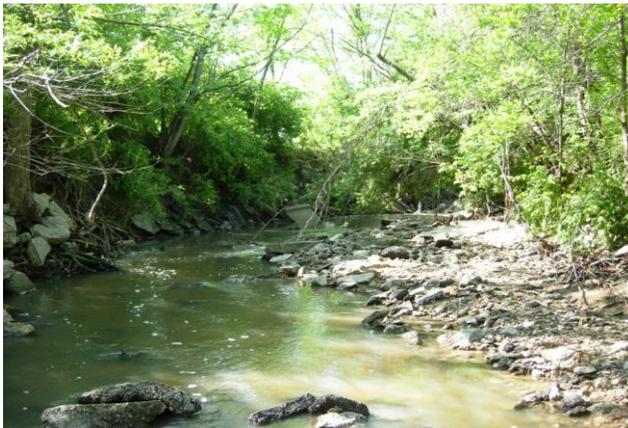
Figure 1. Spencer Trail

This stream reach, located north of Willott Road, is along the main channel of Spencer Creek. Each backyard condition is different and high banks were observed along portions of the reach. Much of the channel was characterized as a long riffle run, stable channel bed, banks were armored with concrete slabs in some areas. There was limited scour around drainage structures

Solution: This concept includes limited bank stabilization to address bank cutting observed in the field. This bank stabilization is recommended for the middle 575 linear feet of the reach along Spencer Creek Park and upstream of the crossing. The riparian corridor along the entire length of channel should be renovated. Two rock checks are included to stabilize the bed profile.

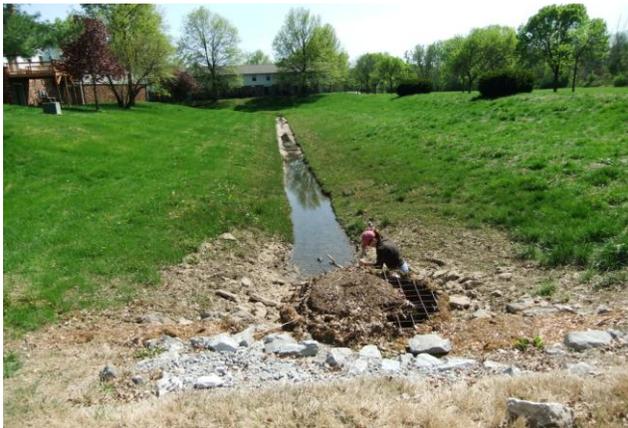
Figure 1. St. Peters Condos Detention

This dry detention basin, DB-7369-07, is located north of Willott Road in the St. Peters Condos subdivision. Erosion was noted around the outfall but the structure was in good condition. This basin is located along an existing trail and has good visibility.

Solution: The proposed concept includes a retrofit to improved dry detention. The high percentage of impervious drainage area to the basin makes the location a good candidate for water quality improvement. Wetland plantings, removal of the concrete flume, and a meandering low flow are all included in the concept. Additional storage volume (1 acft) is excavated.

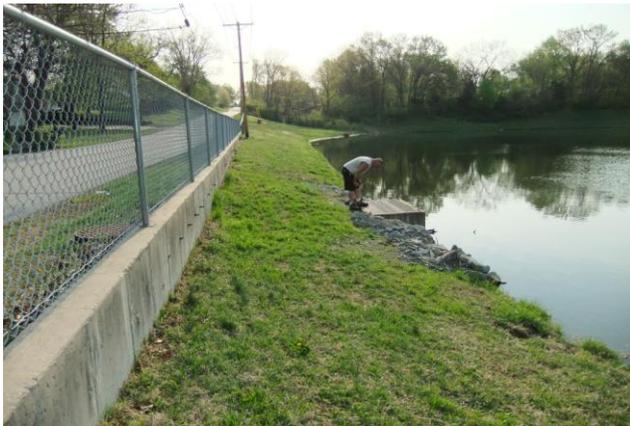
Figure 1. West Drive

Solution: This concept includes improvements to the basin and each of the contributing tributaries. At the detention basin, the capacity should be increased by raising West Drive and replacing the outlet structure. Wetland benching should be established on the southwest and a vegetated buffer should be installed around the entire perimeter. The Hi Pointe tributary entrance to the basin should be regraded to enter on the upstream end (reducing the stream length by 529 linear feet). Riparian renovation is recommended throughout the remaining reach. Stabilization of the Peach Street Tributary includes two strategies, 1) stabilization and vegetation downstream of Peach St., 2) narrow riparian corridor re-established upstream of Peach St. A total of 6 rock check structures are included to stabilize the bed profiles of these streams.

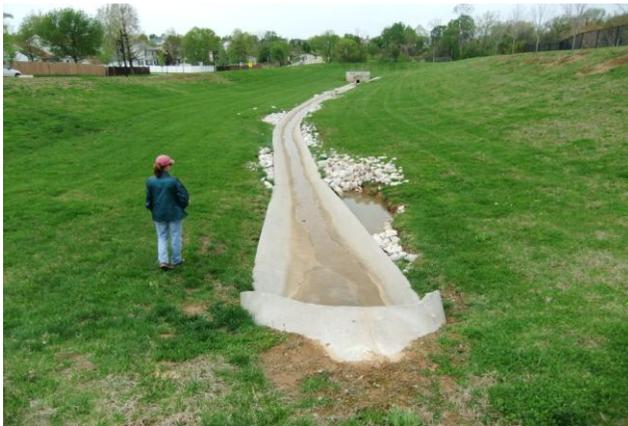
Figure 1. Fort Zumwalt East HS

Solution: The concept recommendation is to retrofit the existing dry detention basin to an improved dry detention and use a silt wall at the downstream end to control flow leaving the basin during small storm events. The concrete flume should be replaced with a vegetated swale and the bottom of the basin should be revegetated to enhance infiltration. Additional capacity at this location does not address improvements on Spencer Creek. The basin has sufficient capacity for the 100-year event.

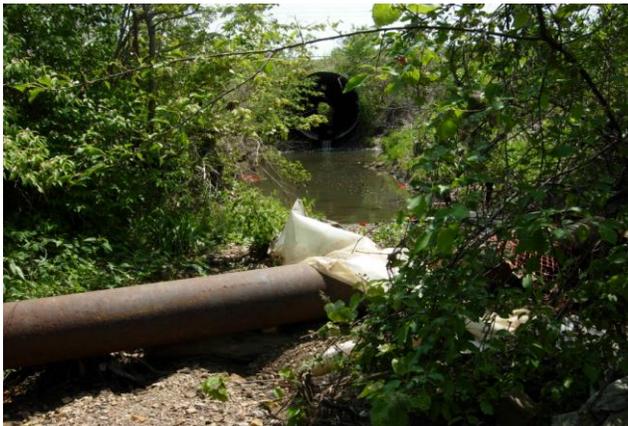
Figure 1. E. Spencer Creek d/s of Jungermann Rd

Solution: The recommended concept is to stabilize the existing channel by sloping and vegetating. Five rock checks are included to stabilize the channel bed. Additionally, the concept includes establishment of a riparian buffer.

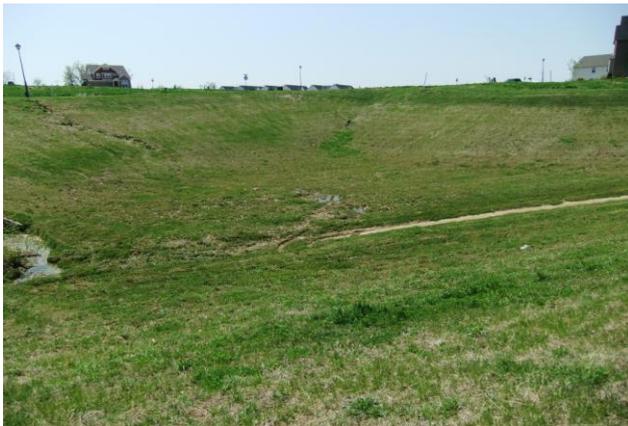
Figure 1. Bella Vista Subdivision

Solution: The recommended concept is to replace the existing concrete swale with vegetation, revegetate the dry detention area and incorporate amended soil in the base, establish vegetation on side slopes, riprap around structures to reduce erosion, reduce mowing, address some rill erosion.

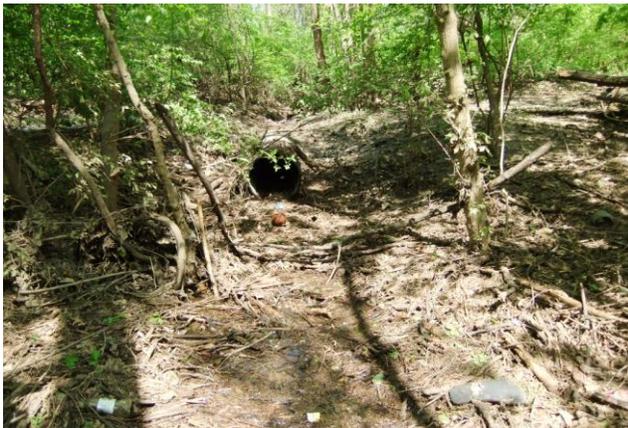
Figure 1. Sun River Village

Solution: The proposed recommendation includes reconstruction of the detention basin into a wet basin and the development of a pocket park. Stabilization is recommended on downstream reach (very incised channel with unconsolidated bed material and soft material on high banks). Stabilization should include benching. Riparian renovation is recommended for the entire project reach.

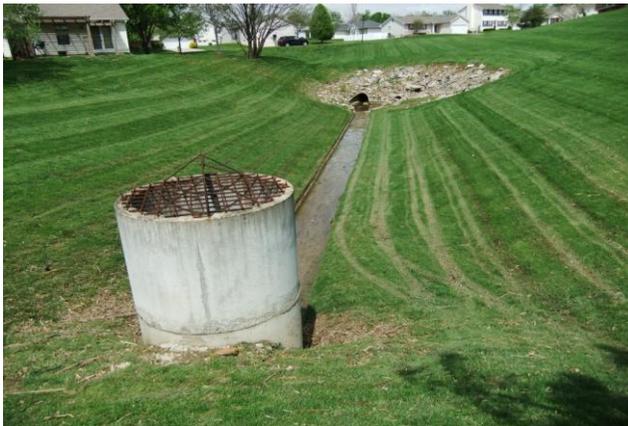
Figure 1. Windwood

Solution: The proposed recommendation includes replacing the concrete swale with a vegetated swale to enhance infiltration. Riprap should be placed around structures to protect from erosion.

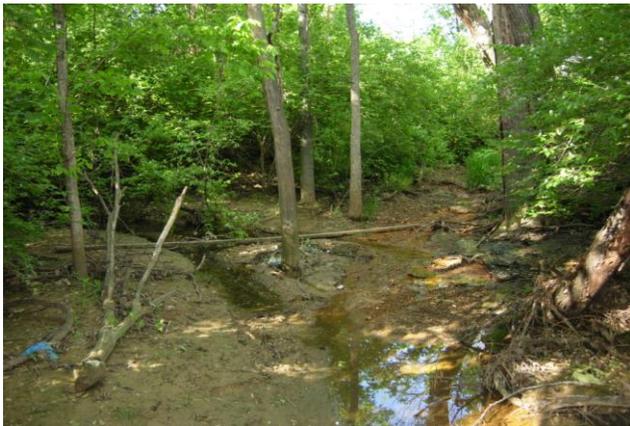
Figure 1. Villages of Windwood

Solution: Riparian renovation is recommended for this stream corridor. (686 linear feet).

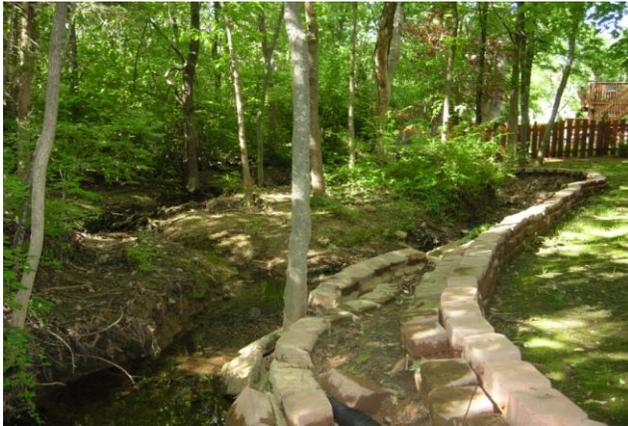
Figure 1. Magnolia Manor

Solution: This concept includes 5 vertical grade control structures and renovation of the riparian corridor. There will be significant grading and clearing to establish a stable slope and remove debris in the channel.

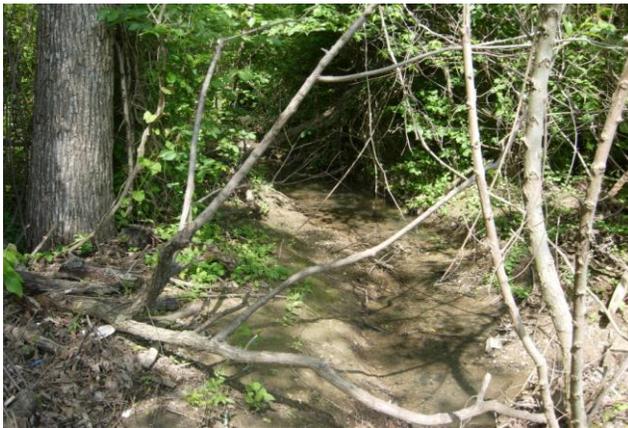
Figure 1. Pointe of Heritage Crossing

Solution: This concept includes 6 vertical grade control structures and vegetation management to develop a more stable channel system. Benching was considered but excluded because of the established trees in this reach and the downstream detention that slows flow. A high wall behind the properties on Calvert Place should be further investigated.

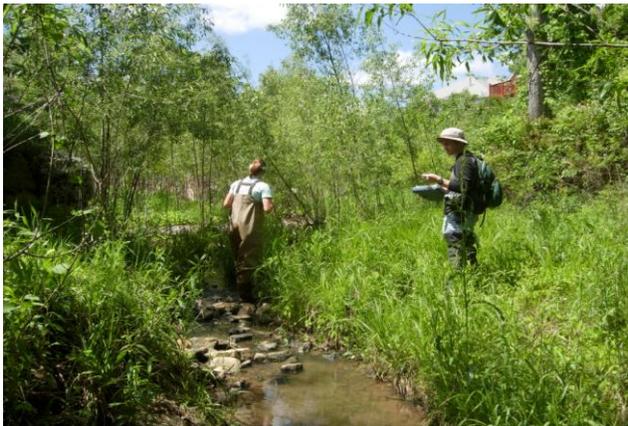
Figure 1. Heritage Manor (PC-1)

Solution: This large BMP should continue to be maintained. The concept recommendation is to develop this area into a more educational and public park with a boardwalk, educational signage. Limited grading is included to address standing water in the backyard along Plantation Manor Court.

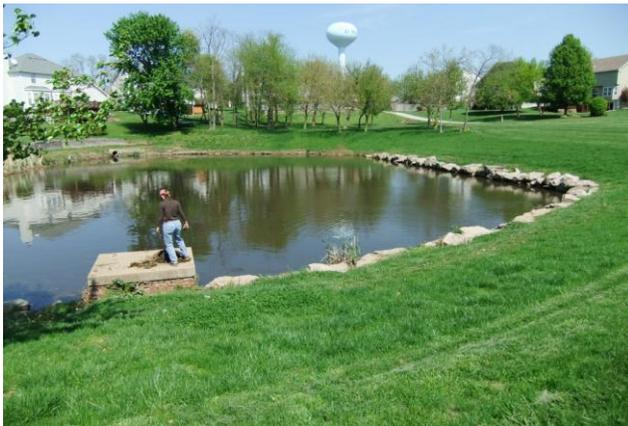
Figure 1. Huntleigh Estates

Solution: The concept recommendation at this project location includes addressing erosion along bank, incorporating wetland plants and a vegetative buffer. An additional 0.5 acft of storage is recommended.

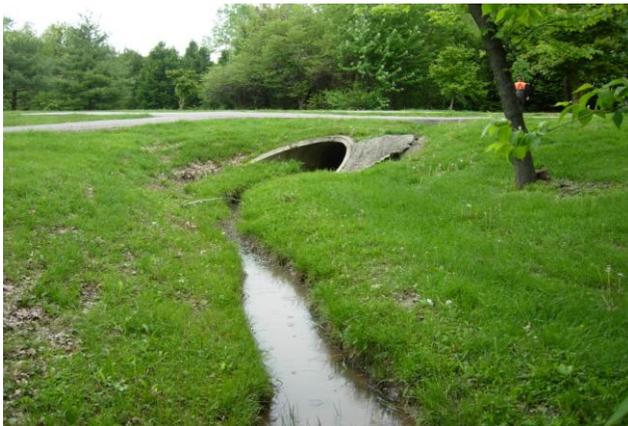
Figure 1. Laurel Park, McClay Valley Blvd

Solution: Riparian renovation suggested for stream corridor (904 linear feet).

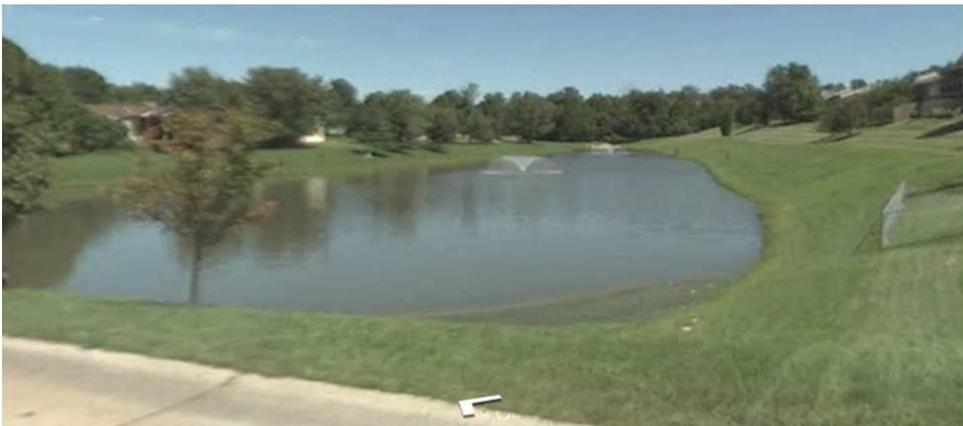
Figure 1. McClay Valley Detention Basin

The McClay Valley Detention Basin, DB-7468-06, receives a significant amount of debris and flow from upstream sources and presents a unique demonstration opportunity as a larger detention basin in the watershed. Additionally, the City noted that the contributing storm sewer infrastructure is not designed to adequately drain the surrounding area to the basin.

Solution: The conceptual solution is focused on addressing the issues at the McClay Valley detention basin and restoring a second detention upstream of the large basin. A berm embankment and outlet works should be constructed for the upstream detention basin. At the main basin, a forebay should be developed with wetland plantings and the outlet structure may be modified. Local drainage infrastructure to the main detention basin should be replaced to allow functional drainage. Edge treatment may include a vegetative buffer, wetland bench, or combination established on the perimeter of the main basin.

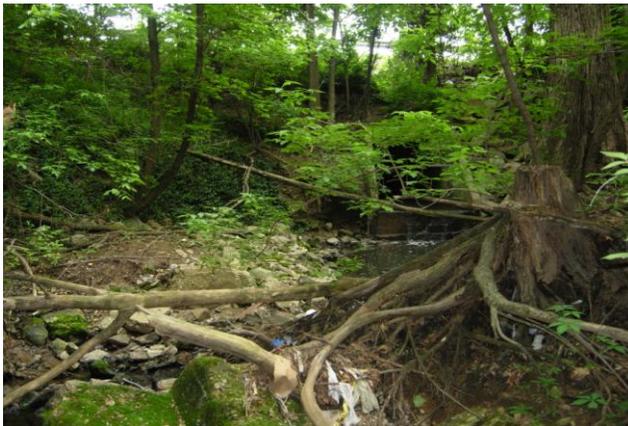
Figure 1. Venture Dr.

This project area includes a short reach of open channel between piped systems. The channel has a good corridor and very tall steep slopes. Rill erosion was noted, likely from parking lot drainage on the east.

Solution: Stabilize banks and rill erosion with the use of walls, grading, and vegetation.
